KEYSTONE WOODS LAKE DAM (29-5)

2021 Dam Safety Inspection Report
Hamilton County, IN | September 2021
Inspection Date: August 3, 2021

Burke Project No. 15-0171.00004

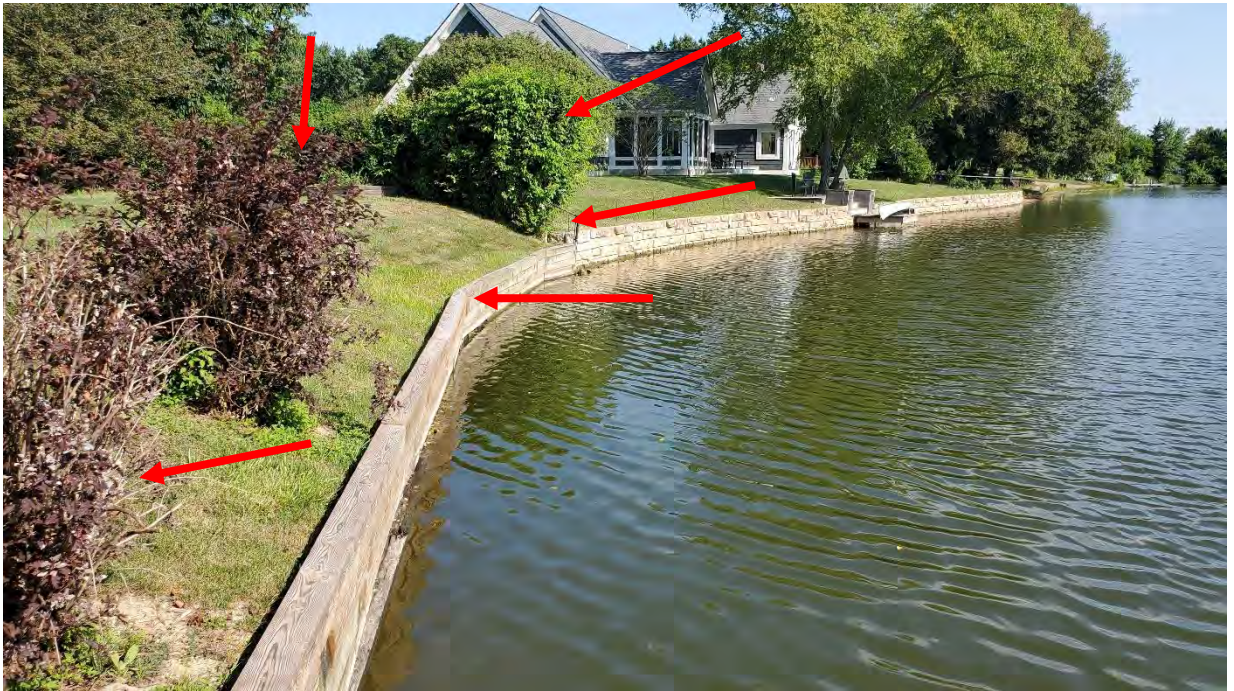
Top: Upstream slope right side. Note timber seawall protection on this section with slight deflection towards lake. Also note several encroachments of fences, trees, and bushes.

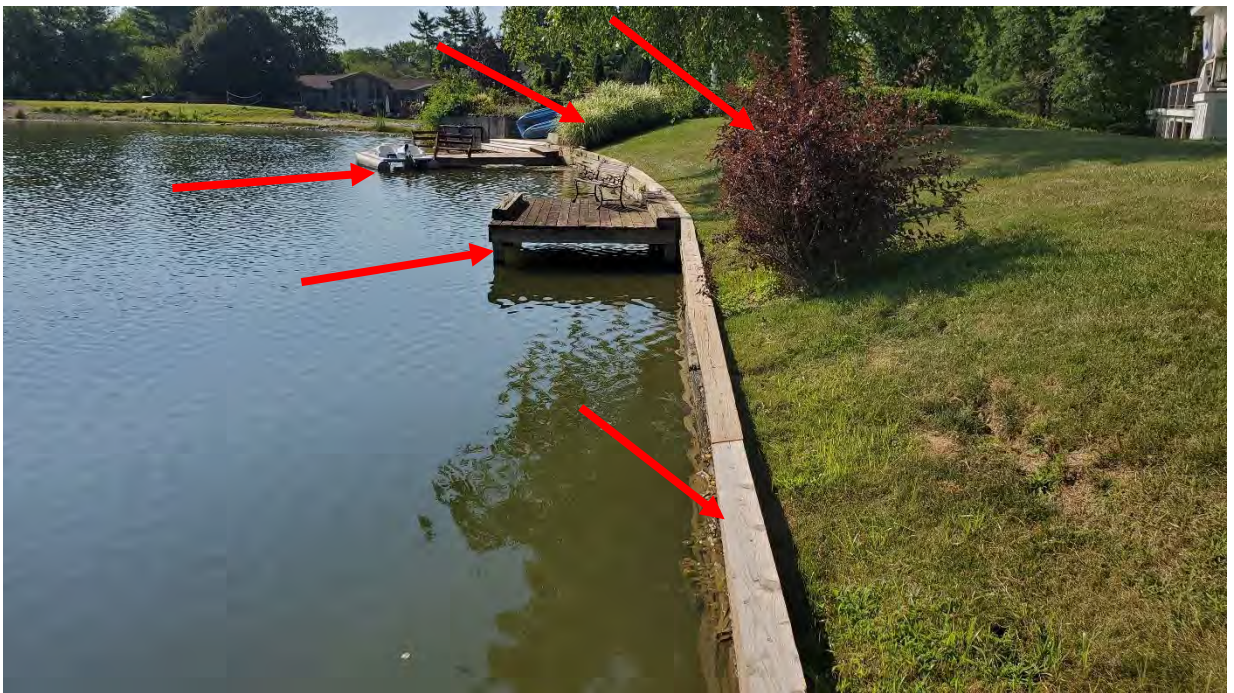
Bottom: Upstream slope right side. Note timber seawall protection on this section with slight deflection towards lake. Also note several encroachments of docks, fences, landscaping, trees, and bushes.

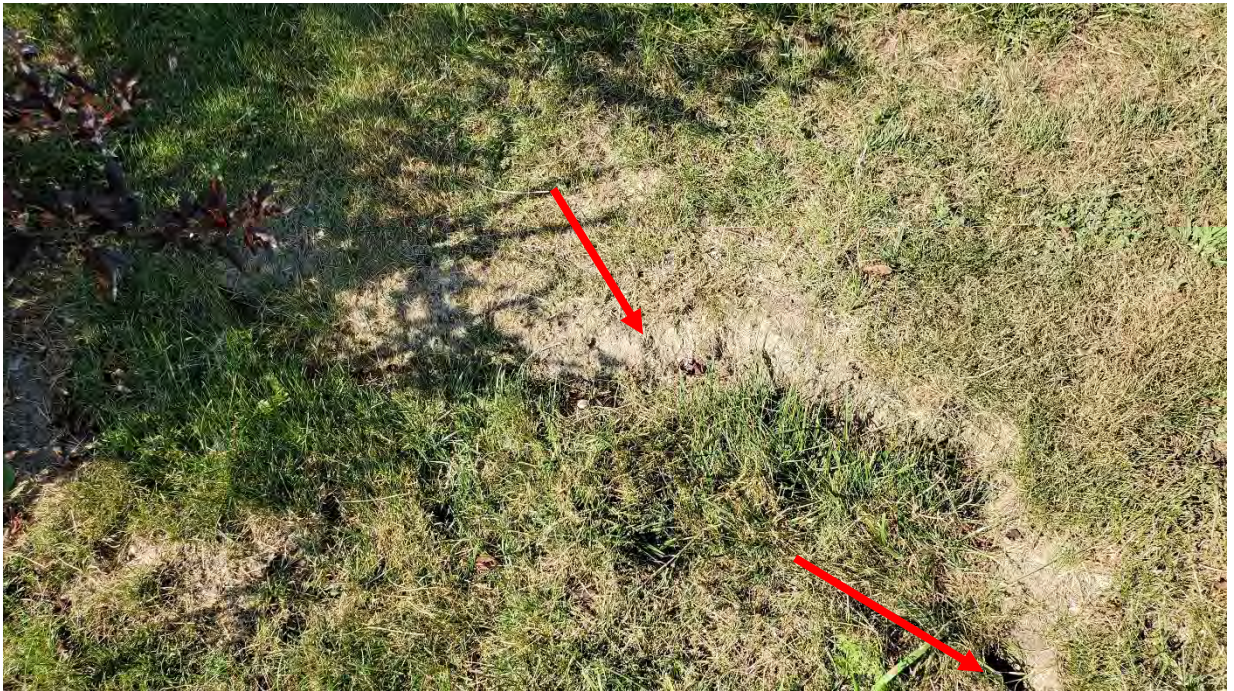
Top: Upstream slope right side. Note small burrow and rodent run.

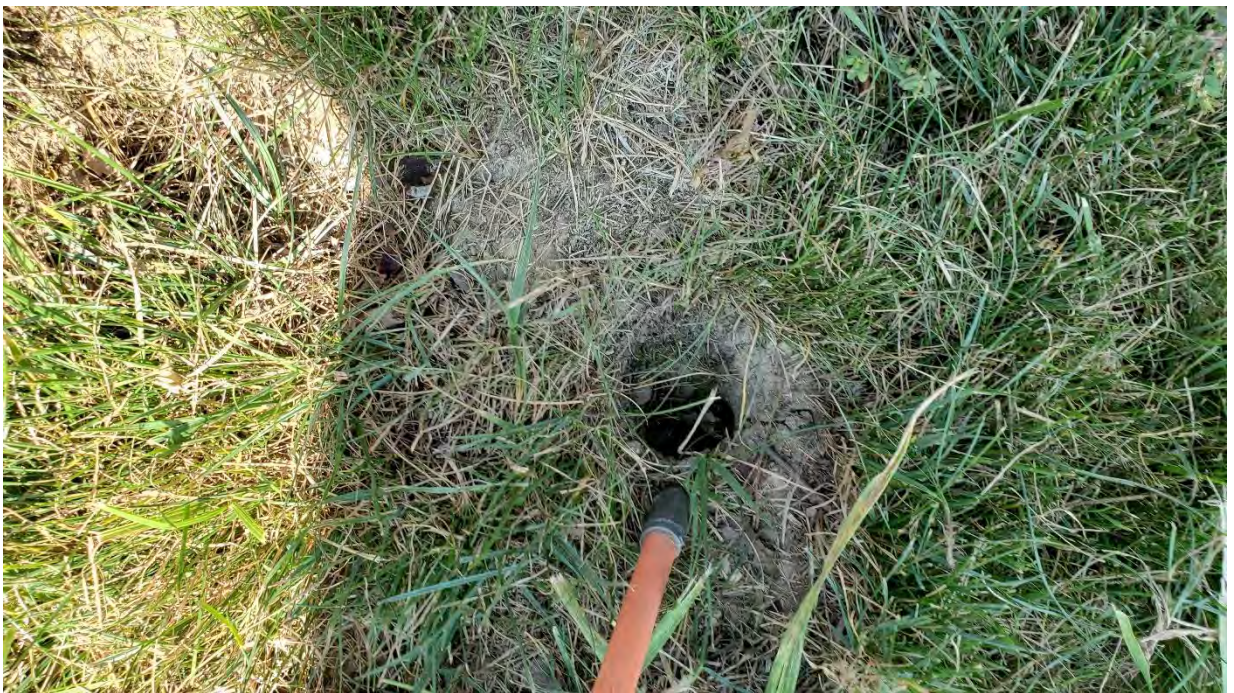
Bottom: Upstream slope. Note rodent burrow (typ.) located sporadically along embankment.

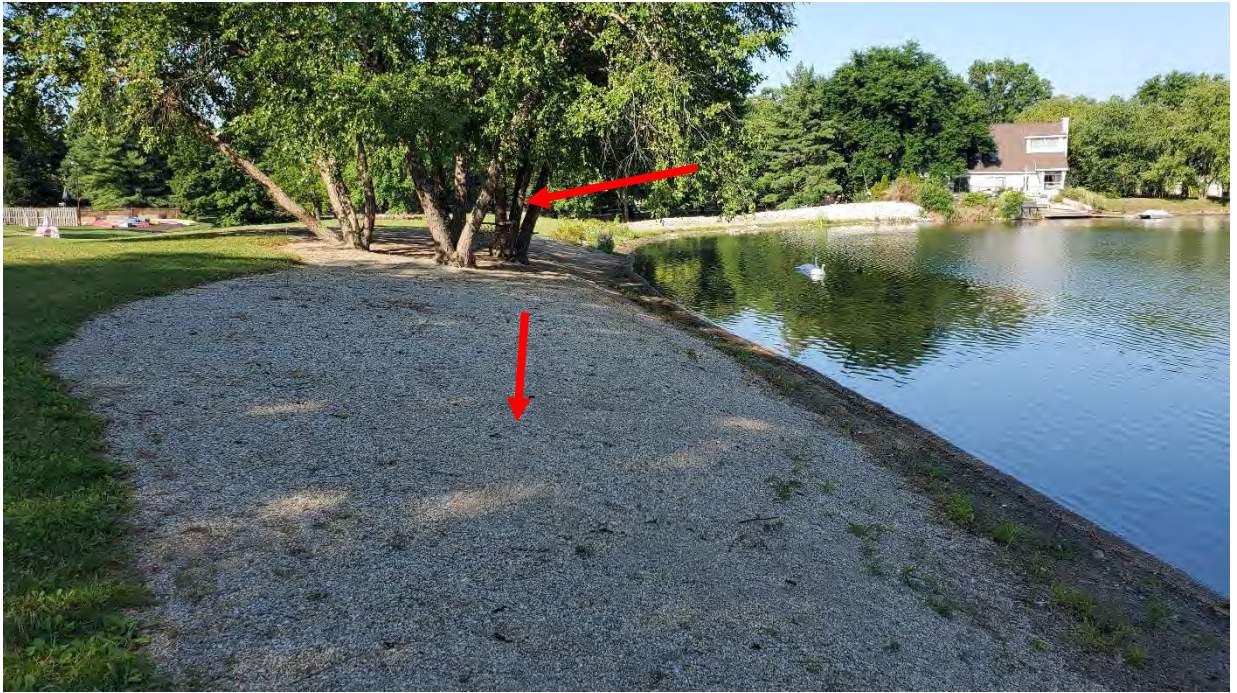
Top: Upstream slope left side. Note inadequate slope cover in gravel area with trees encroaching.

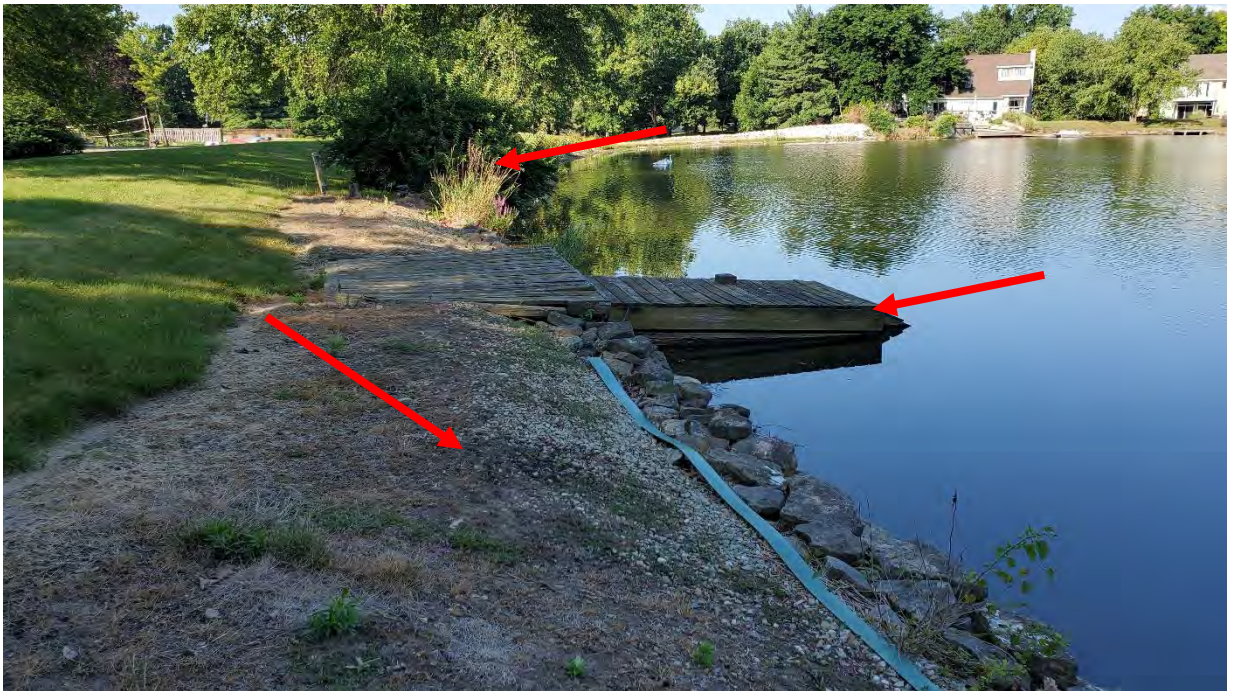
Bottom: Upstream slope left side. Note inadequate slope cover near toe. Brush, landscaping, and dock encroachments.

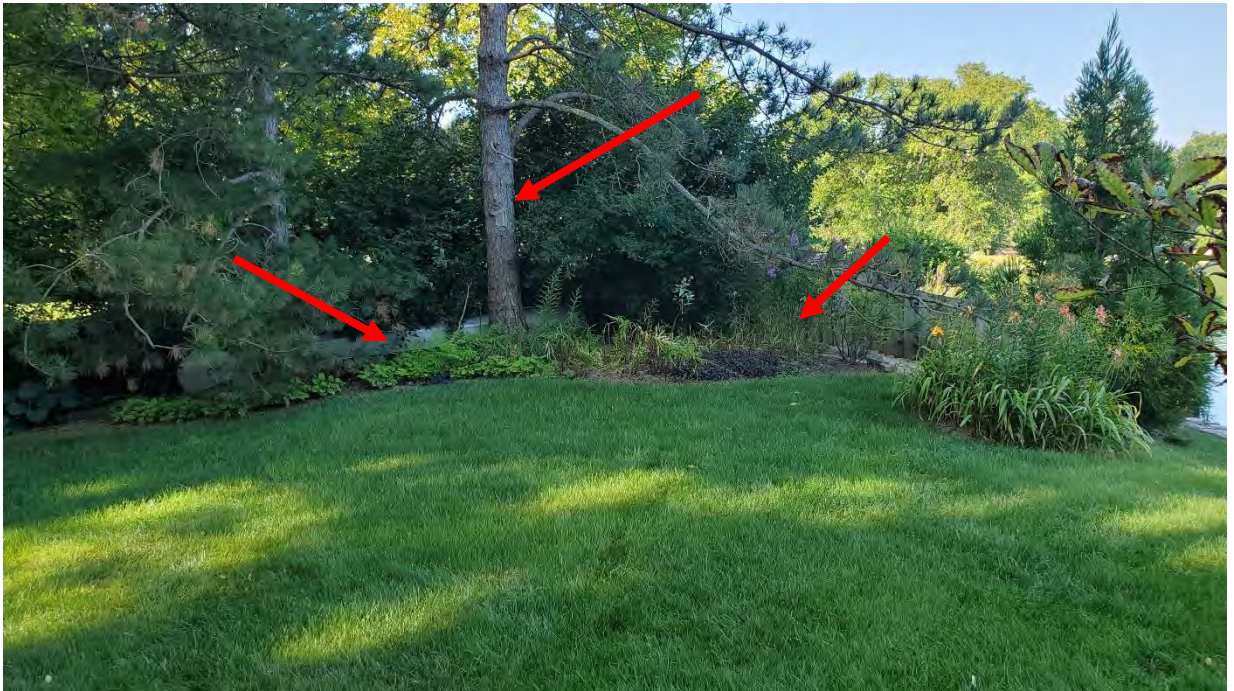
Top: Embankment crest on left abutment. Note trees, brush, landscaping, and watercraft (canoe).

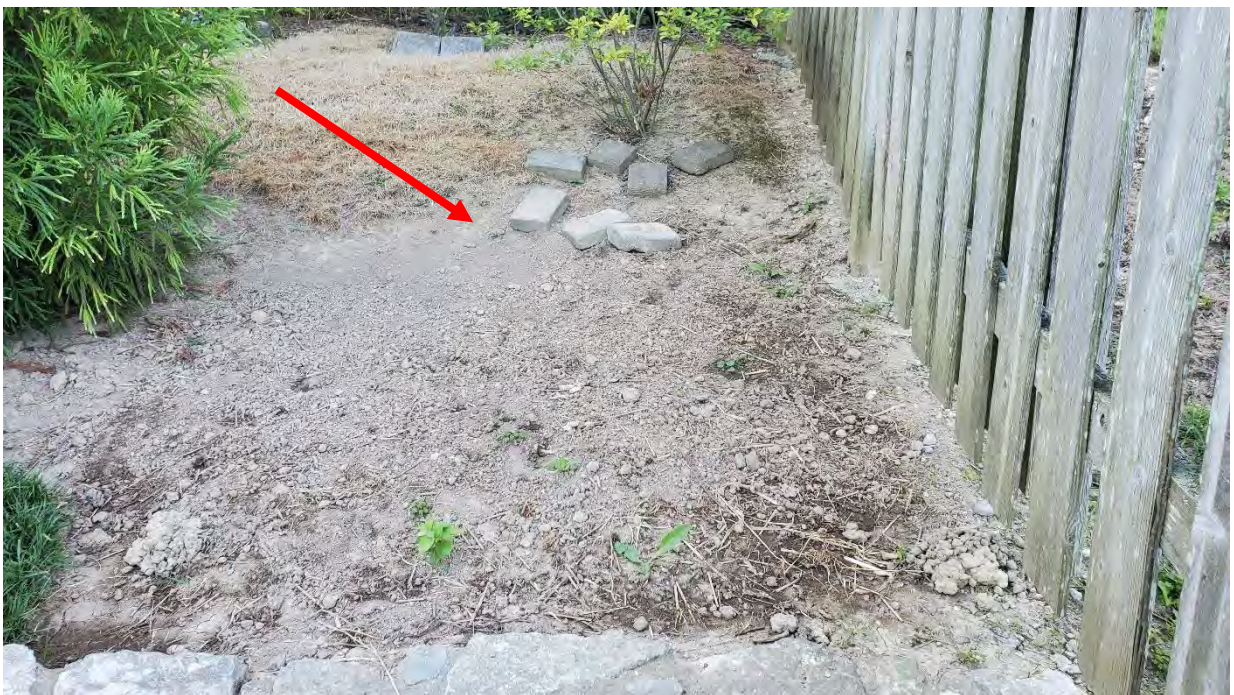
Bottom: Embankment crest at left abutment fence. Note private fence across embankment and bare area.

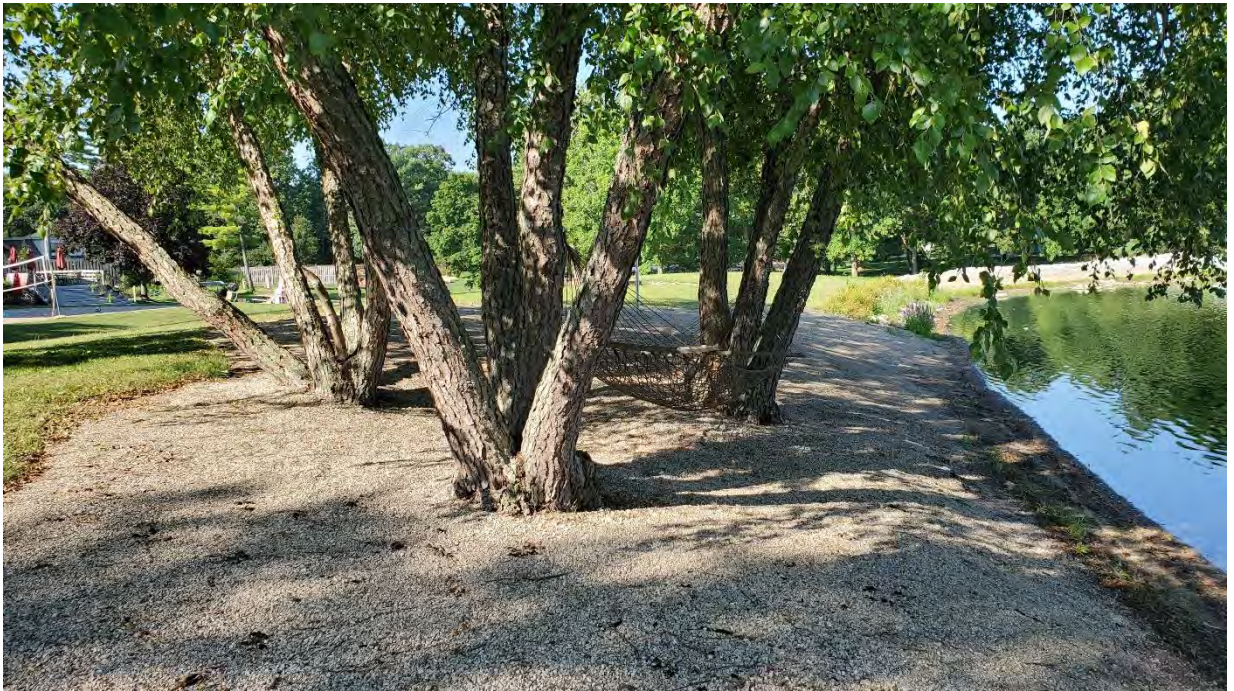
Top: Embankment crest left side. Note trees on crest in gravel covered area.

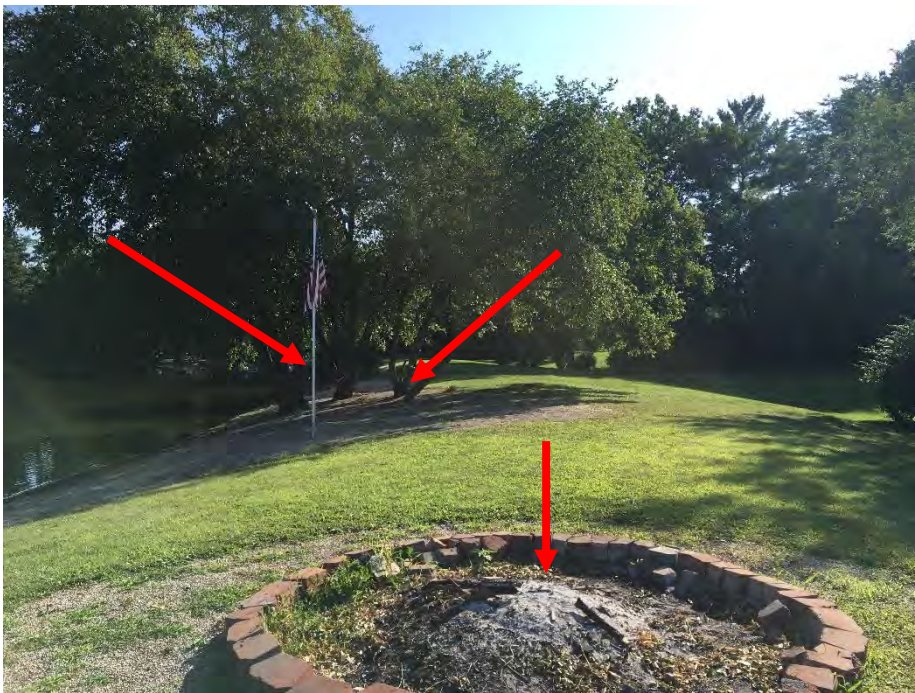
Bottom: Embankment crest left side. Note firepit, flagpole, and tree encroachments.

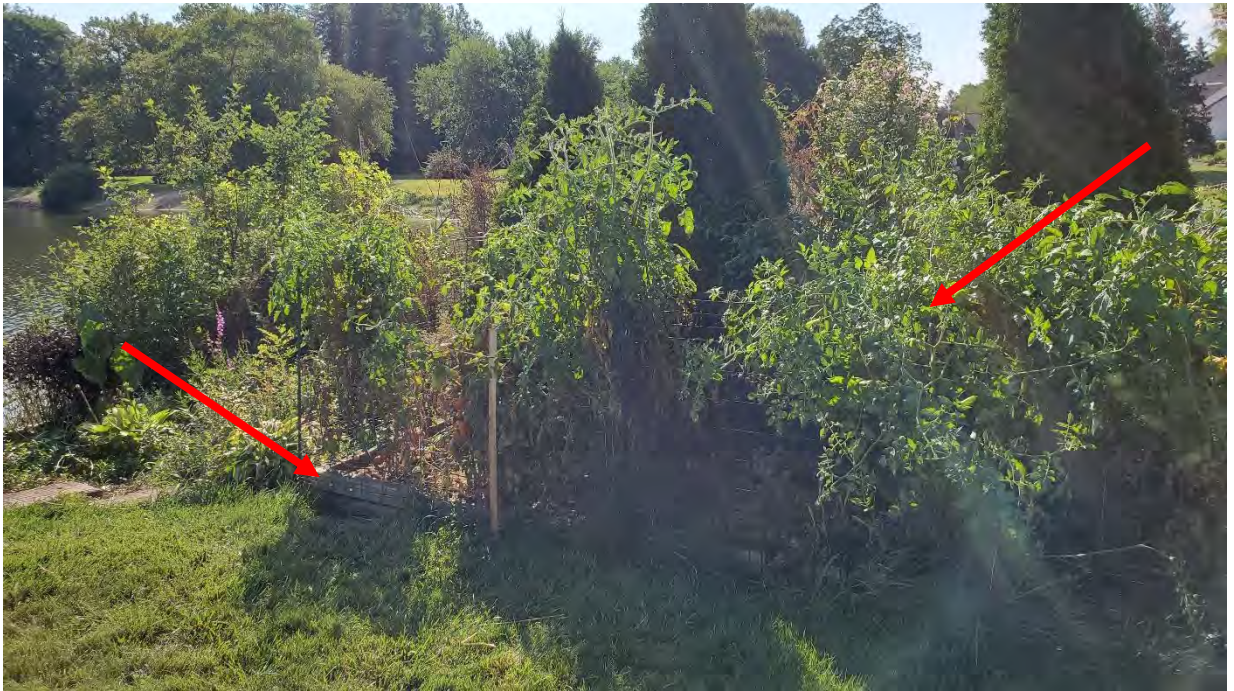
Top: Embankment crest right side. Note landscaping and brush encroaching along property line.

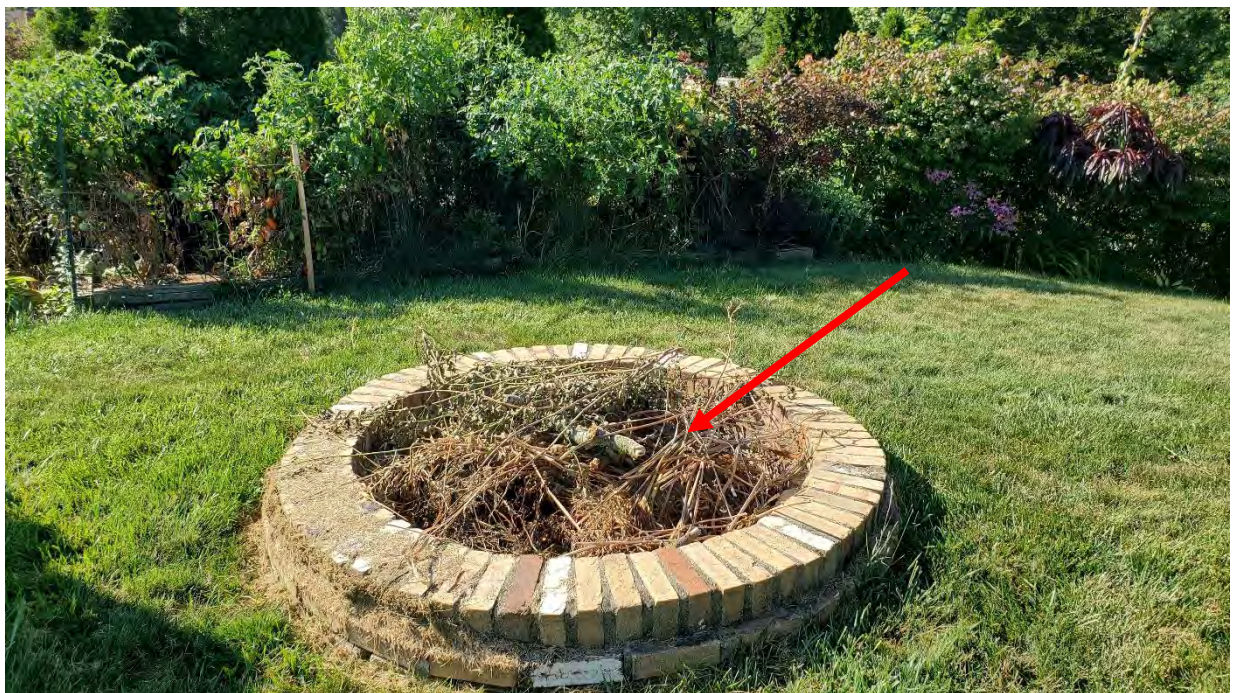
Bottom: Embankment crest right side. Note firepit encroachment.

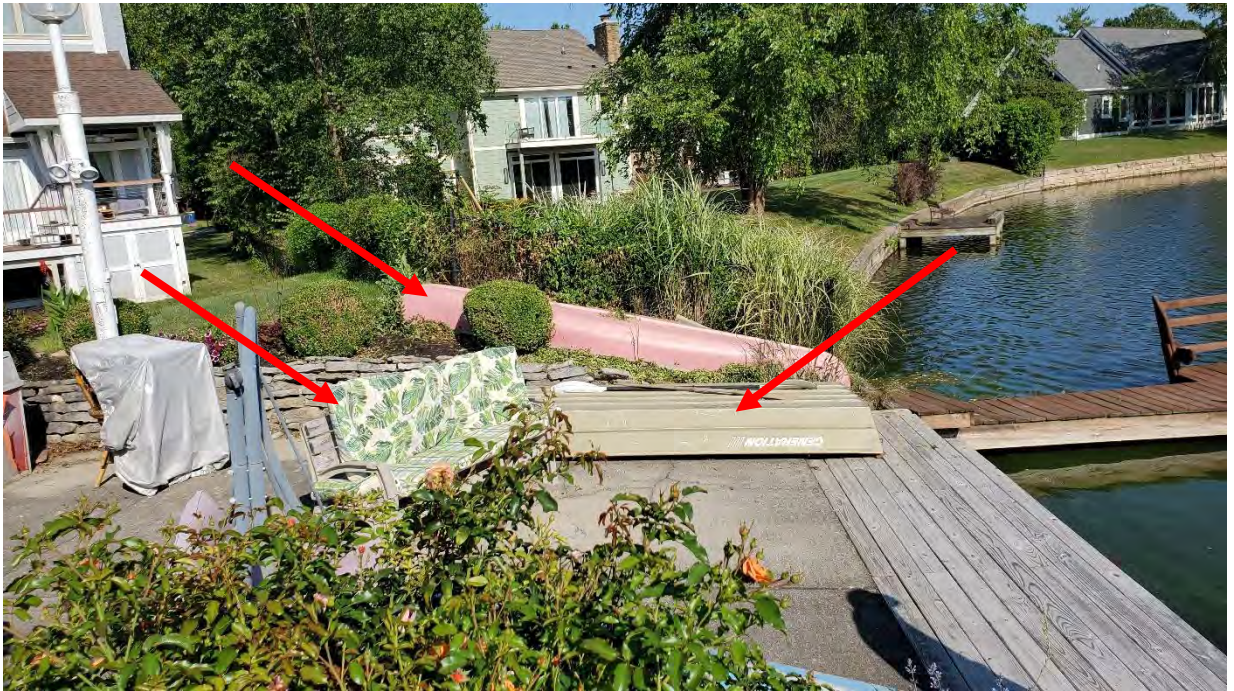
Top: Embankment crest right side. Note concrete patio is cut into the embankment resulting in loss of embankment height and width. Watercraft and outdoor furniture also present.

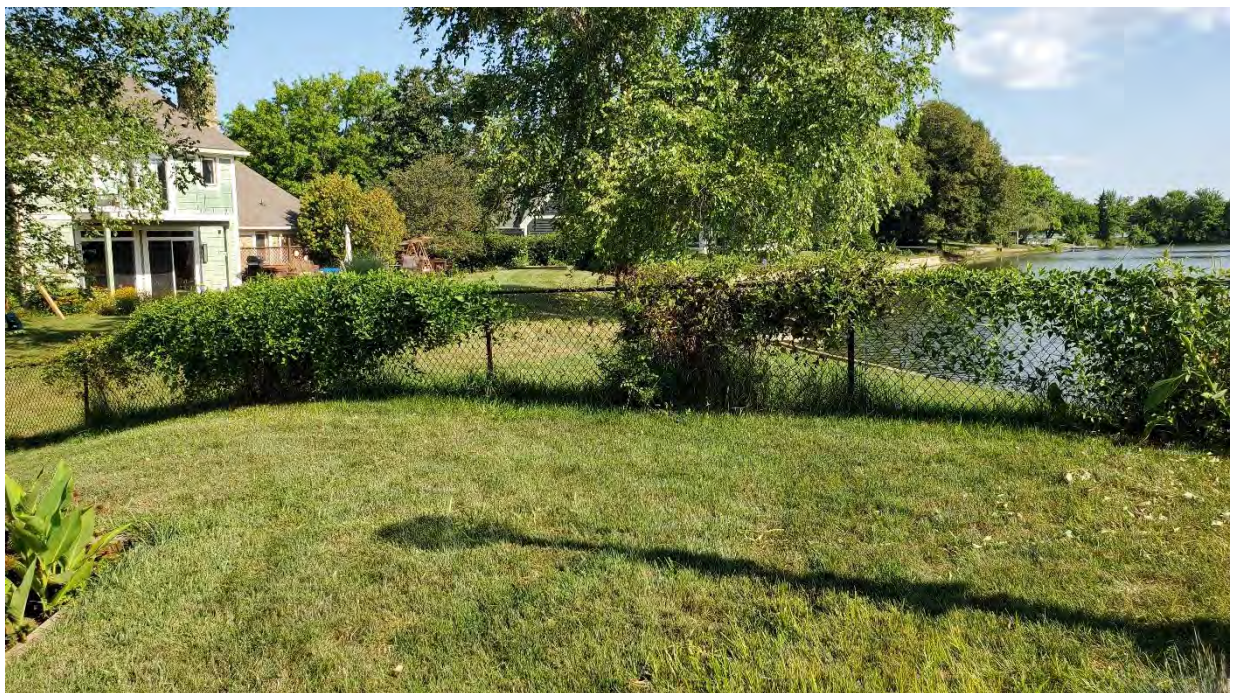
Bottom: Embankment crest right side. Note fencing and brush across embankment.

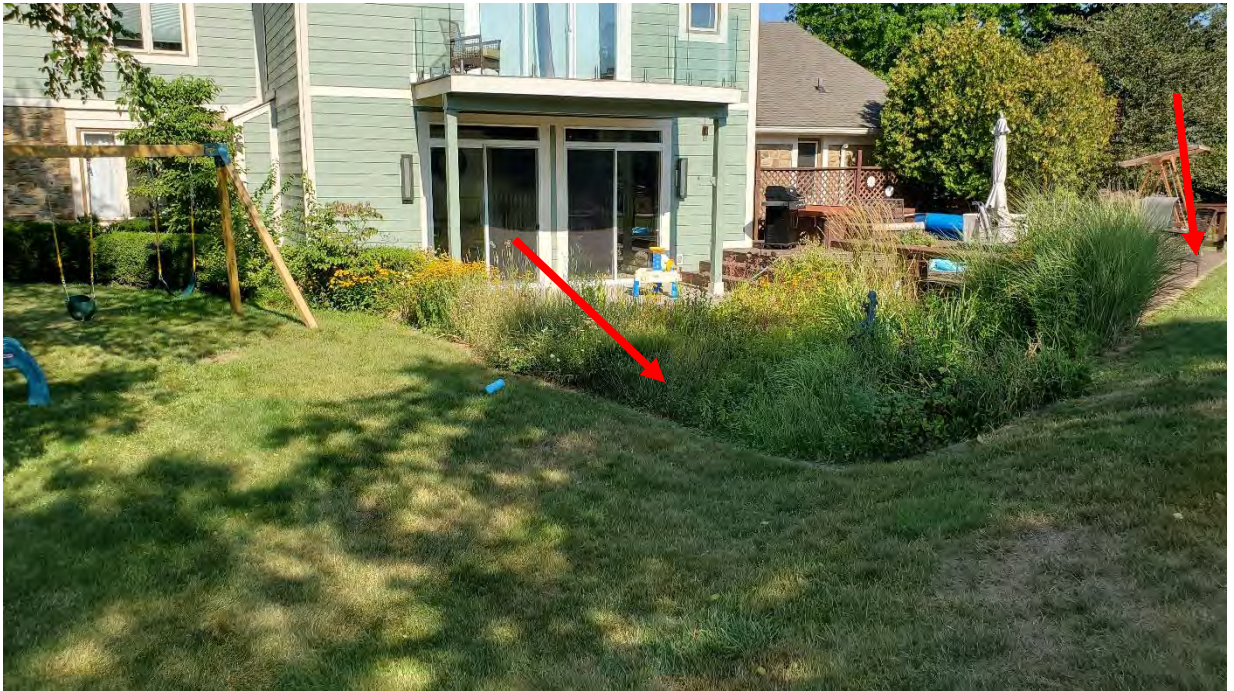
Top: Embankment crest/downstream slope from right side. Note landscaping and decking built into embankment.

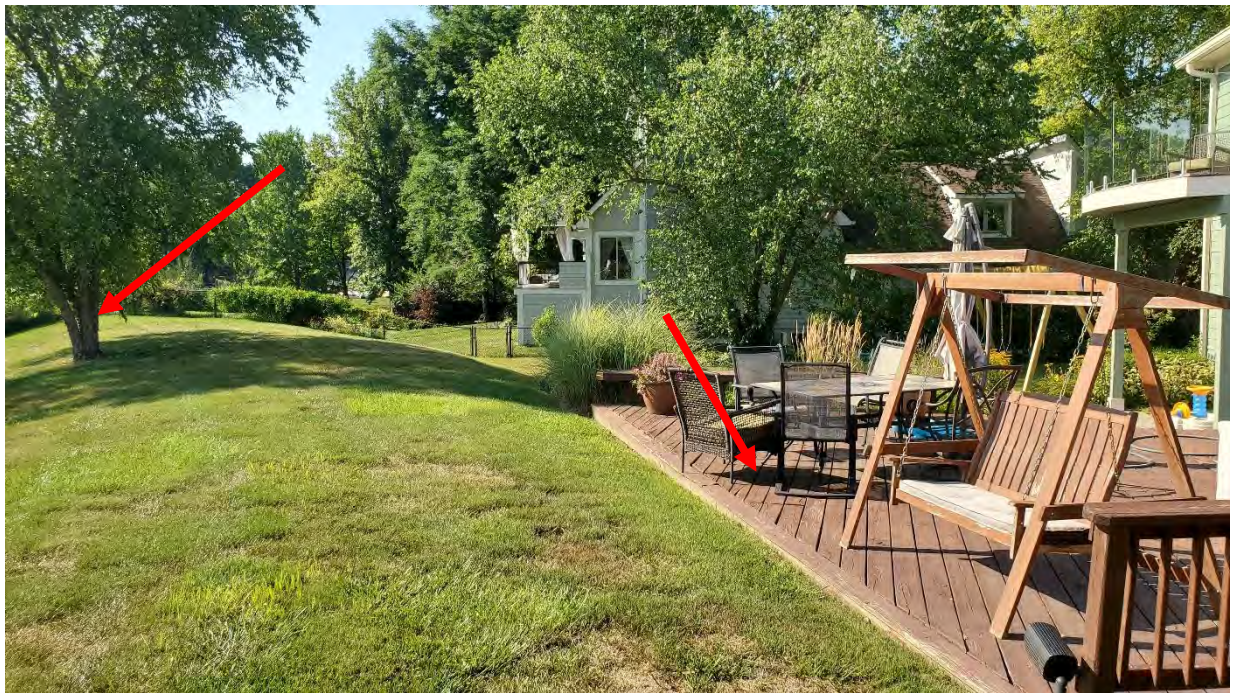
Bottom: Embankment crest/downstream slope from right side. Note extended decking on embankment and tree on embankment.

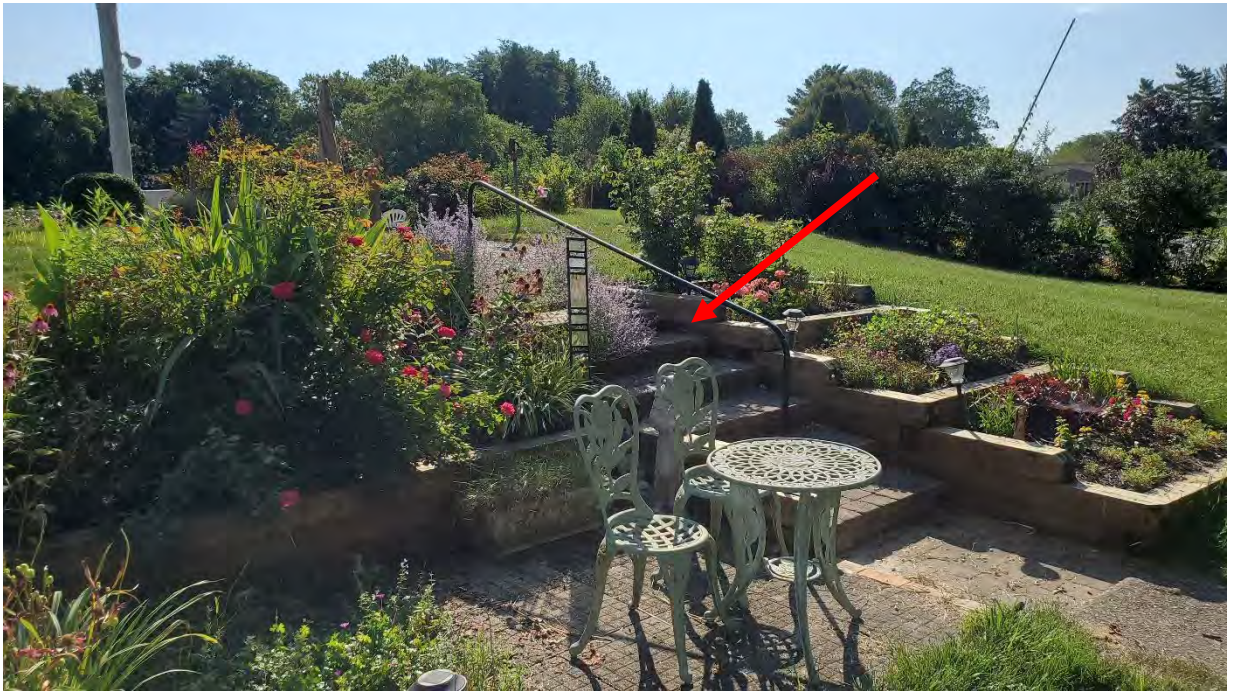
Top: Downstream slope right side. Note landscaping and stairs cut into embankment slope.

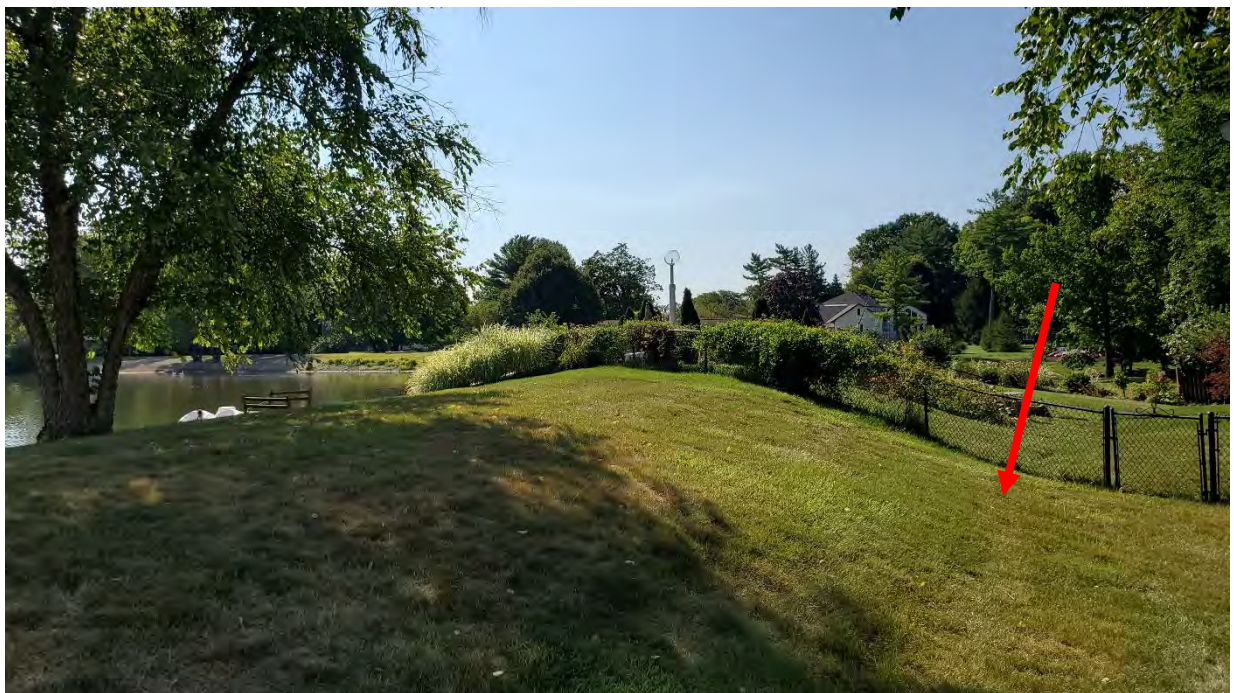
Bottom: Downstream slope right side. Note fencing across embankment and bare area found by fence.

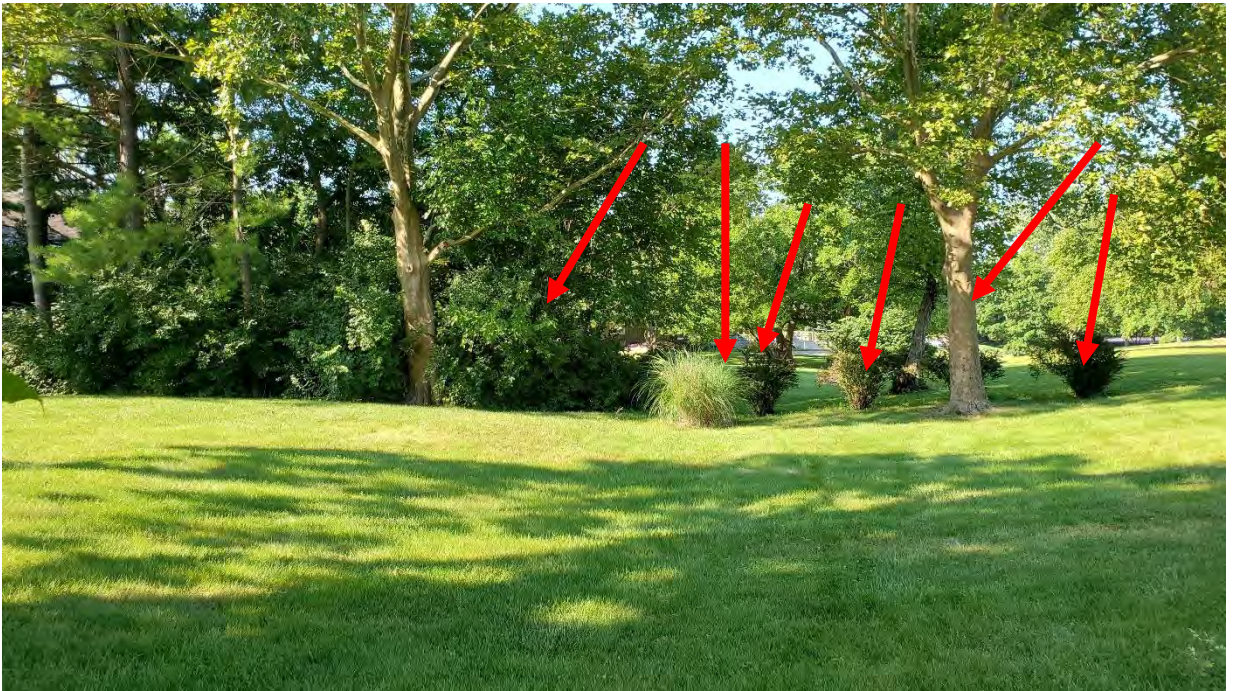
Top: Downstream slope left side. Note trees and bushes growing on and within 25 feet of embankment.

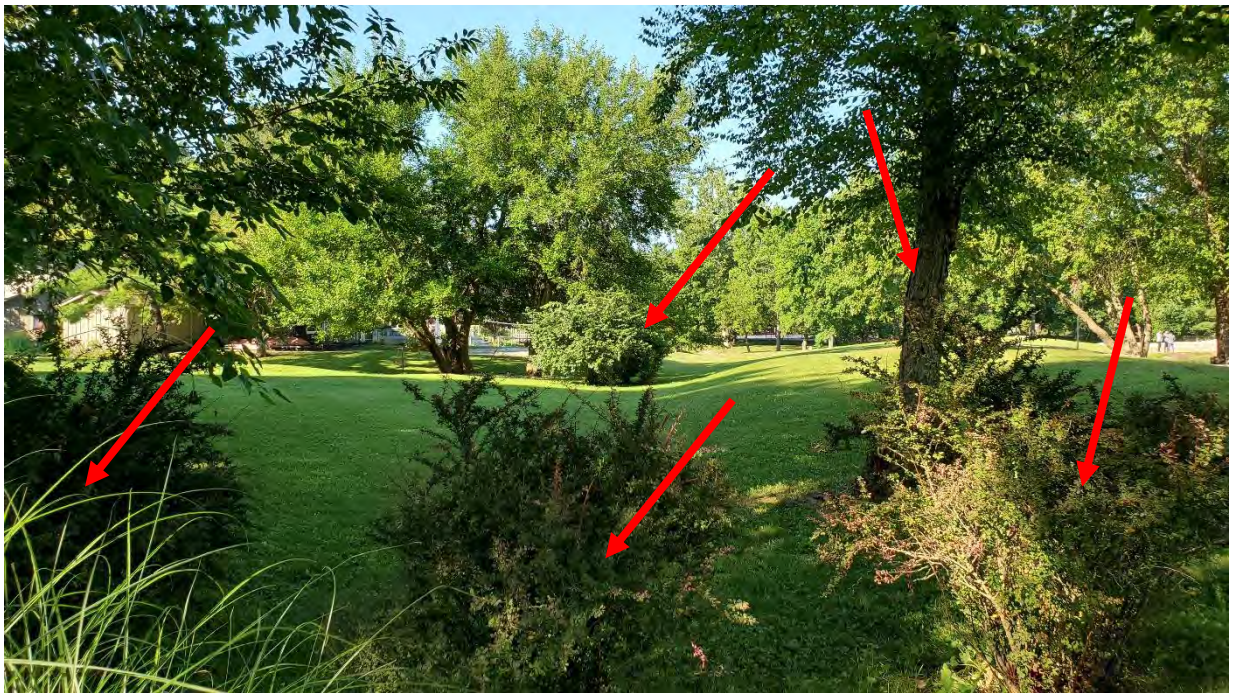
Bottom: Downstream slope from left side. Note trees and bushes growing on and within 25 feet of embankment.

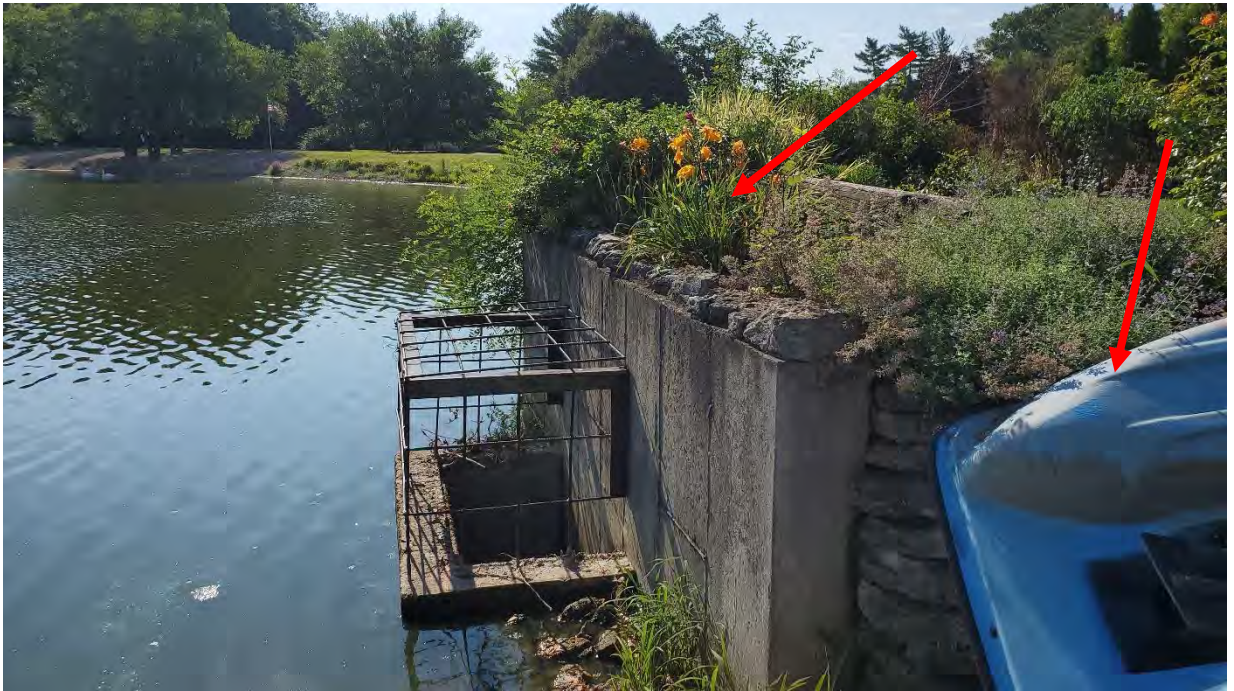
Top: Principal spillway drop inlet riser with trashrack near dock. Note landscaping and watercraft encroachments along upstream slope.

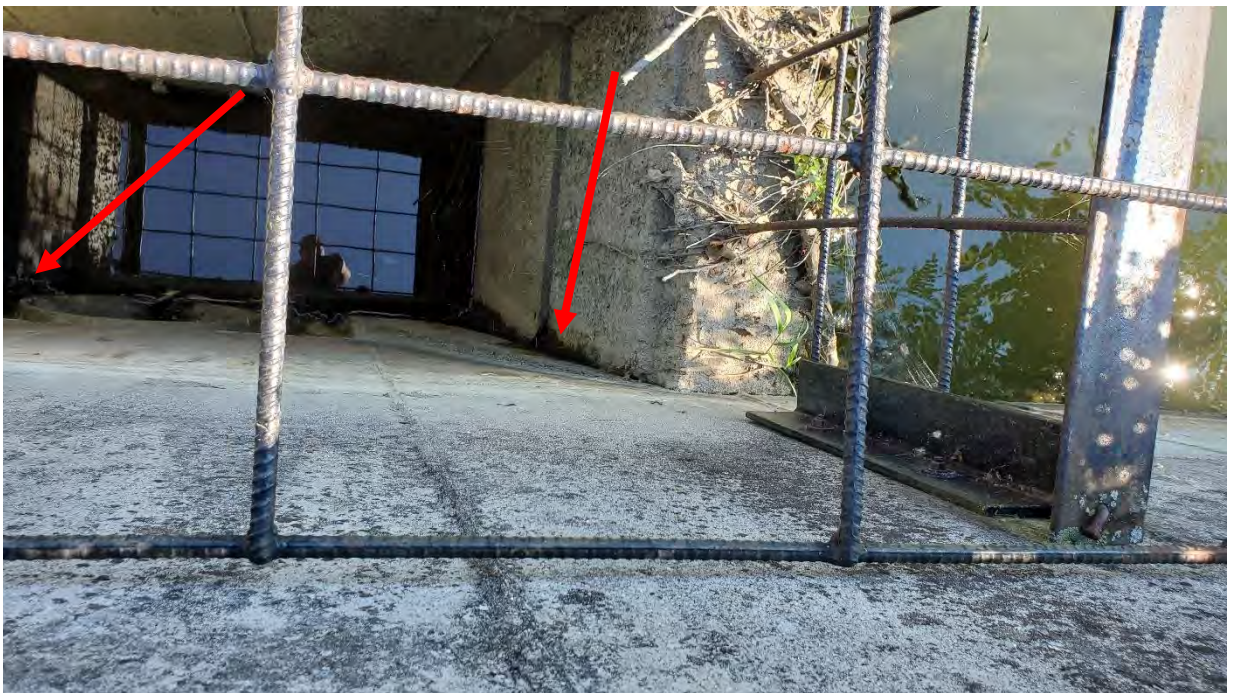
Bottom: Principal spillway drop inlet interior. Note seepage around concrete joints and minor surface rust on trashrack.

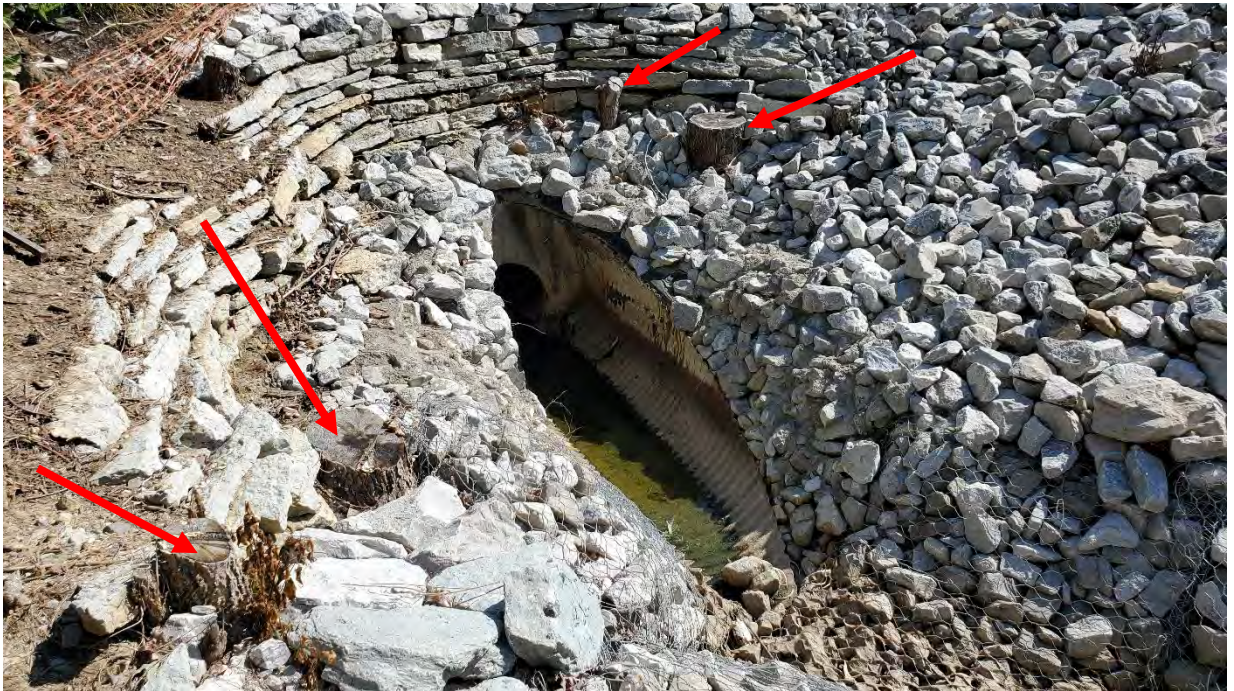
Top: Principal spillway outlet channel. Note newly place riprap armoring around outfall. Note tree stumps in Auxiliary Spillway riprap.

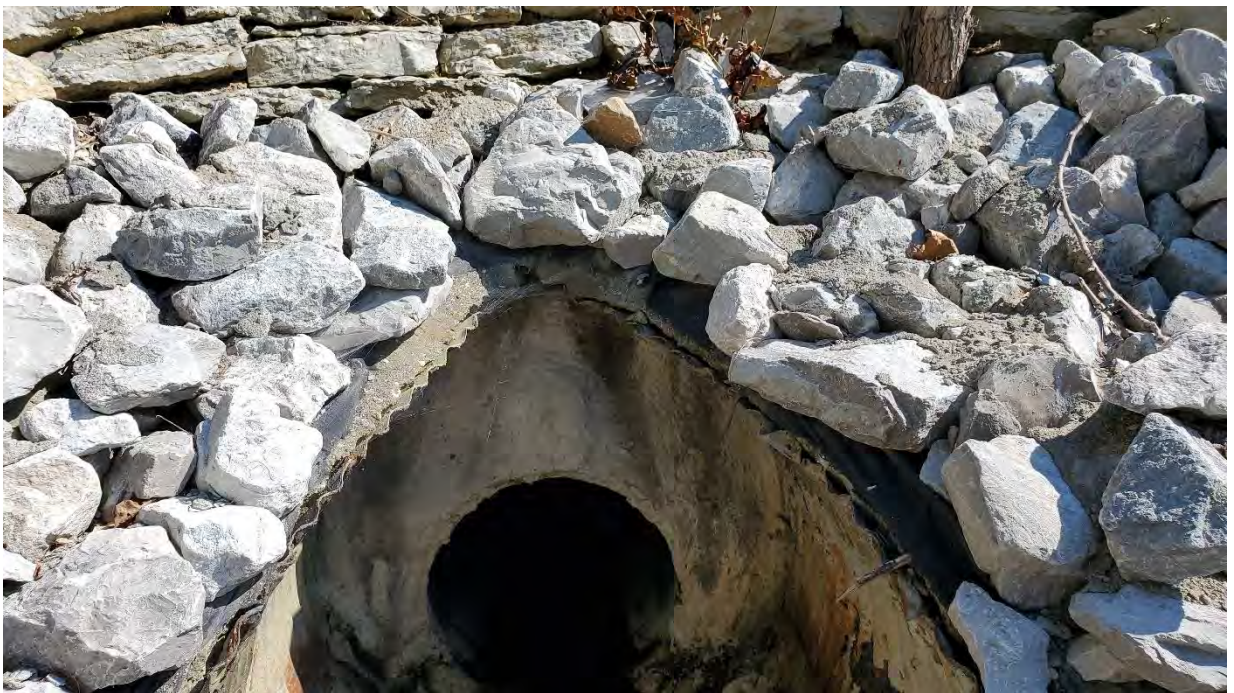
Bottom: Principal spillway outlet and interior of 24-inch CCFRPM discharge pipe outlet.

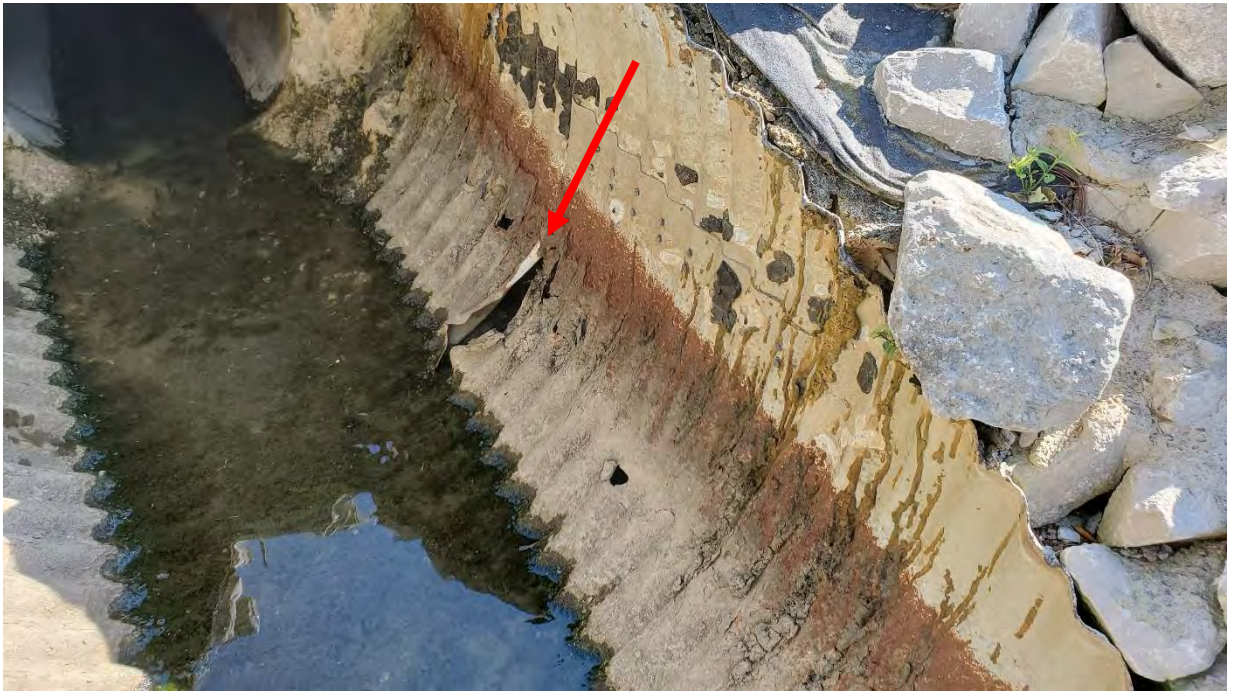
Top: Principal spillway outlet. Note metal end section rust and hole on side.

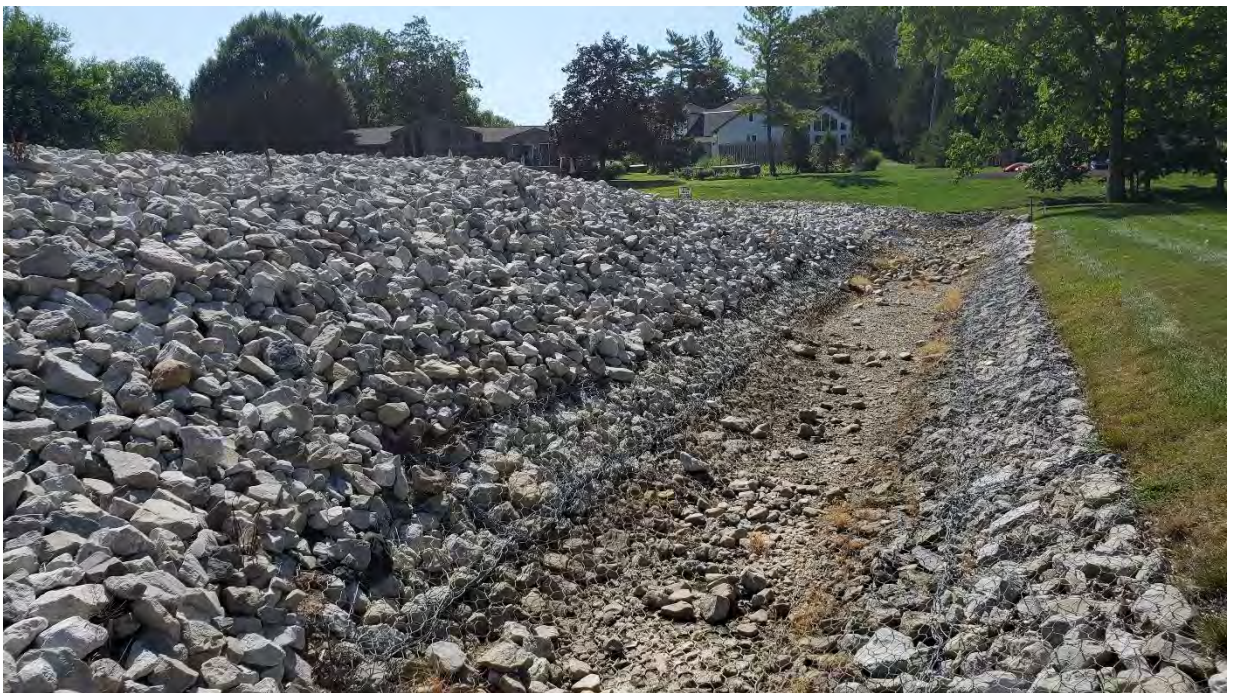
Bottom: Principal spillway concrete outlet channel. Note newly placed riprap.
