KEYSTONE WOODS LAKE DAM (29-5)

2021 Dam Safety Inspection Report
Hamilton County, IN | September 2021
Inspection Date: August 3, 2021

Burke Project No. 15-0171.00004

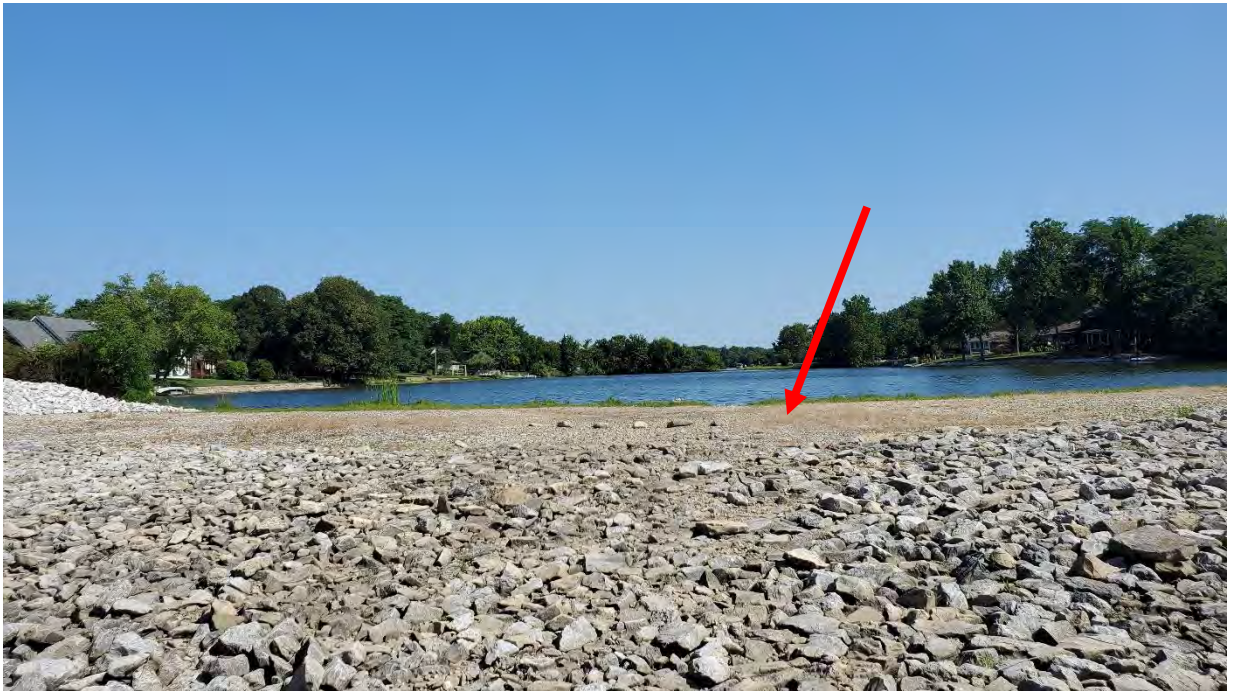
Top: Auxiliary spillway open channel. Note smaller riprap at inlet section.

Auxiliary Spillway	Deficient	<ul style="list-style-type: none"> Add appropriately sized riprap or other armoring to the spillway inlet section for erosion protection Seed bare spots on left side Evaluate options for removal of the large tree stump on left side and other tree stumps on right side in riprap; monitor areas adjacent to the stumps for seepage or other surficial deficiency monthly and/or after large rain events and notify a registered professional engineer of observed changes 	<ul style="list-style-type: none"> 2-4 years 2 years 2 years 	<ul style="list-style-type: none"> Low Low Low
Maintenance and Repairs	Deficient	<ul style="list-style-type: none"> Perform spillway capacity analysis in accordance with current IDNR requirements Retain a geotechnical engineer to evaluate the stability of the dam under various loading conditions Conduct a video inspection of the principal spillway outlet pipe; subsequent inspections should be performed every six years Multiple owners to work to resolve dam inspection recommendations 	<ul style="list-style-type: none"> 2 years 2-4 years 2 years Ongoing 	<ul style="list-style-type: none"> High High Low High

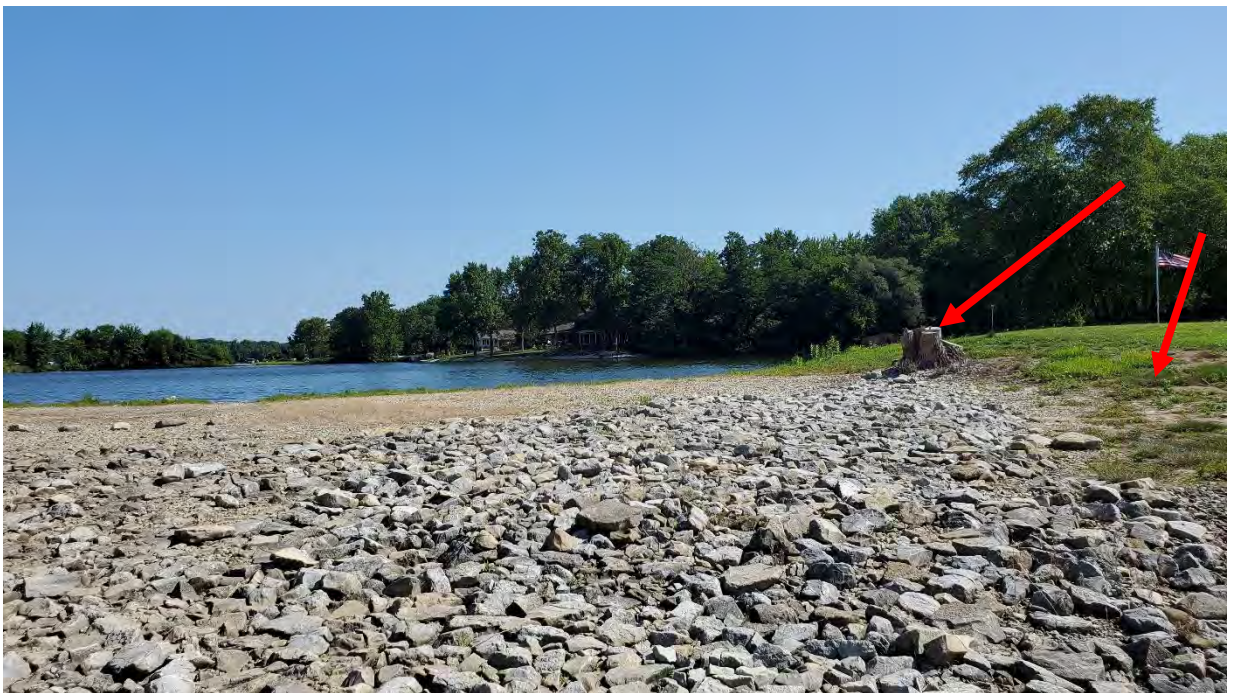
Bottom: Auxiliary spillway open channel. Note stump on left side and bare spots in grassed area.

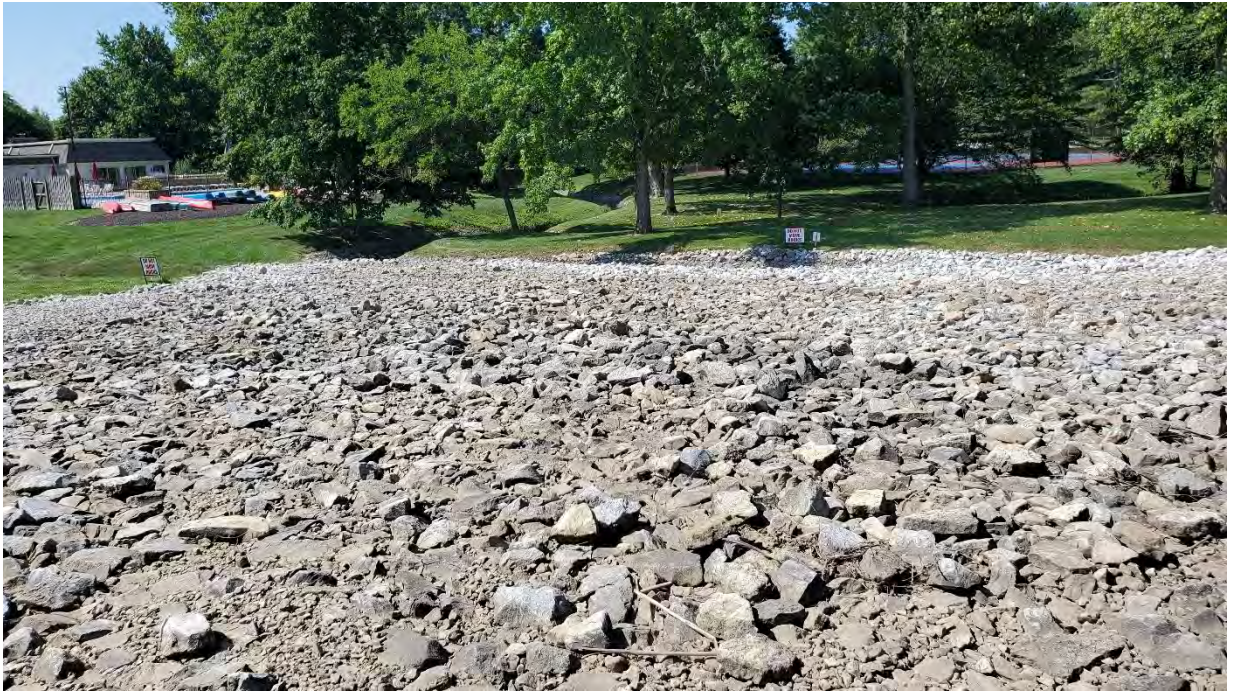
Top: Auxiliary spillway open channel. Note newly placed riprap.
