KEYSTONE WOODS LAKE DAM (29-5)

2023 Dam Safety Inspection Report
Hamilton County, IN | December 2023
Inspection Date: August 2, 2023

Burke Project No. 15-0171.00005

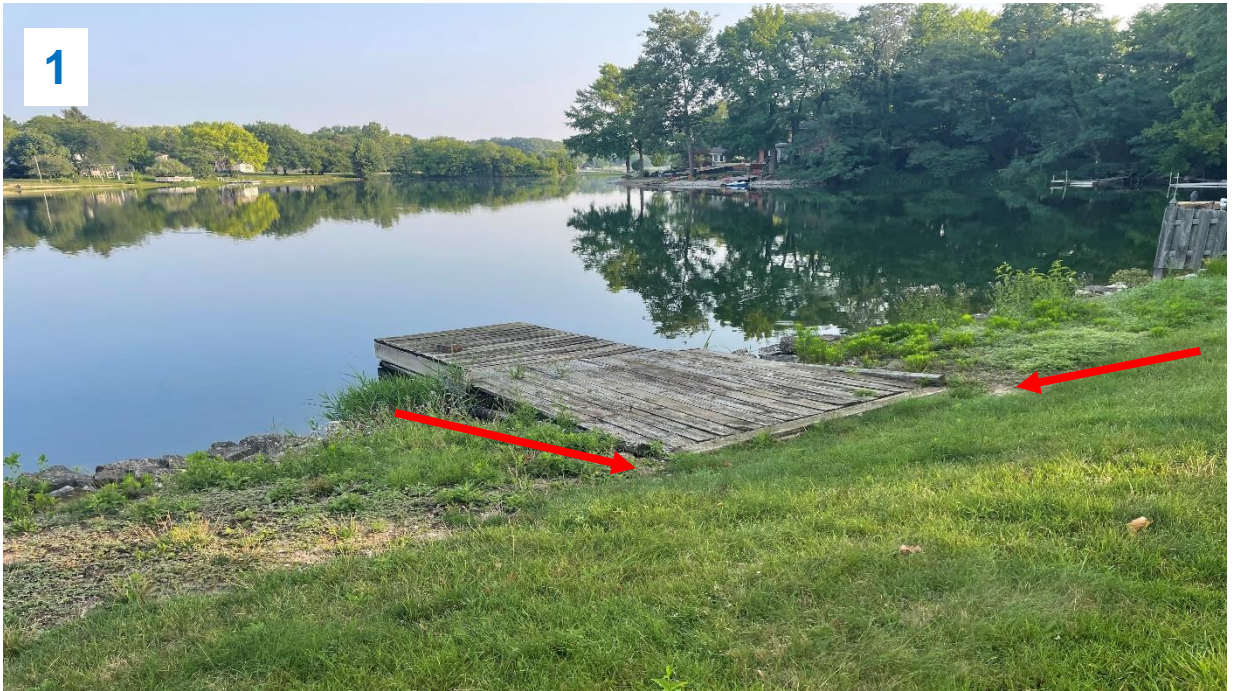
Top: Upstream slope left side. Dock encroaching on upstream slope. Note bare areas and depressions behind dock.

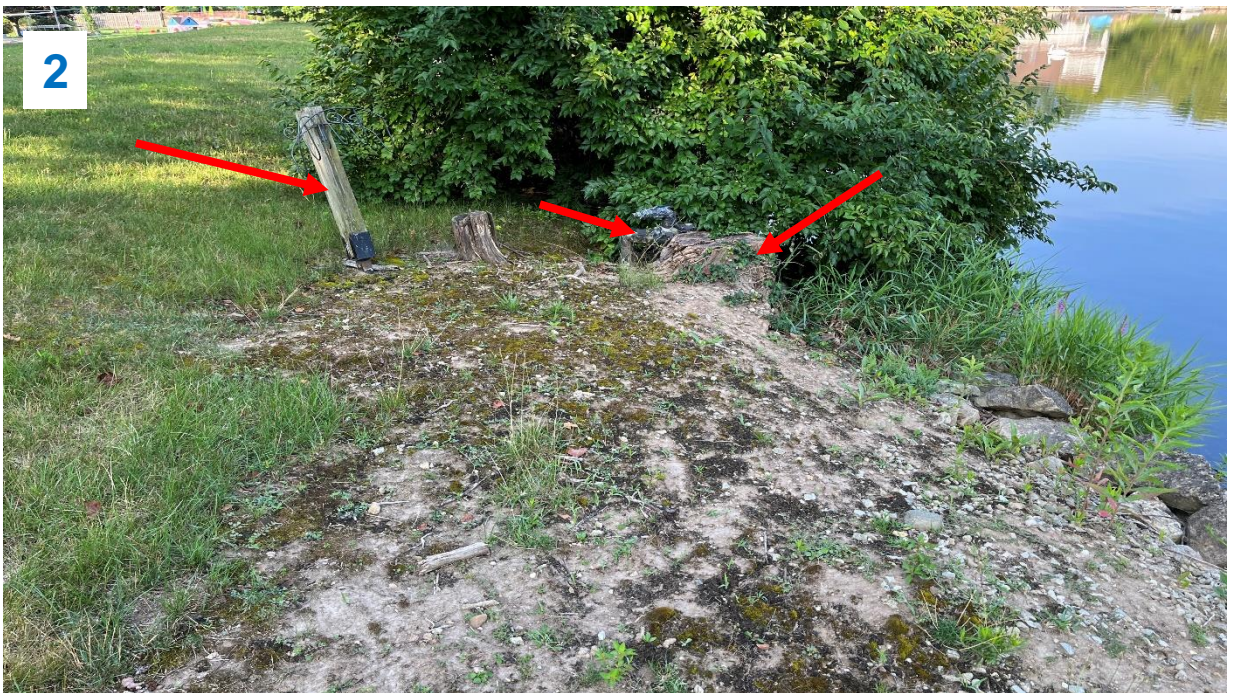
Bottom: Upstream slope left side. Large bush, tree stump, post, and water valve located on the upstream slope.

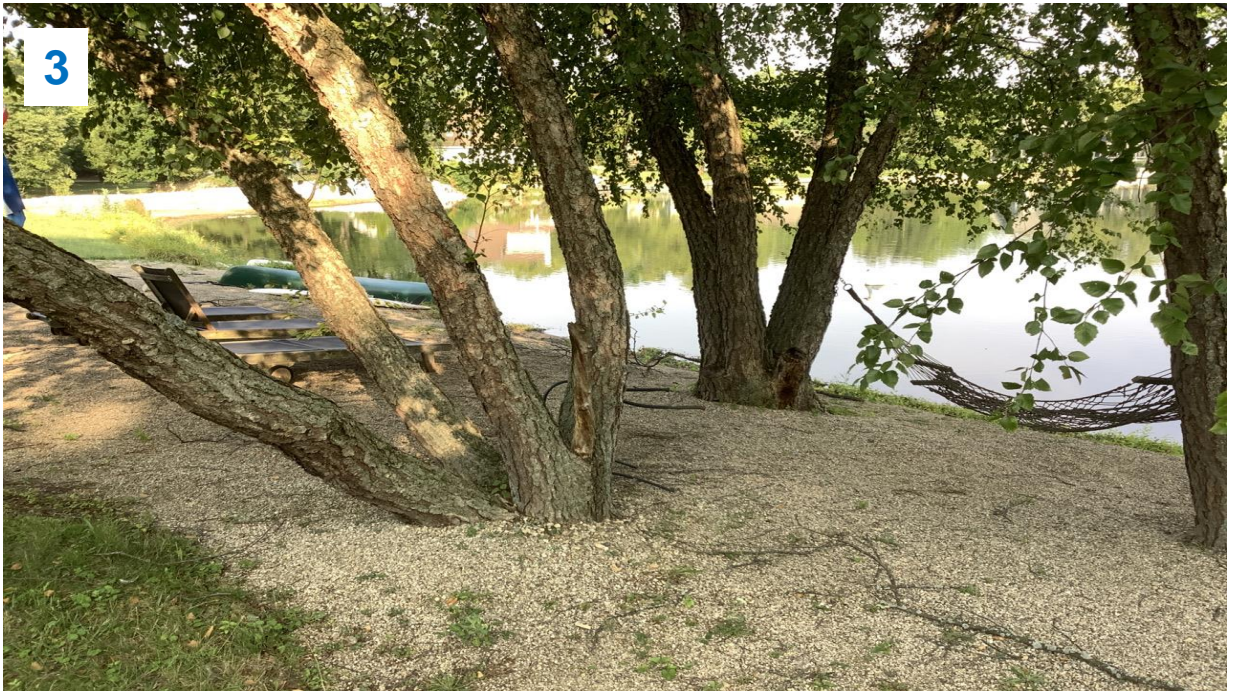
Top: Upstream slope left side. Trees and hammock located on upstream slope.

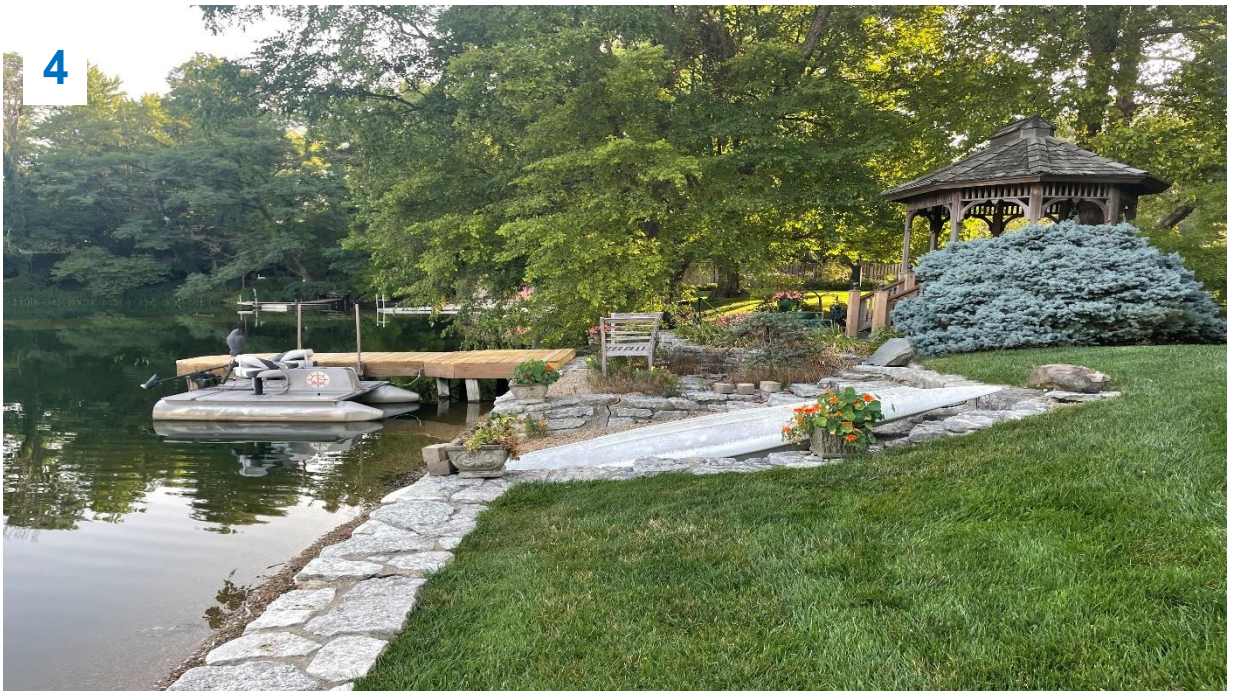
Bottom: Upstream left side. Gazebo, ramp, dock, landscaping, and trees located on upstream slope and crest.

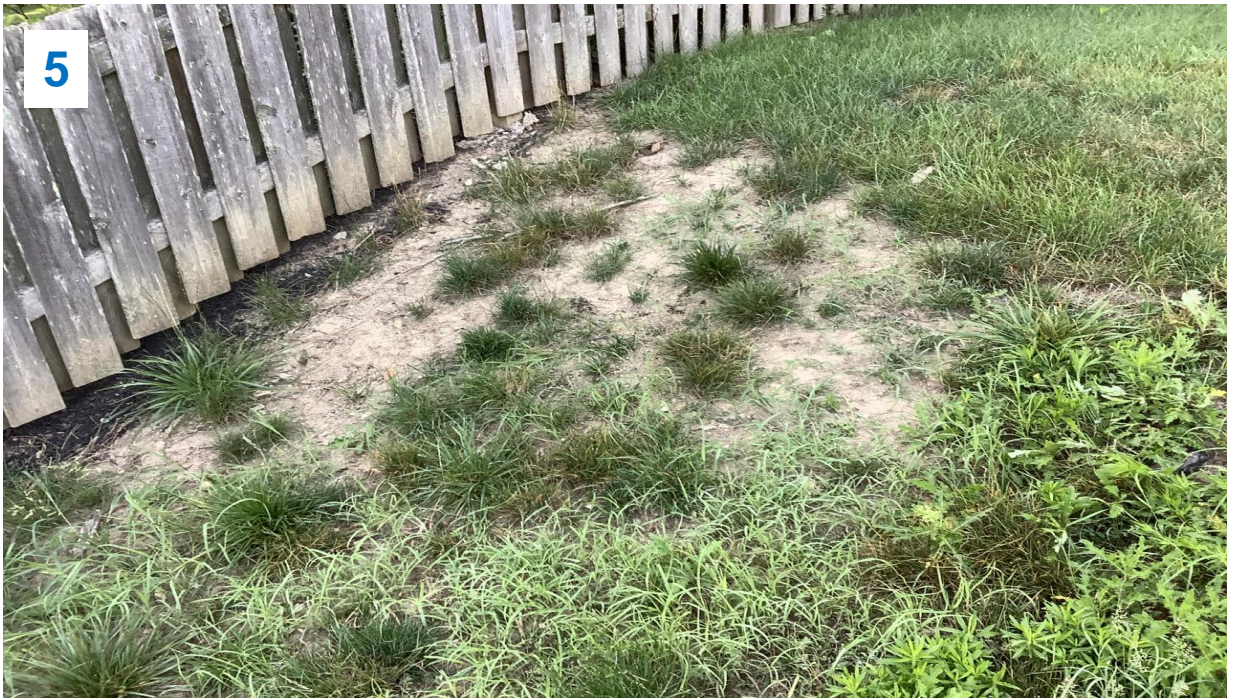
Top: Upstream slope left side. Bare area along fence line.

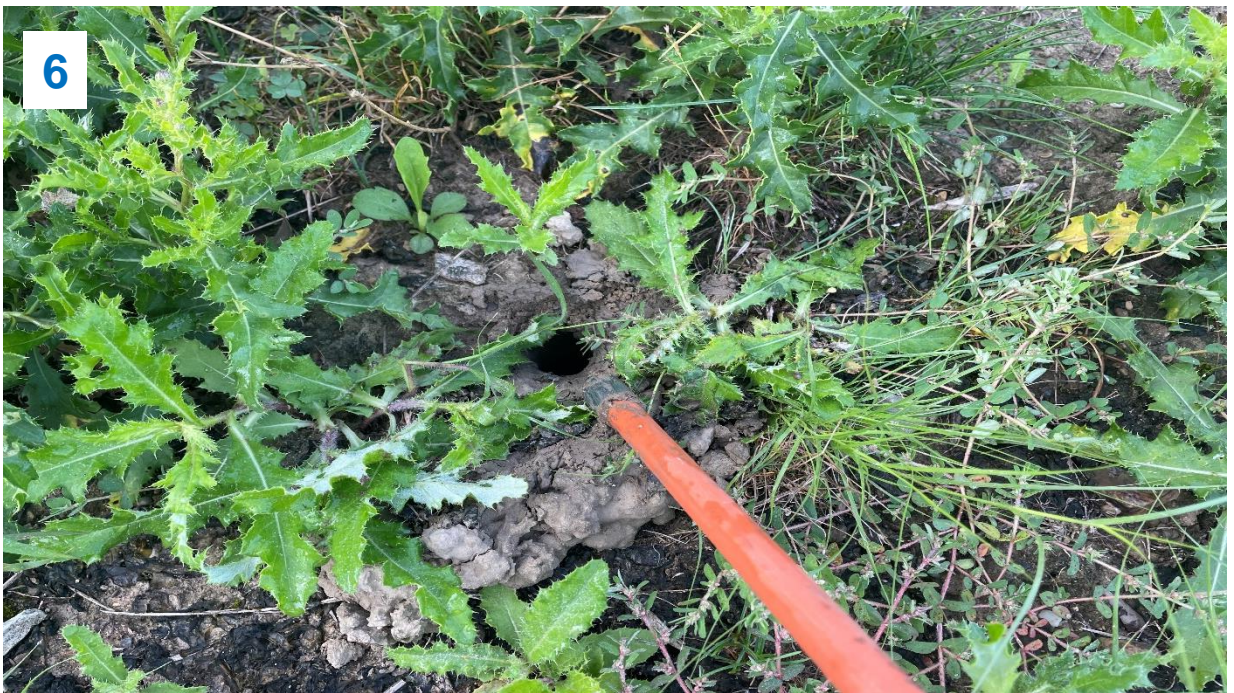
Bottom: Upstream slope on left side, typical burrow hole.

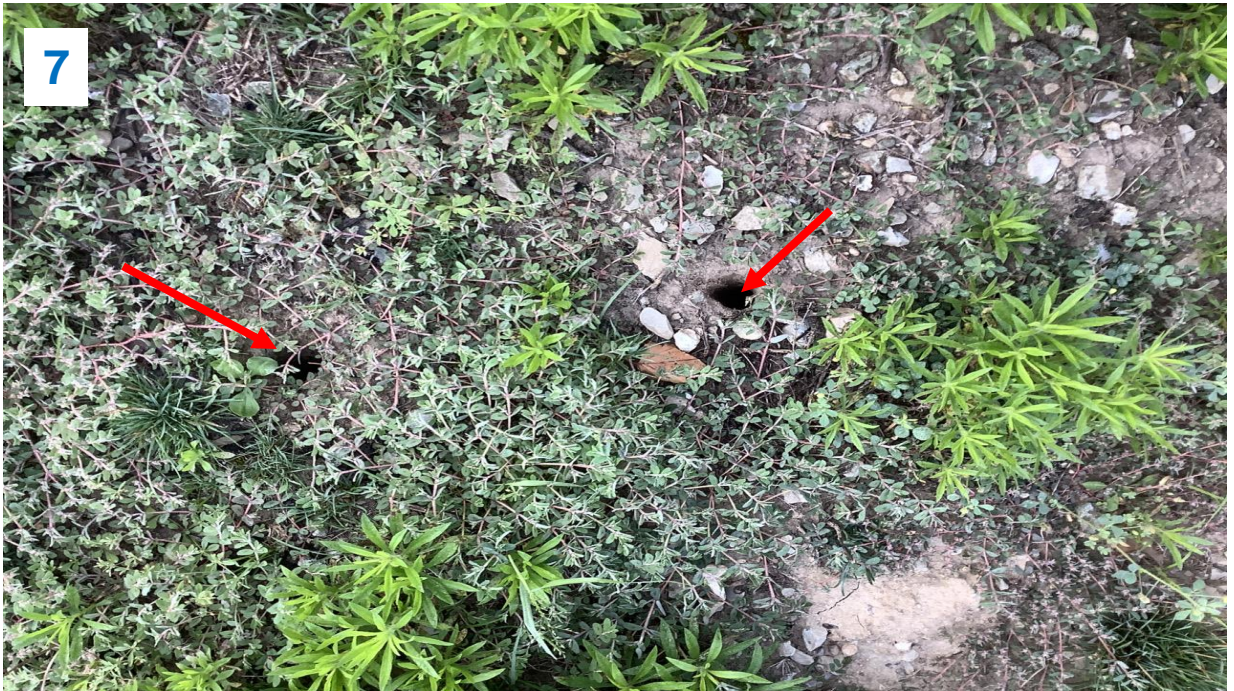
Top: Upstream slope on the left side, burrow holes by dock.

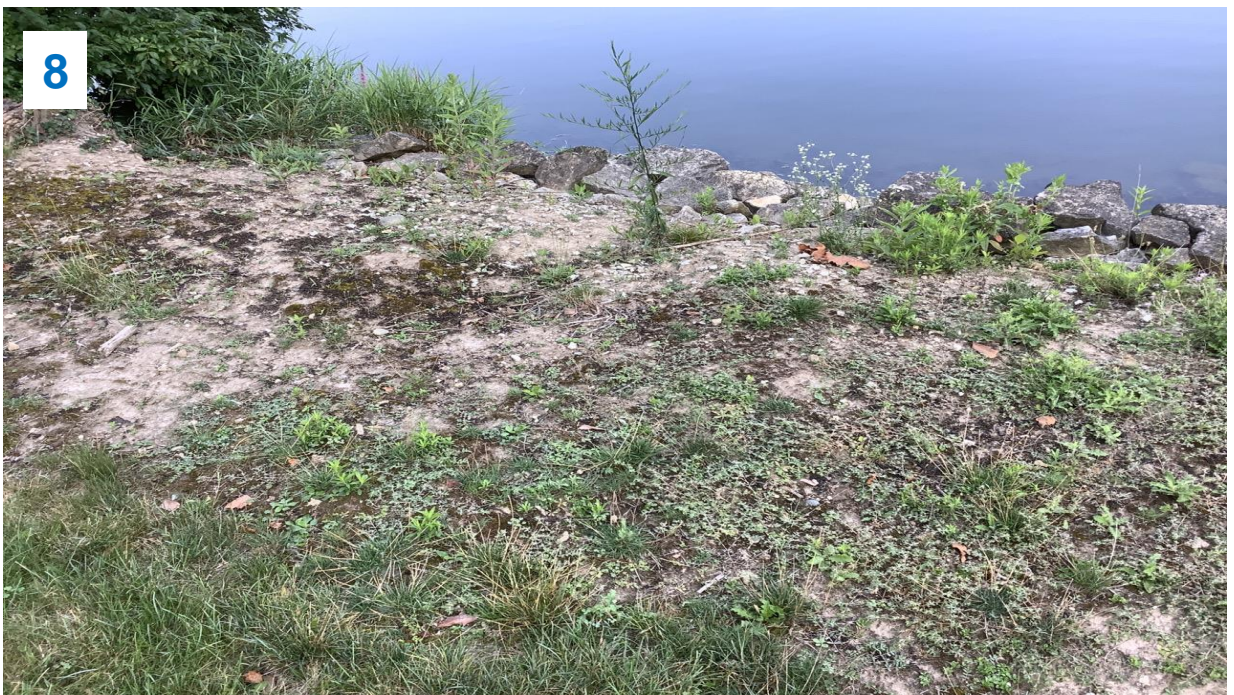
Bottom: Upstream slope on the left side, bare area near dock.

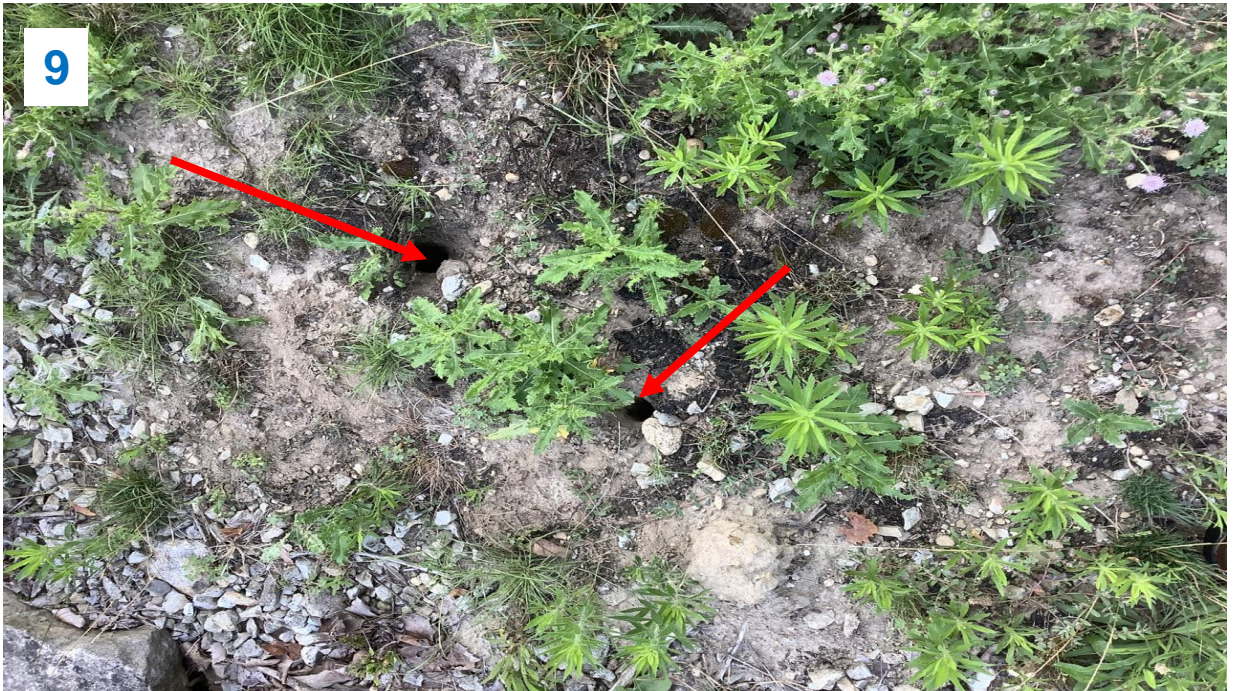
Top: Upstream slope on the left side, burrow holes near bush.

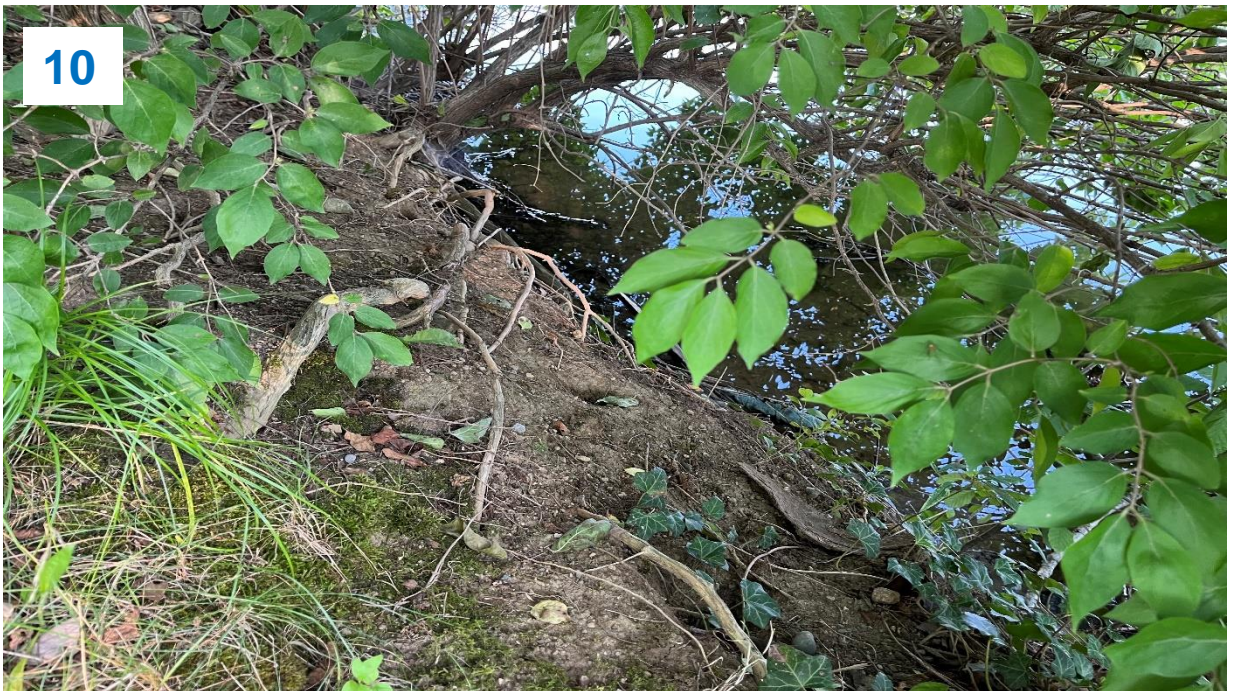
A 10-inch deep and 10-foot-long scarp was observed inside of a bush on the left side of the dam. A few animal burrows about 1-inch in diameter were noted near the fence on the left side of the dam and in the gravel covered slope. A few small burrows were found behind the timber seawall on the right side. Bare areas were observed by the dock and wooden fence on the left side of the slope. The upstream slope was considered **“Deficient”** according to IDNR rating criteria.

Bottom: Upstream slope on the left side, ten inch deep, ten-foot-wide scrap inside of bush.

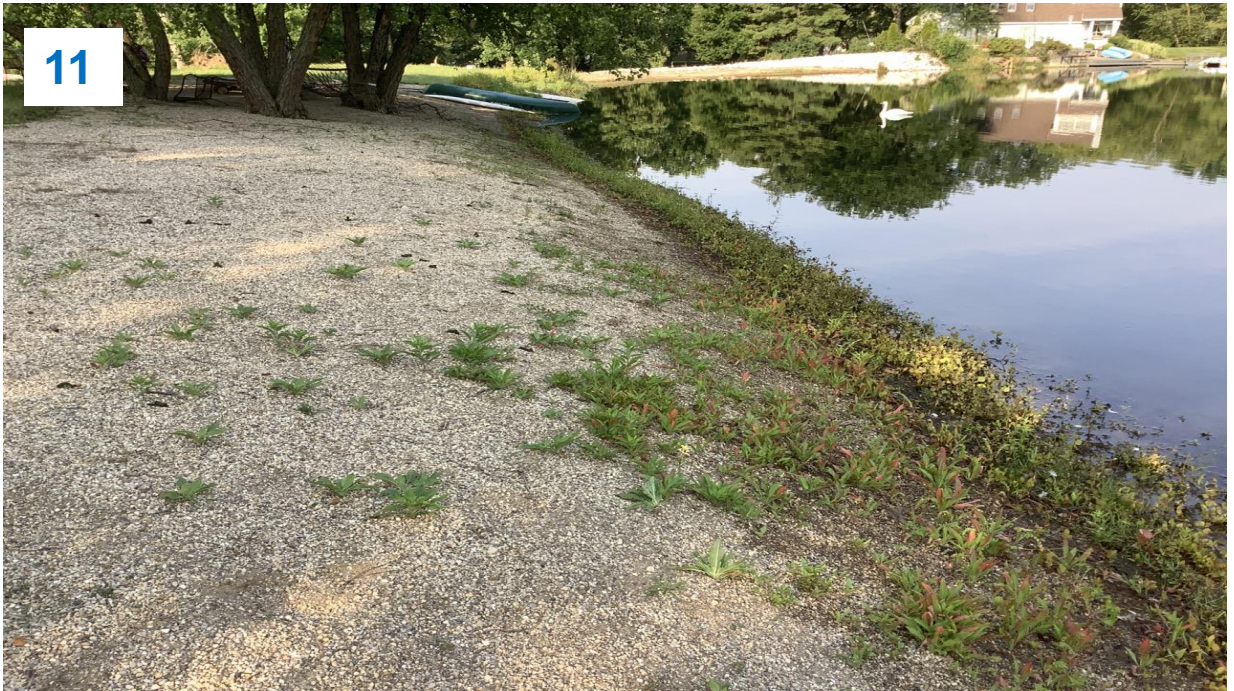
Top: Upstream slope on left side, gravel landscaping, undulating slope, and aquatic vegetation.

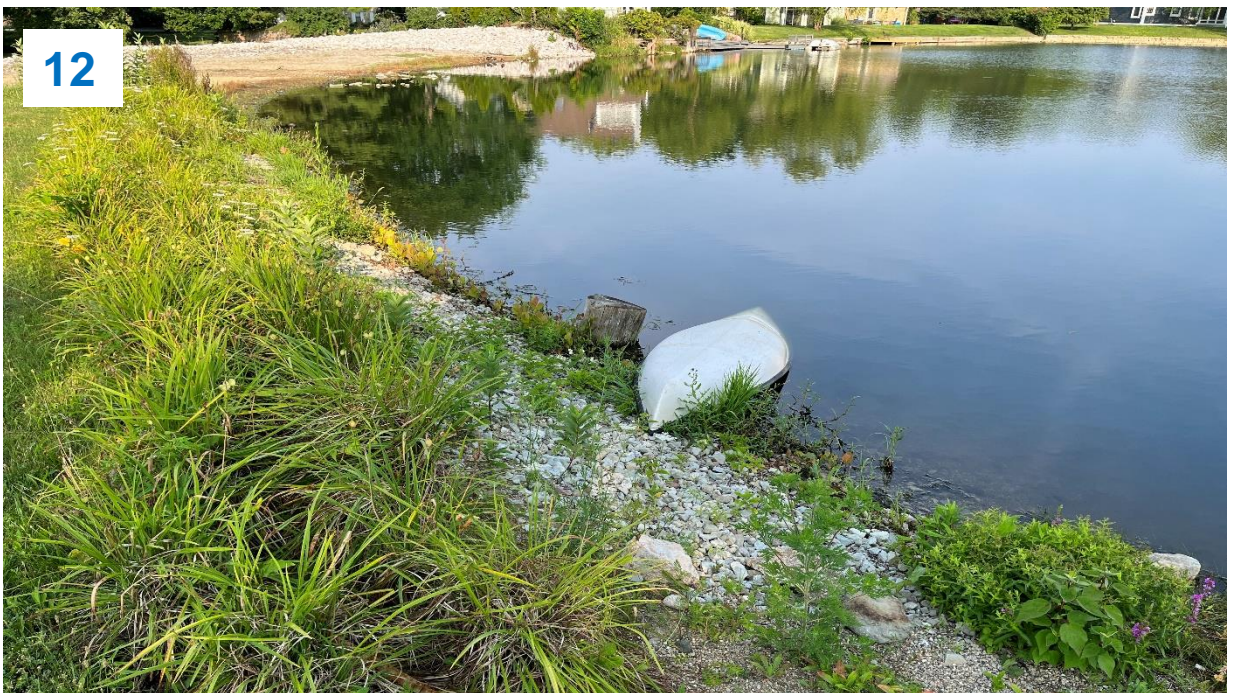
Bottom: Upstream slope near middle, note watercraft along slope.

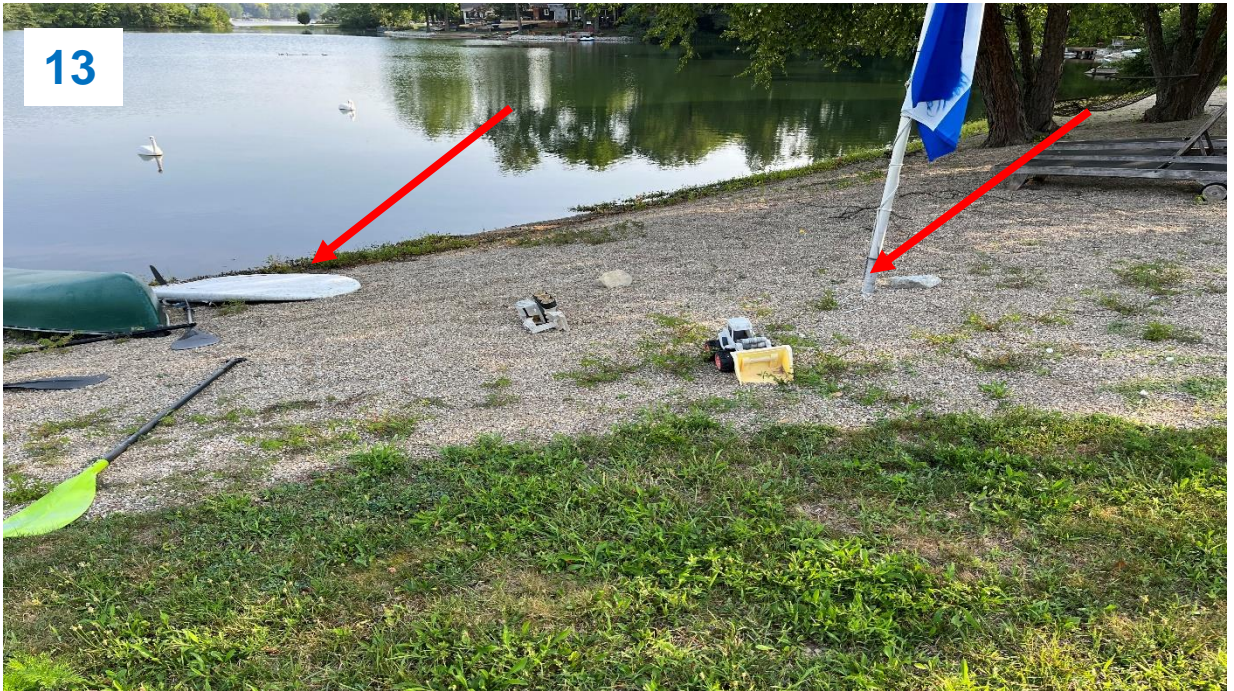
Top: Upstream slope near middle, watercraft, flagpole, and landscaping found on slope.

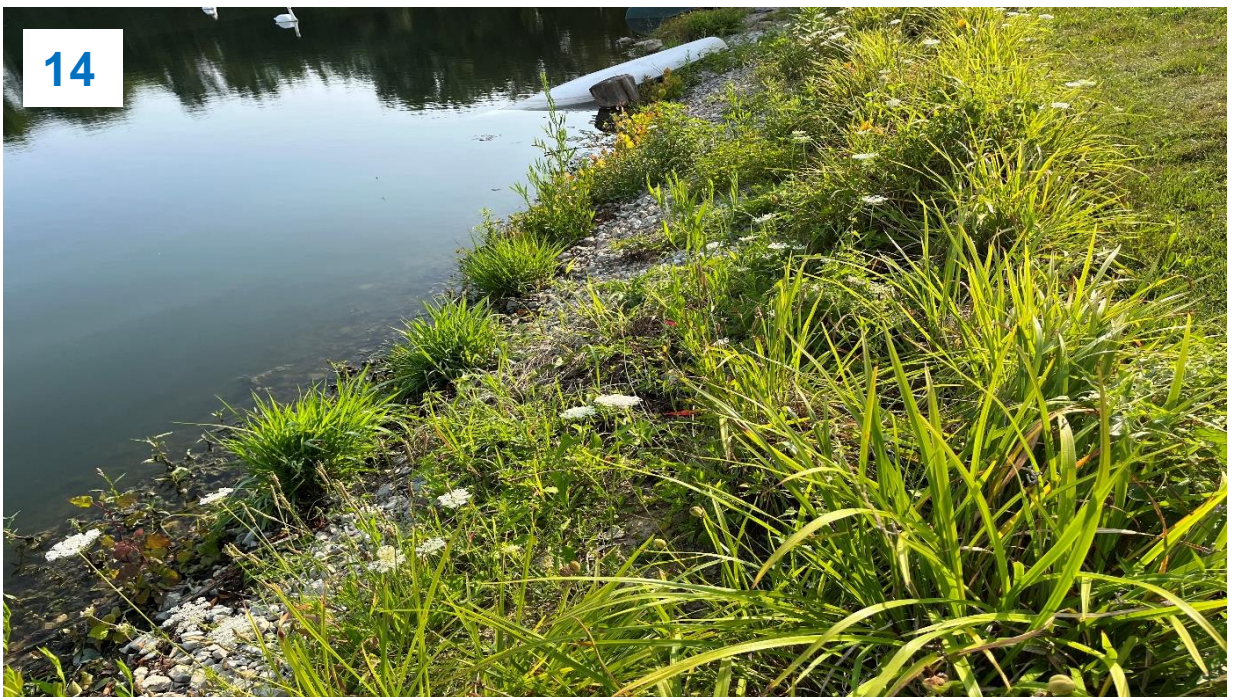
Bottom: Upstream slope near middle, vegetation below, within, and above sparse riprap protection.

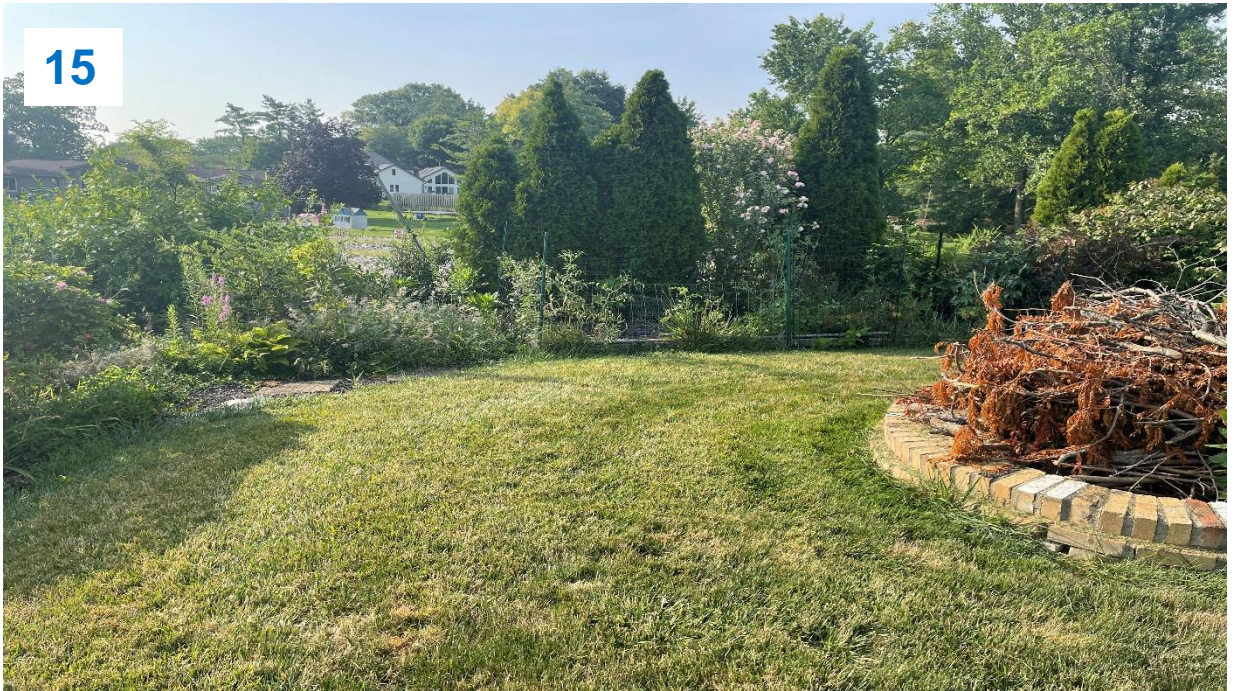
Top: Upstream slope right side, landscaping, fireplace, and garden on embankment.

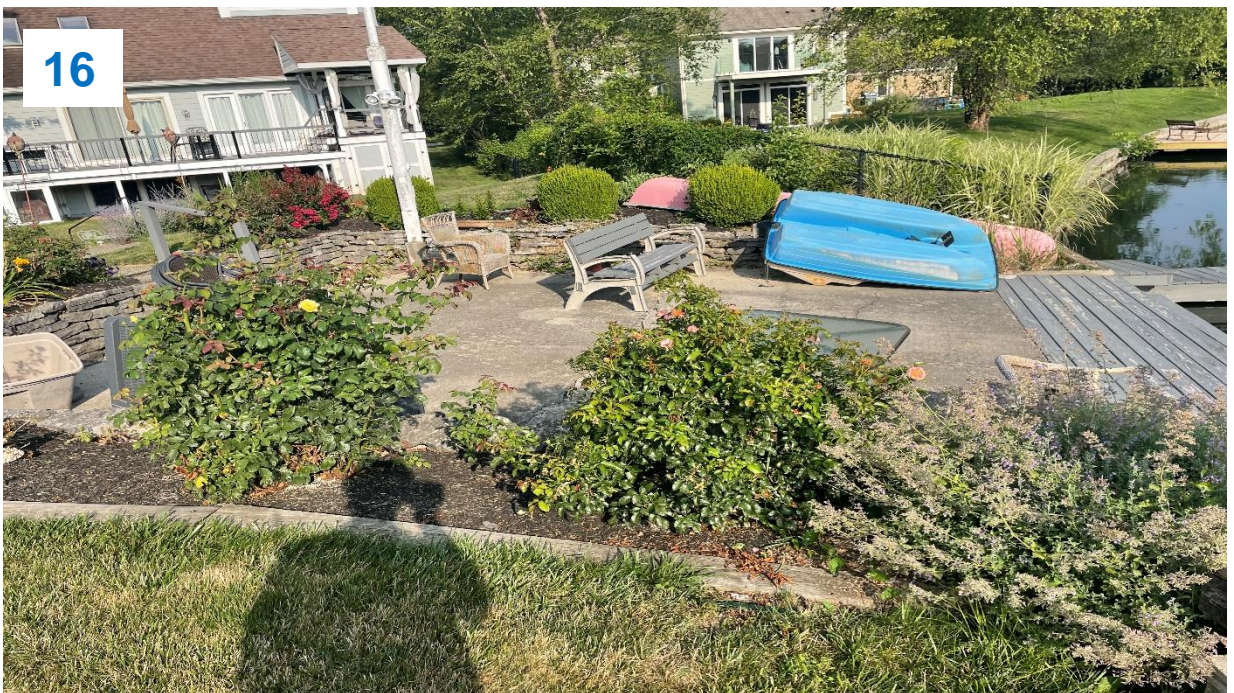
Bottom: Upstream slope right side, dock built into embankment with patio furniture and watercraft.

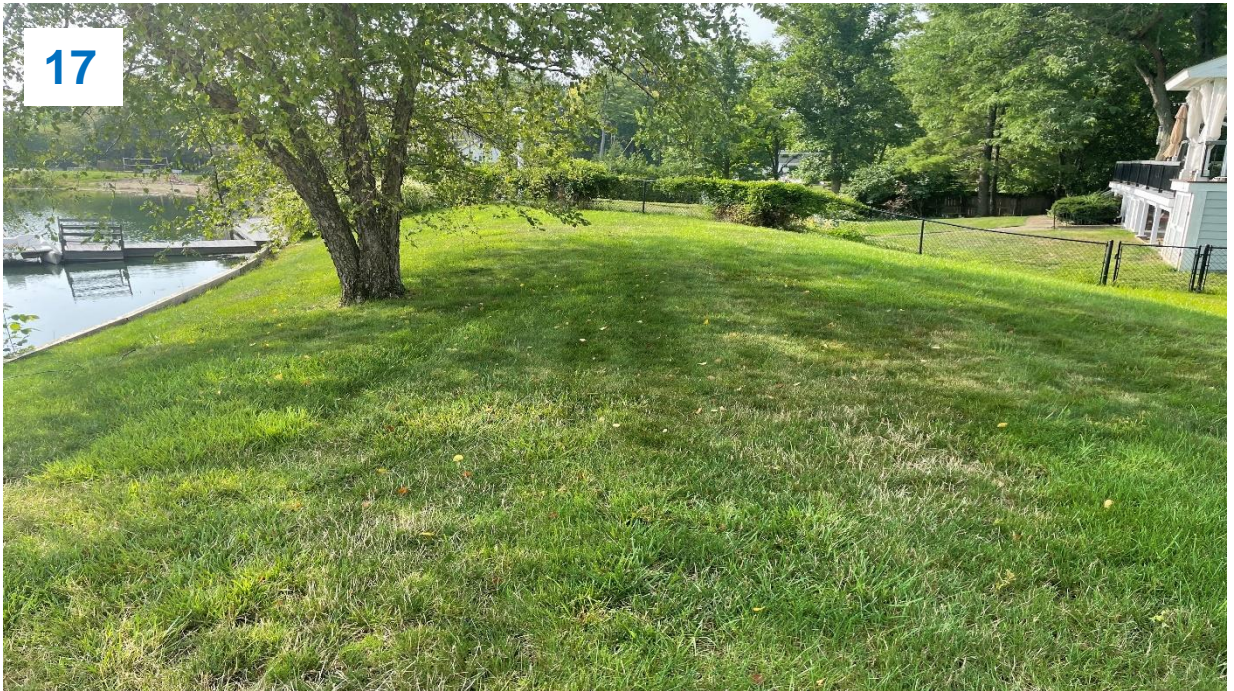
17

Top: Upstream slope right side, note tree on slope.

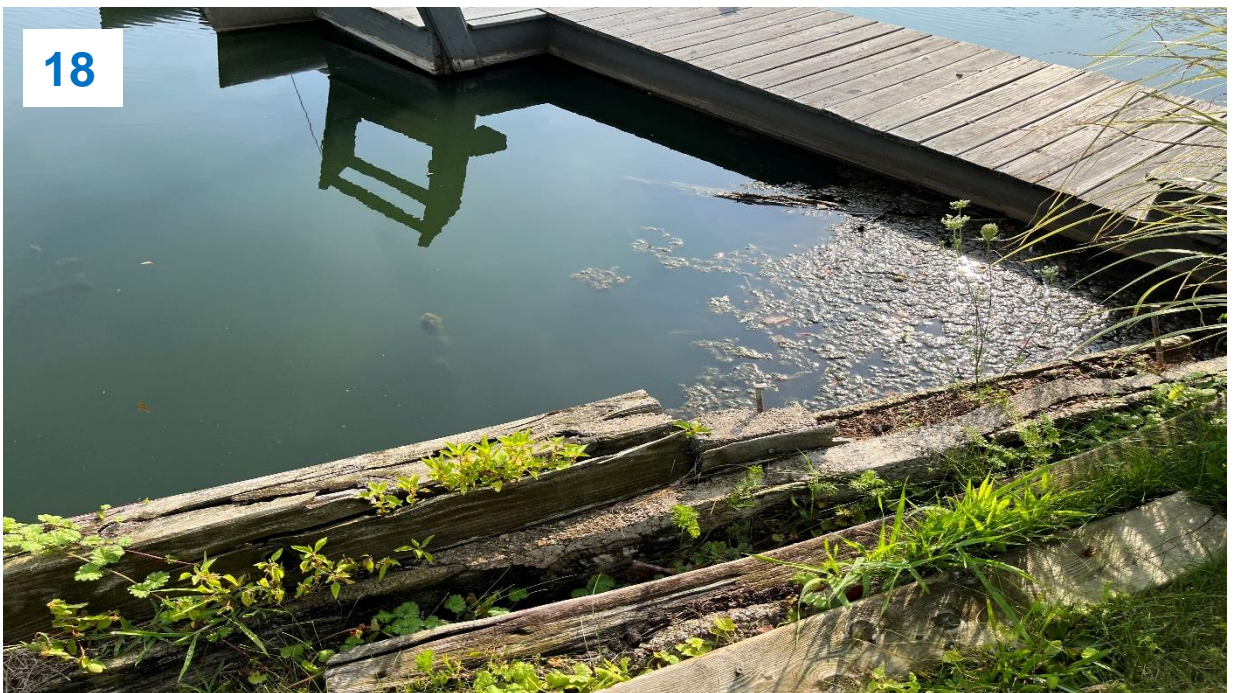
18

Bottom: Upstream slope right side, area of deterioration on left side of wooden sea wall.

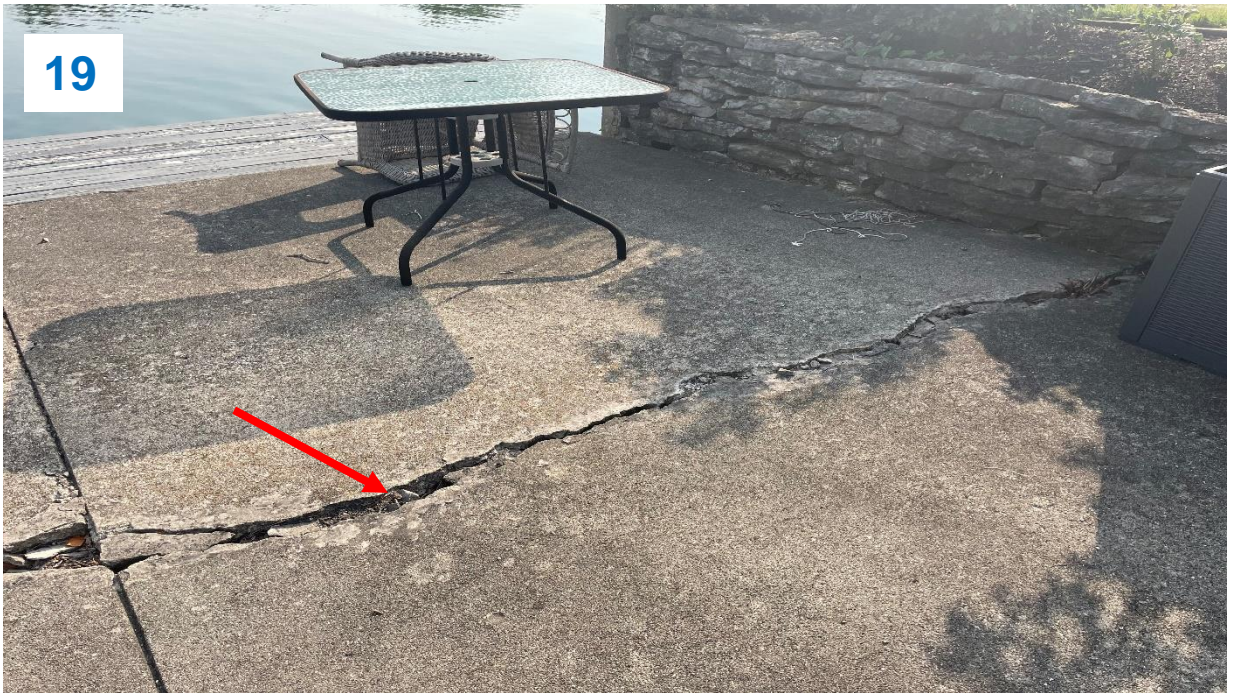
Top: Upstream slope right side, concrete slab cracking and settling into dam.

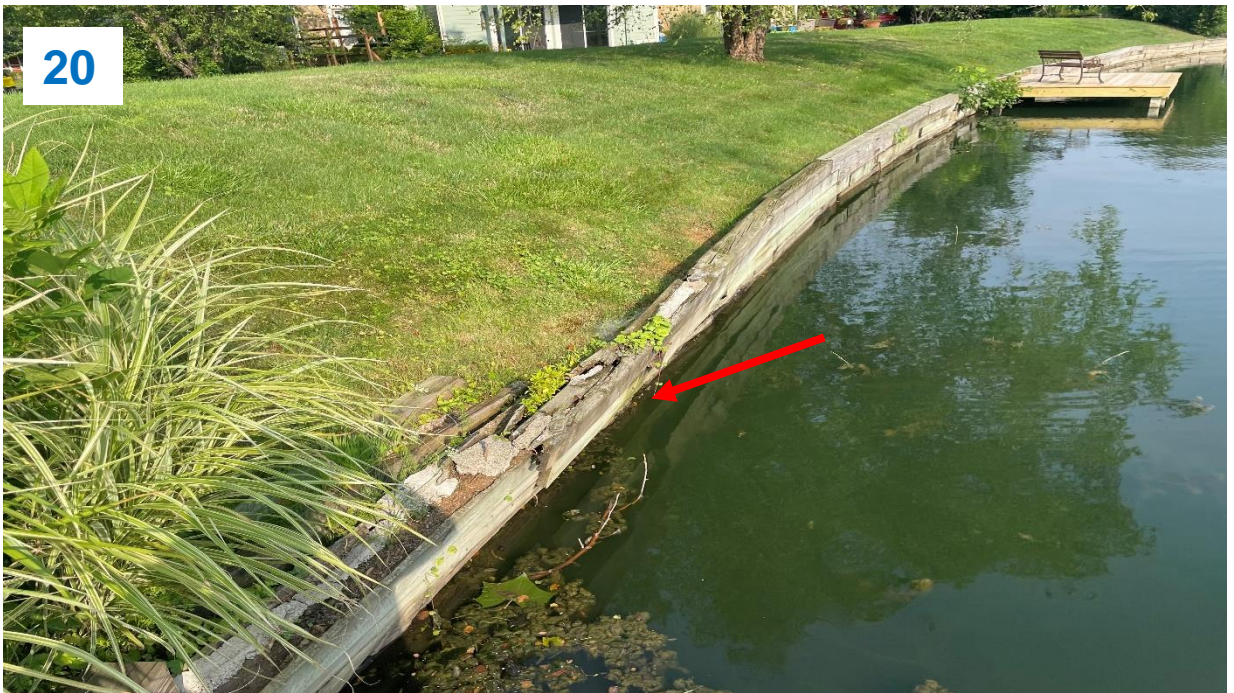
Bottom: Upstream slope right side, wooden seawall rotting below normal pool and angling toward lake.

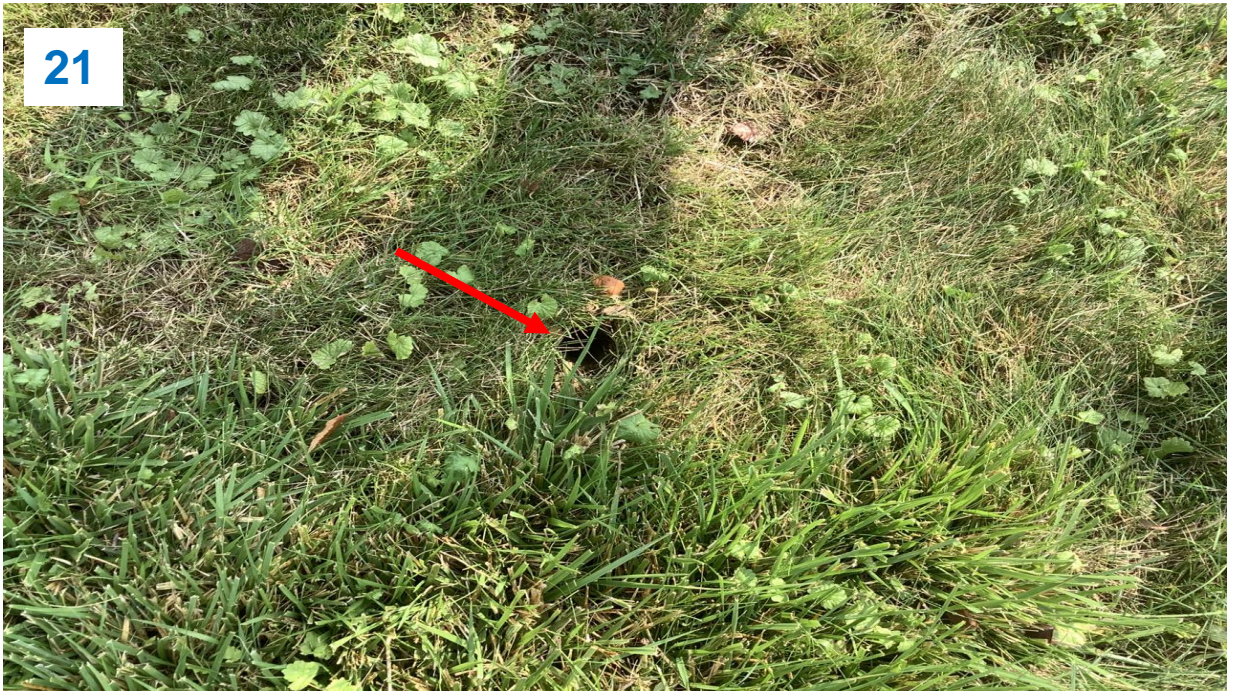
Top: Upstream slope right side, 2-inch, 3.5 feet deep animal burrow.

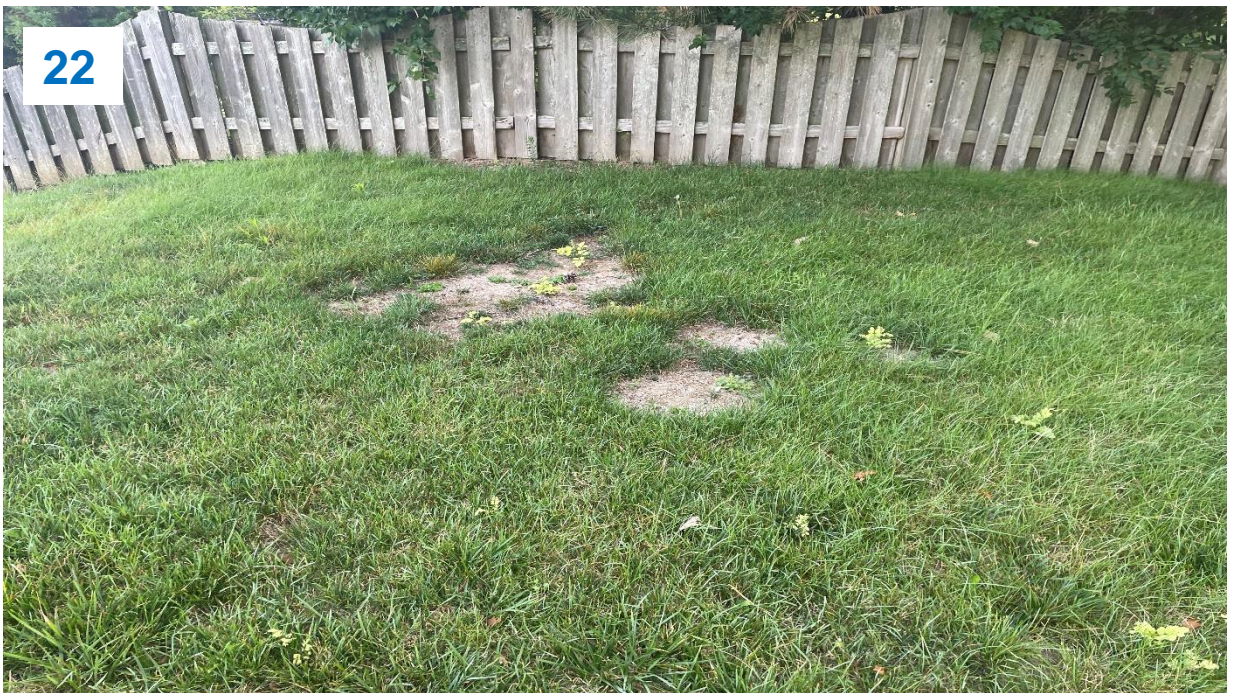
Bottom: Crest on left side, bare area next to fenceline.

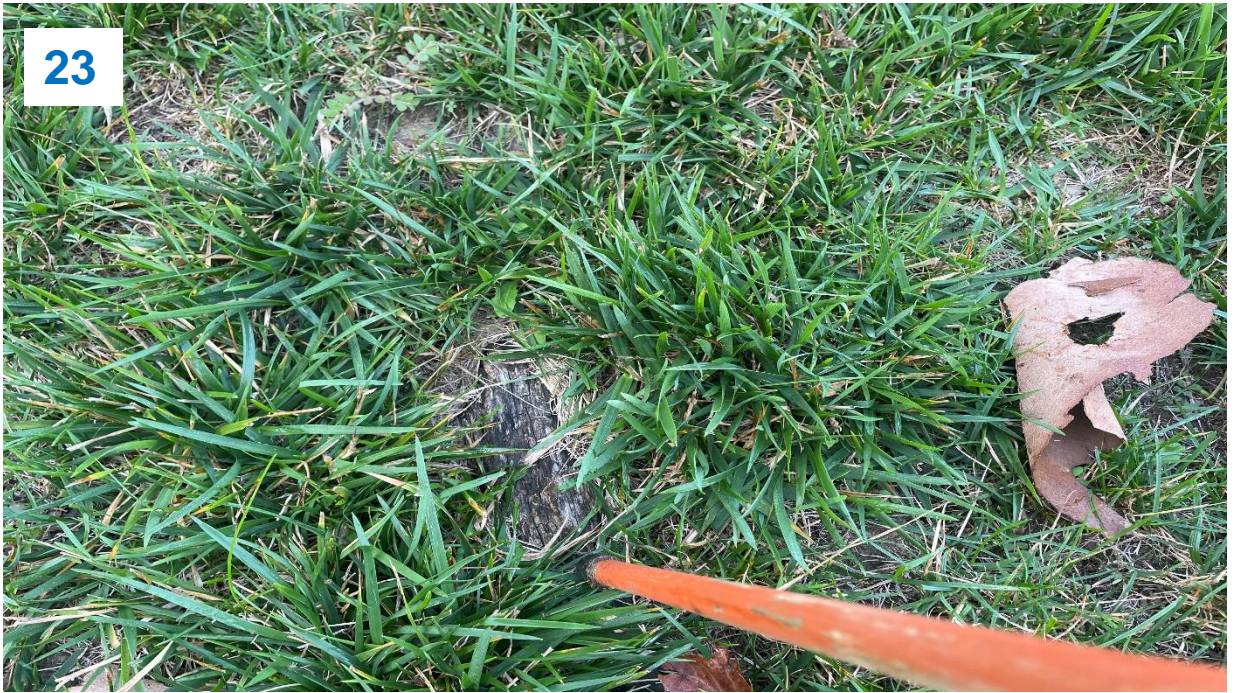
Top: Crest on left side, soft area with tree roots.

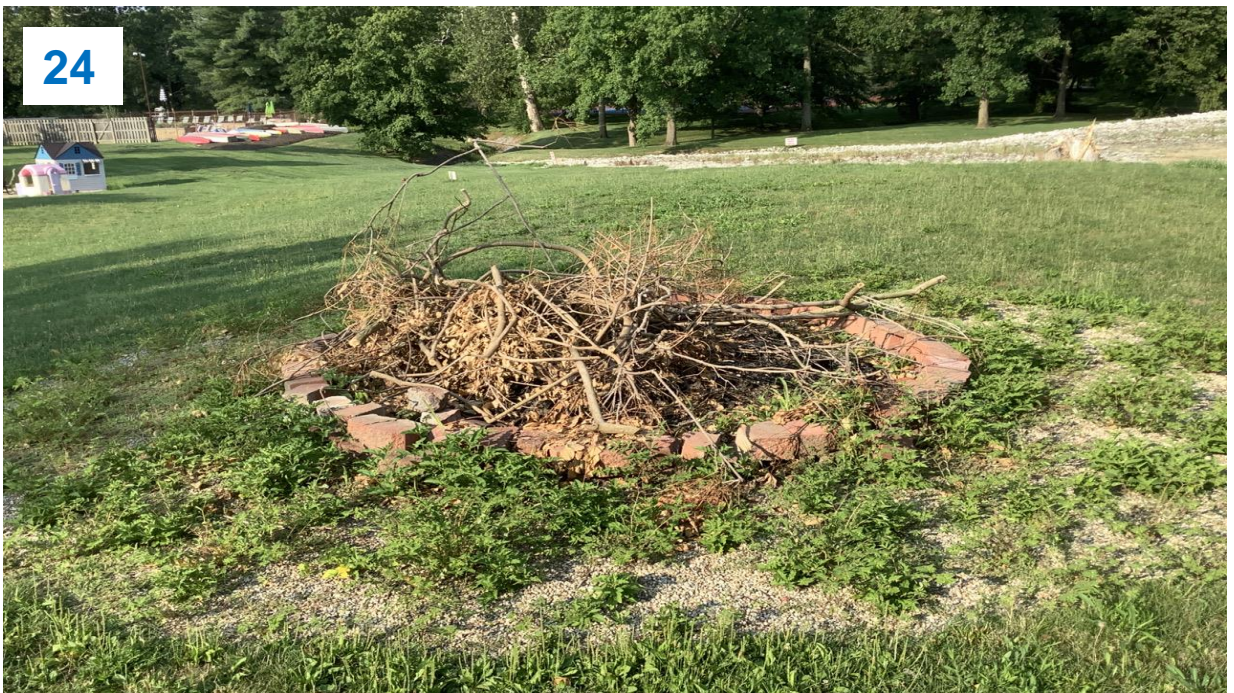
Bottom: Crest in the middle of the dam. large fire pit with brush.

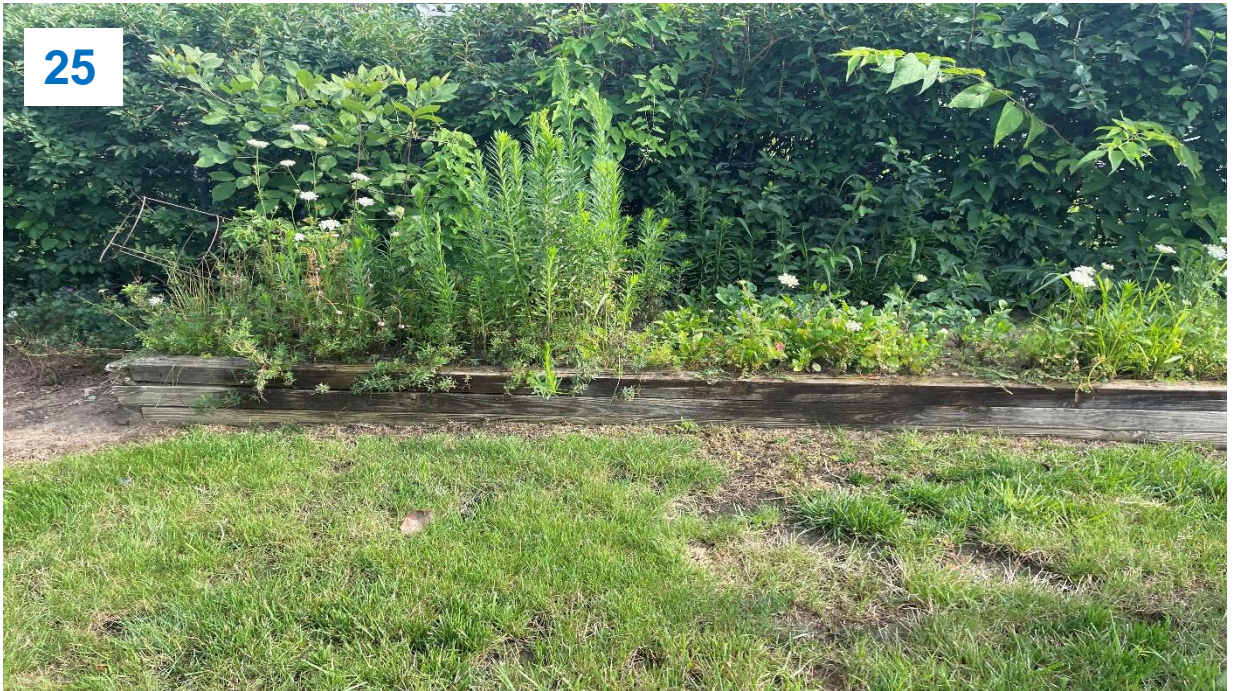
Top: Crest near right abutment, garden and vegetation with surrounding bare areas.

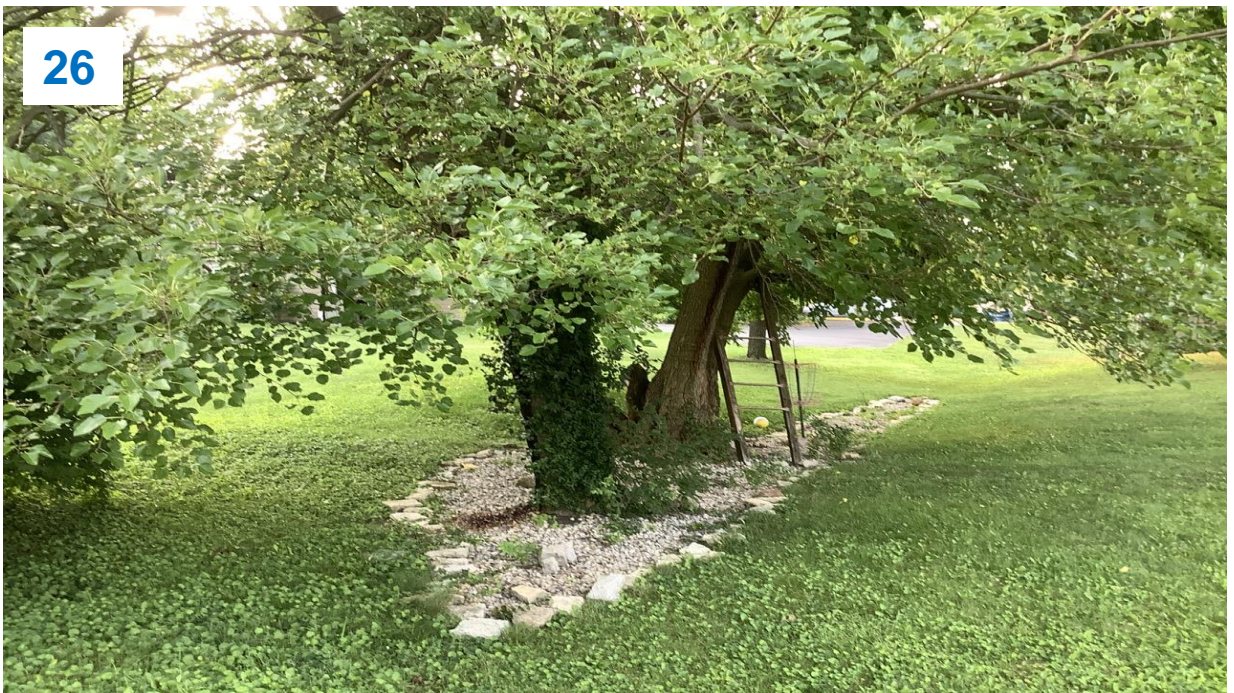
Bottom: Downstream slope left side, trees and landscaping within 25 feet of toe.
