KEYSTONE WOODS LAKE DAM (29-5)

2023 Dam Safety Inspection Report
Hamilton County, IN | December 2023
Inspection Date: August 2, 2023

Burke Project No. 15-0171.00005

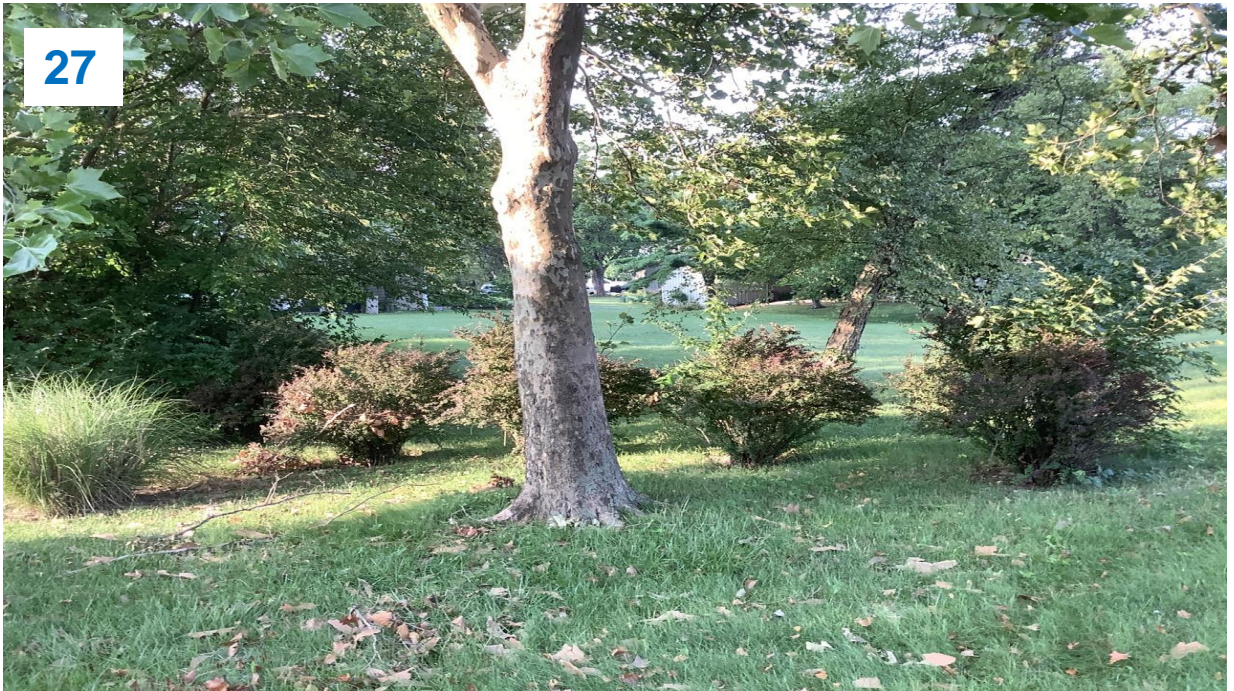
Top: Downstream slope left side, trees and brush within 25 feet of toe of slope.

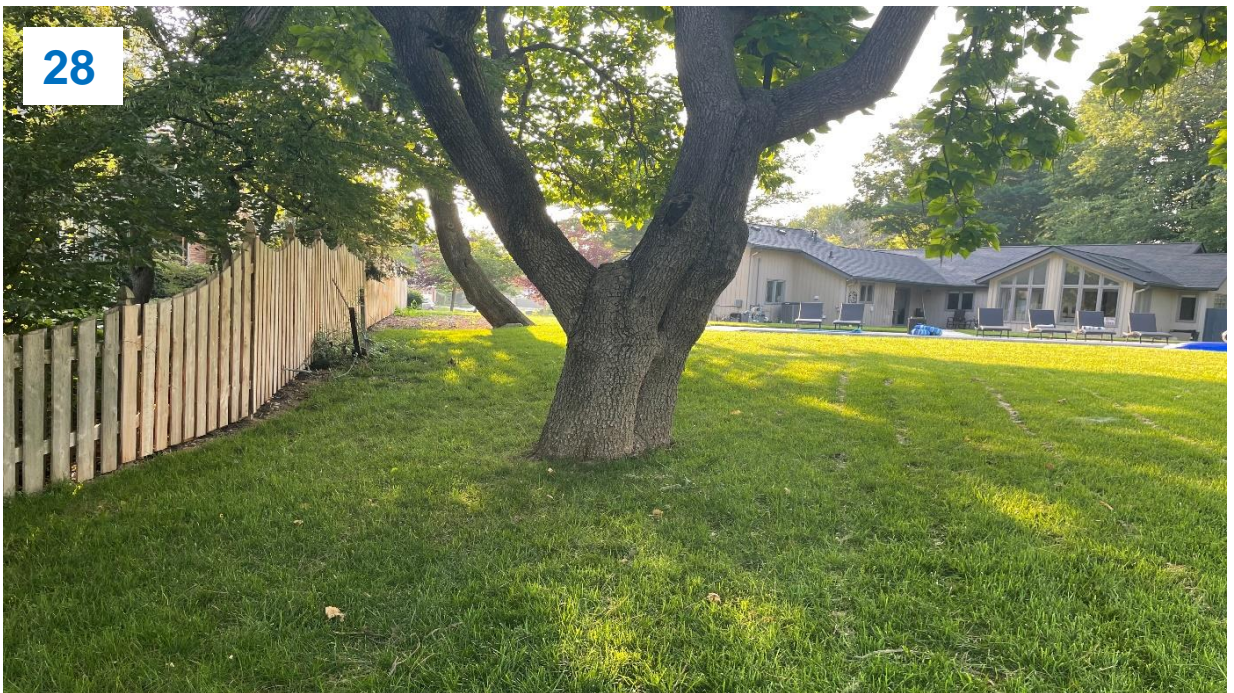
Bottom: Downstream slope left side, tree within 25 feet of toe of slope.

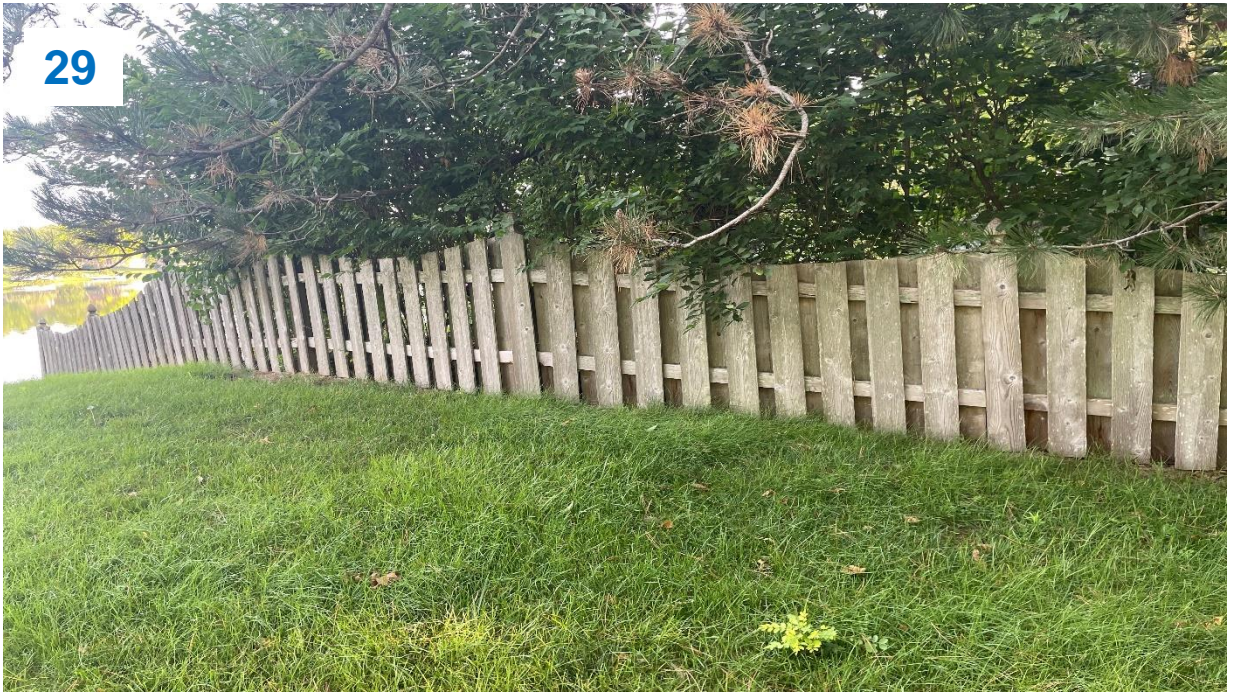
Top: Downstream slope left side, property line fence traversing embankment.

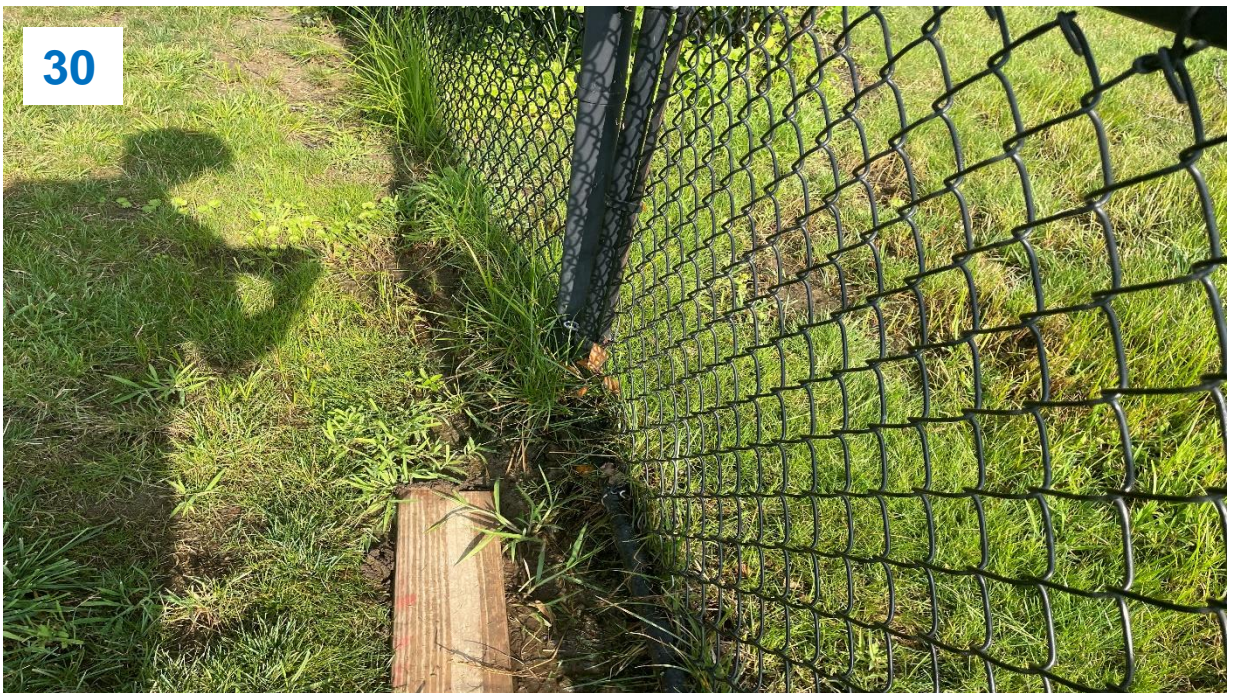
Bottom: Downstream slope right side, wet area along fence line likely due to yard irrigation

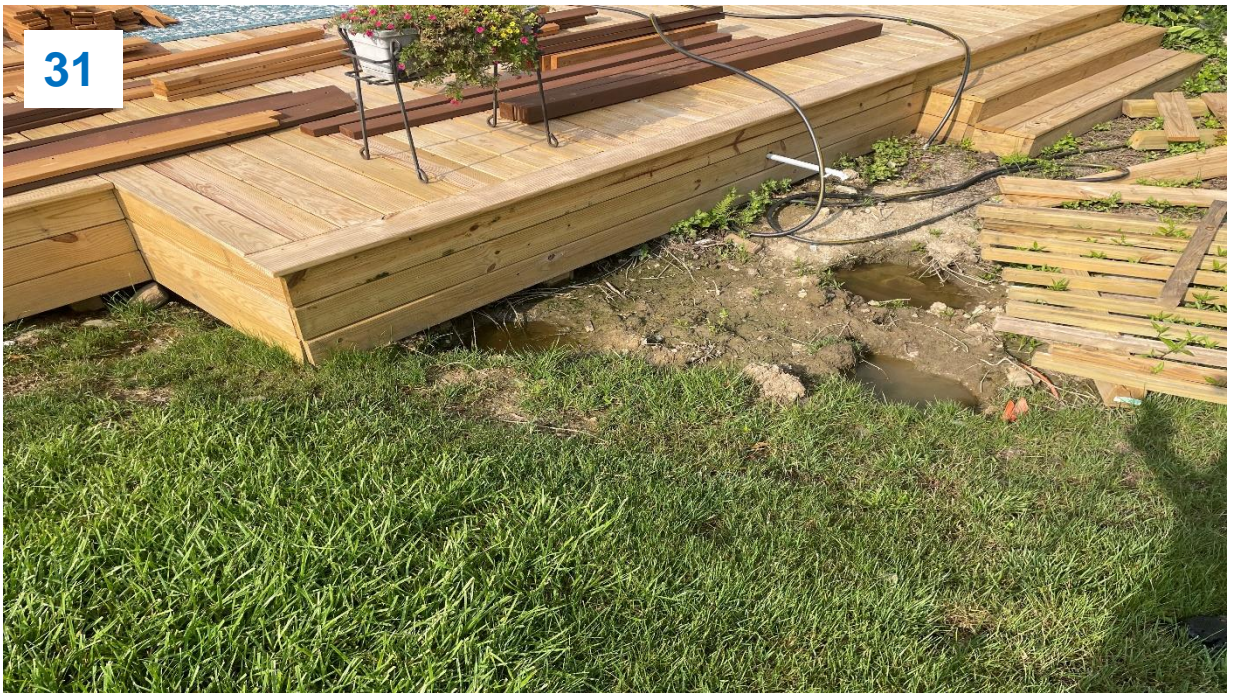
Top: Downstream slope right side, wet area with standing water near deck construction area likely due to yard irrigation.

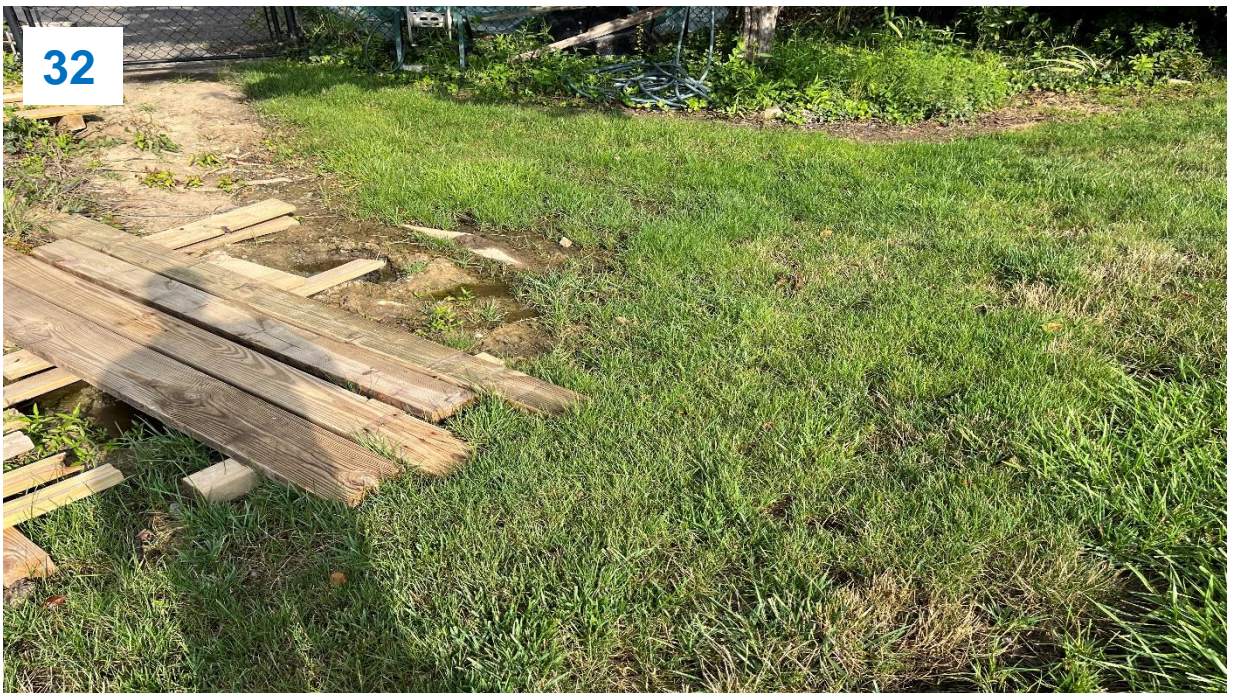
Bottom: Downstream slope right side, saturated dam slope approximately 11 foot by 23 foot likely due to yard irrigation.

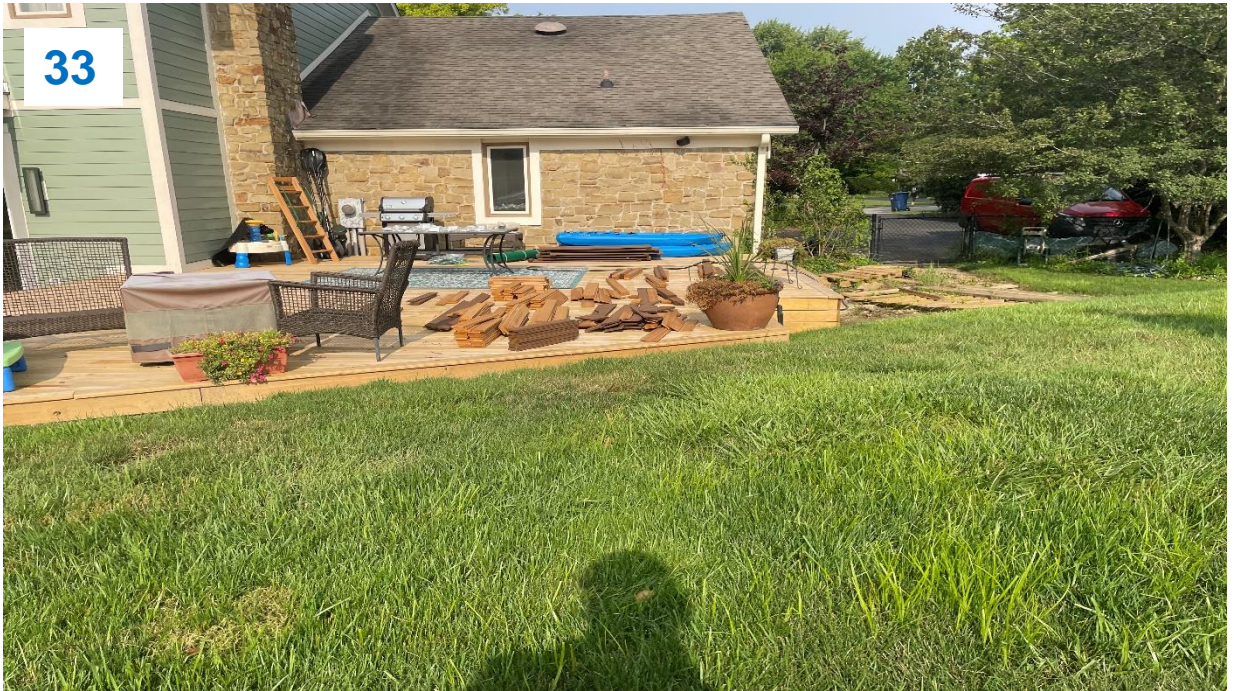
Top: Downstream slope right side, deck with furniture encroaching on slope.

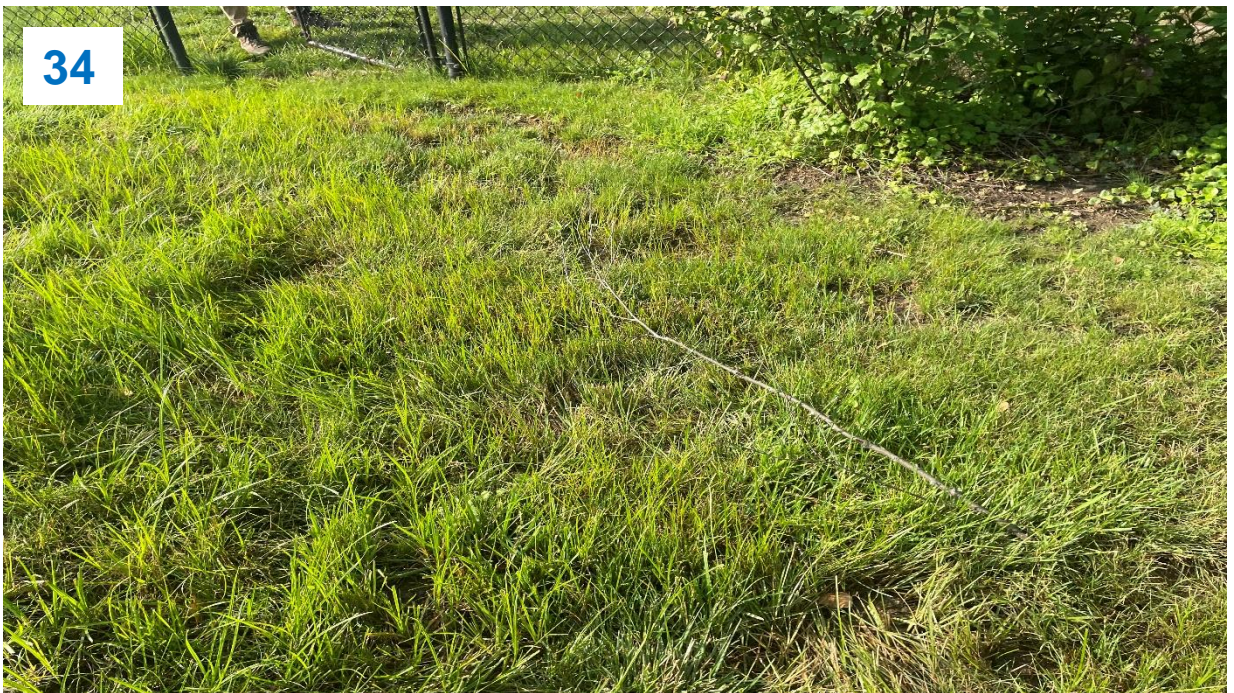
Bottom: Downstream slope right side, saturated backyard likely due to yard irrigation.

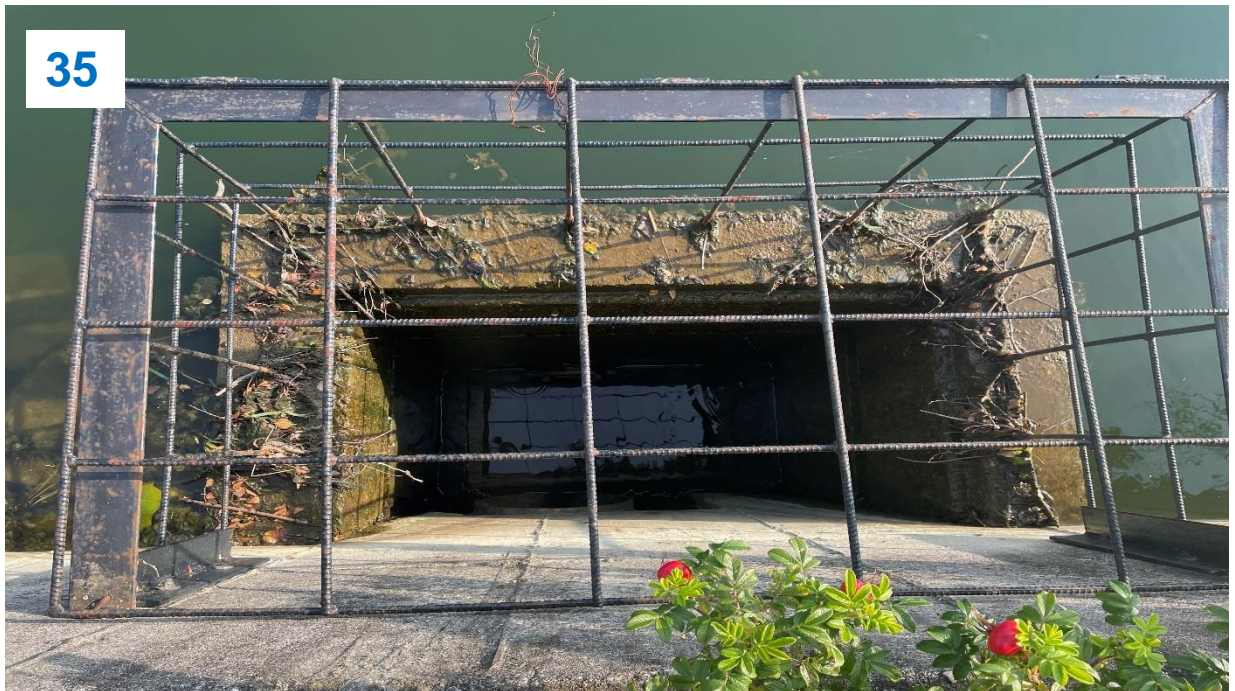
35

Top: Principal spillway inlet, note rust on trash rack, vegetation, and leafy debris.

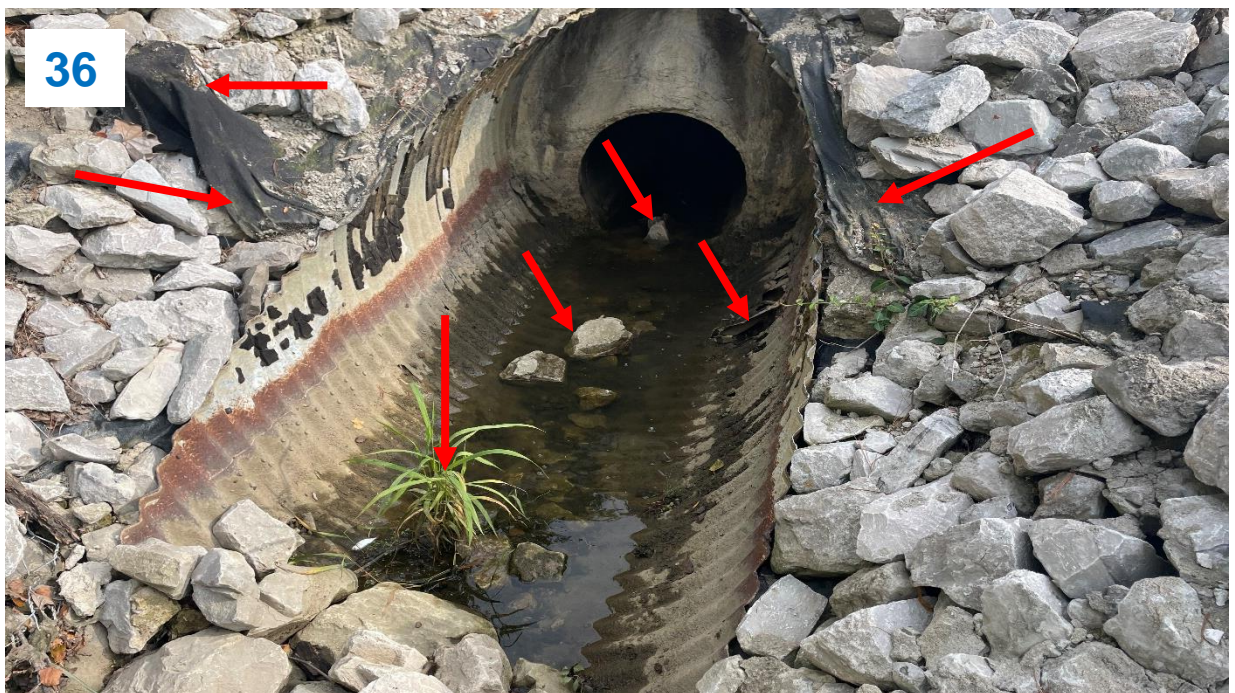
36

Bottom: Principal spillway outlet, Note deterioration of metal end section with holes in invert, roots around outlet, exposed geotextile fabric, and riprap fallen into pipe outlet.

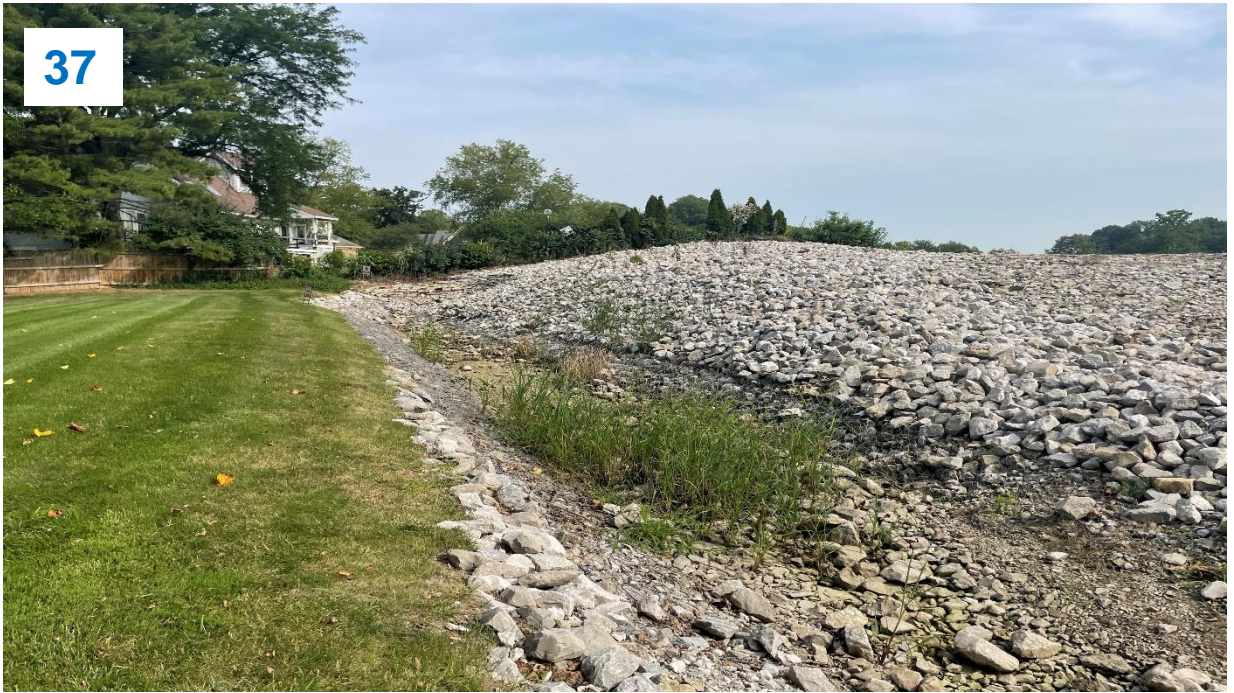
Top: Principal spillway outlet, vegetation in outlet channel.

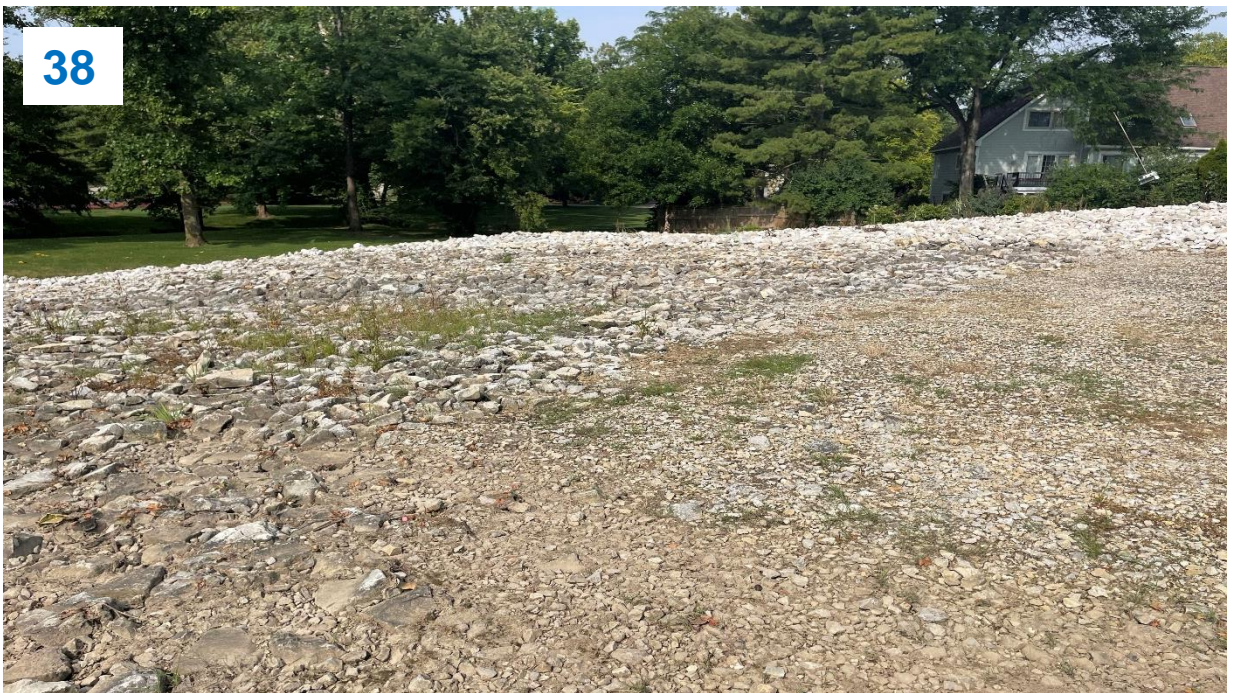
Bottom: Auxiliary spillway, note vegetation in riprap and varying riprap sizes.

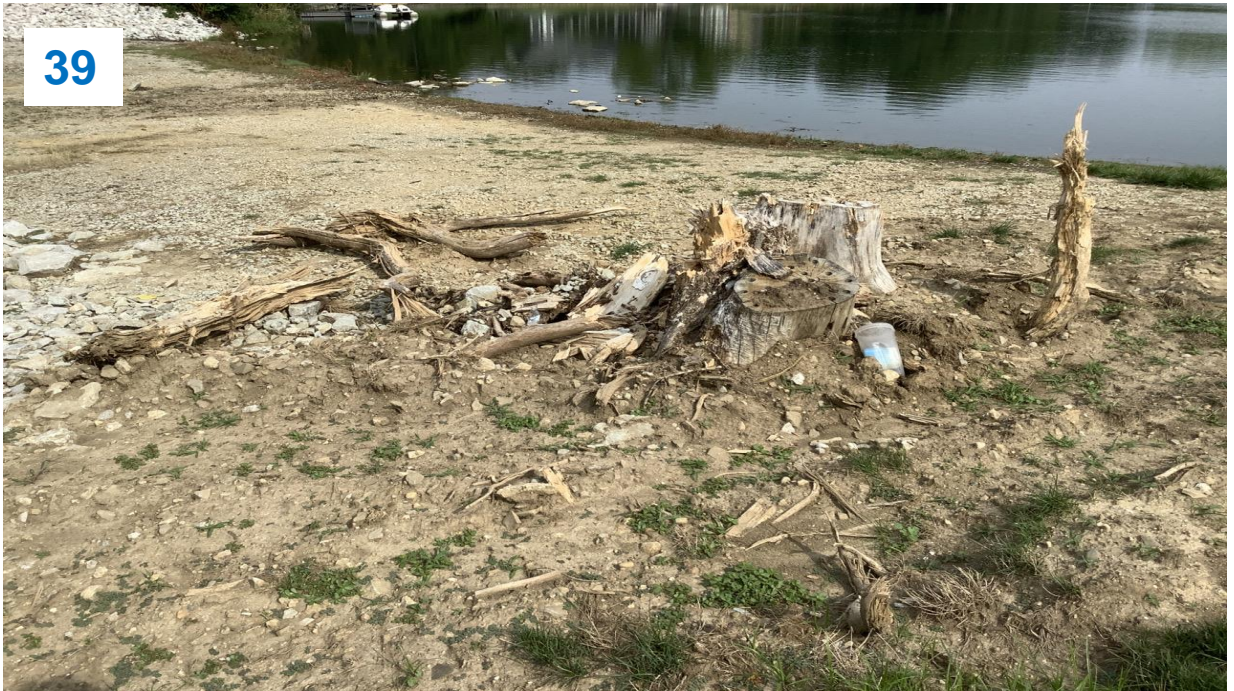
Top: Auxiliary spillway left side, bare area around tree stump.

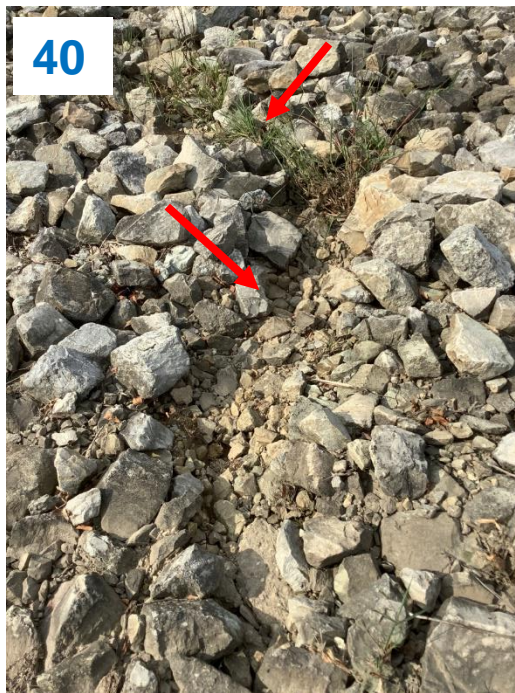
Bottom: Auxiliary spillway near middle, head cut forming from low flow in auxiliary spillway with vegetation growth.

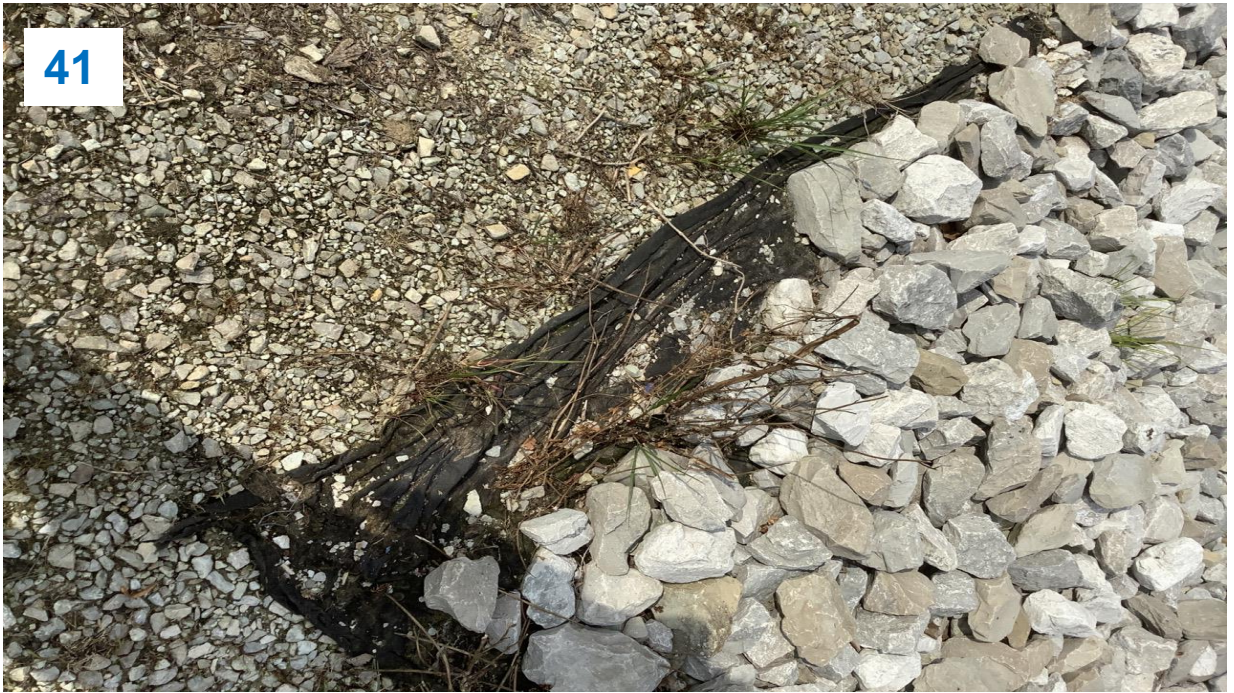
Top: Auxiliary spillway right side, exposed geotextile fabric.

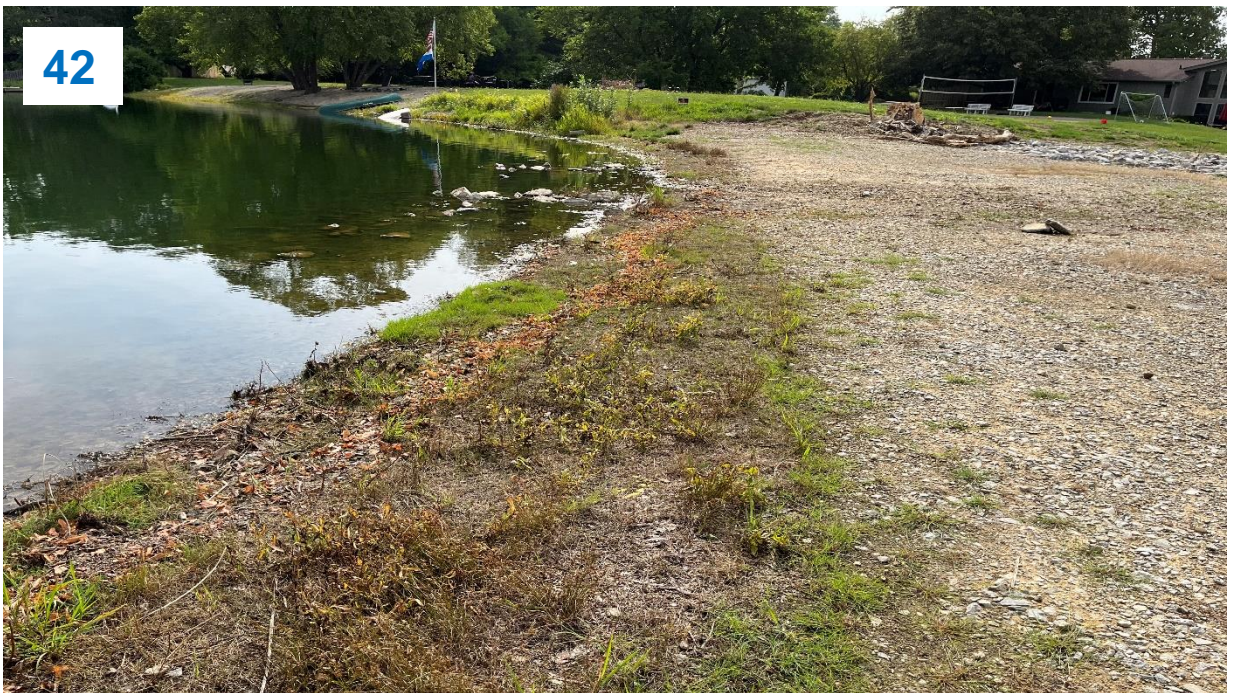
Bottom: Auxiliary spillway inlet, aquatic vegetation along shoreline.
