KEYSTONE WOODS LAKE DAM (29-5)

2025 Dam Safety Inspection Report

Hamilton County, IN | November 2025

Inspection Date: July 25, 2025

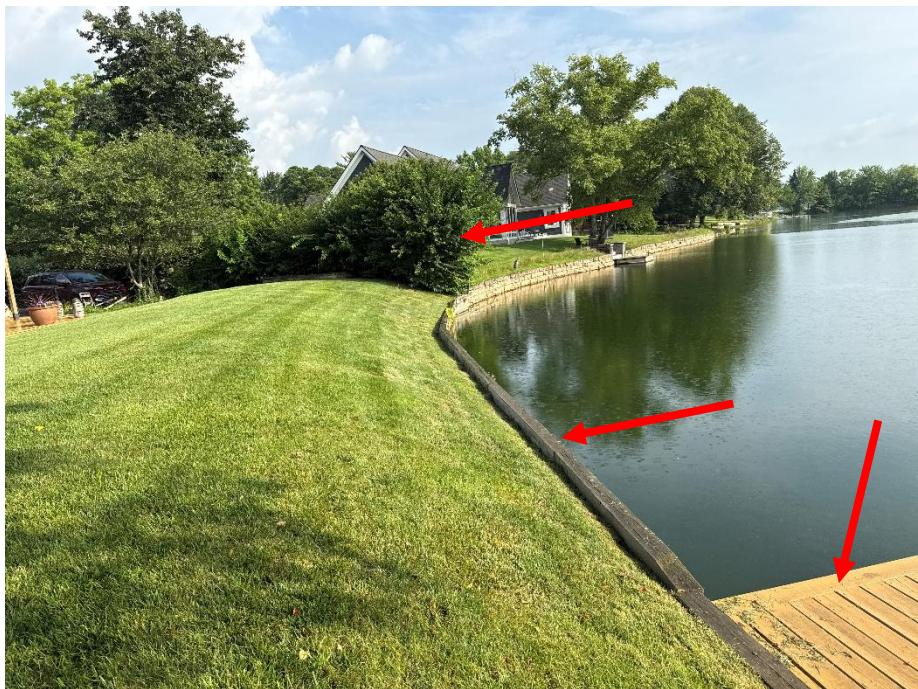
Top: Upstream slope right side. Note timber seawall protection on this section with slight deflection towards lake. Also note several encroachments of fences, trees, and bushes.

| Component | Rating | Recommendations | Schedule | Importance |
|---|---|--|---|---|
| | | Monitor right side wooden seawall for deflection and deterioration; notify a registered professional engineer of observed changes | Ongoing | Low |

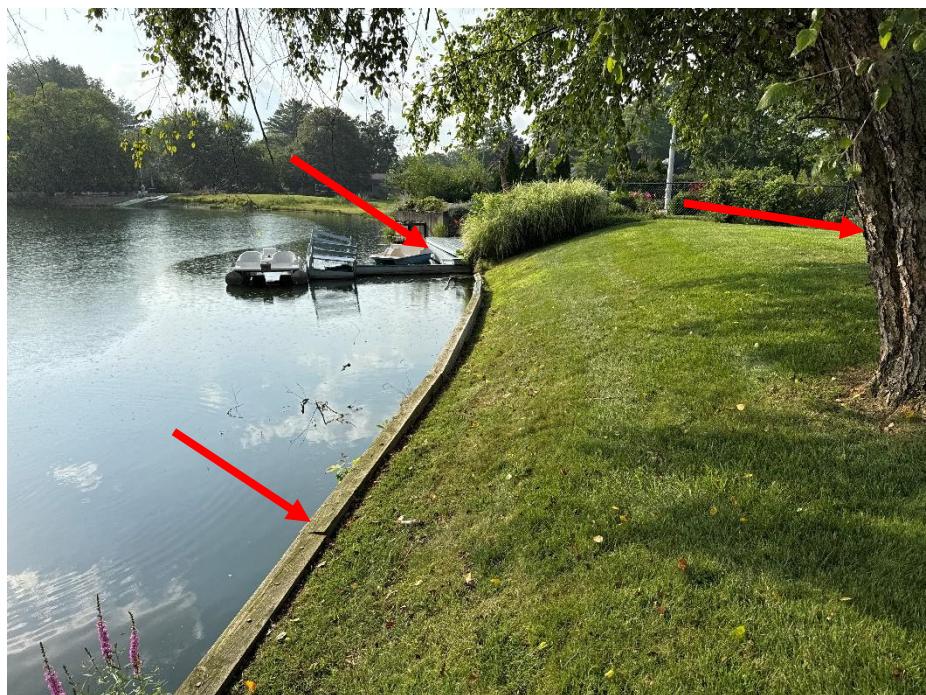
Bottom: Upstream slope right side. Note timber seawall protection on this section with slight deflection towards lake. Also note several encroachments of docks, fences, landscaping, trees, and bushes.

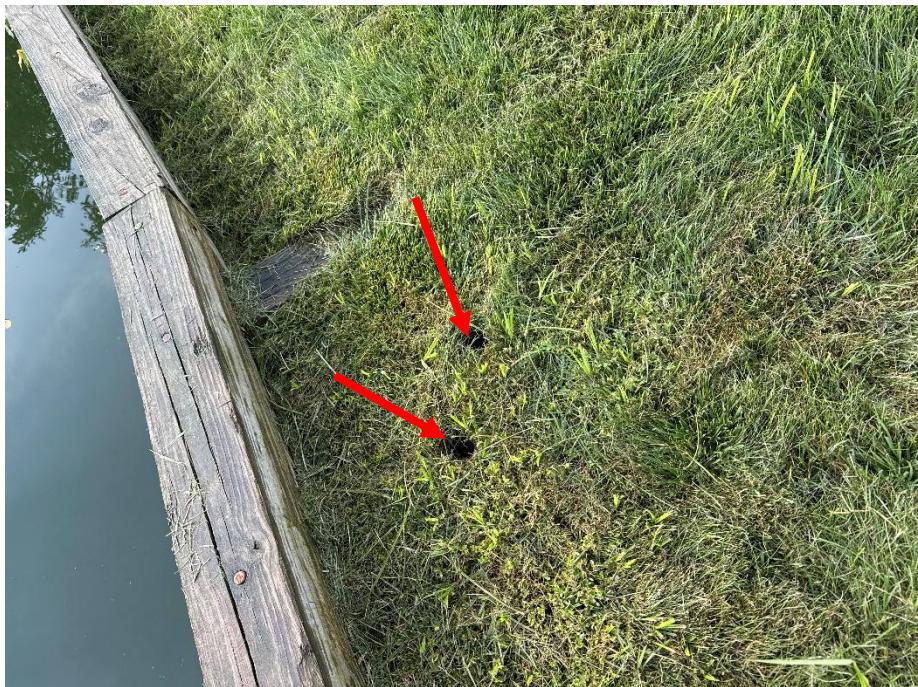
Top: Upstream slope right side. Note typical small diameter burrow holes behind wooden seawall.

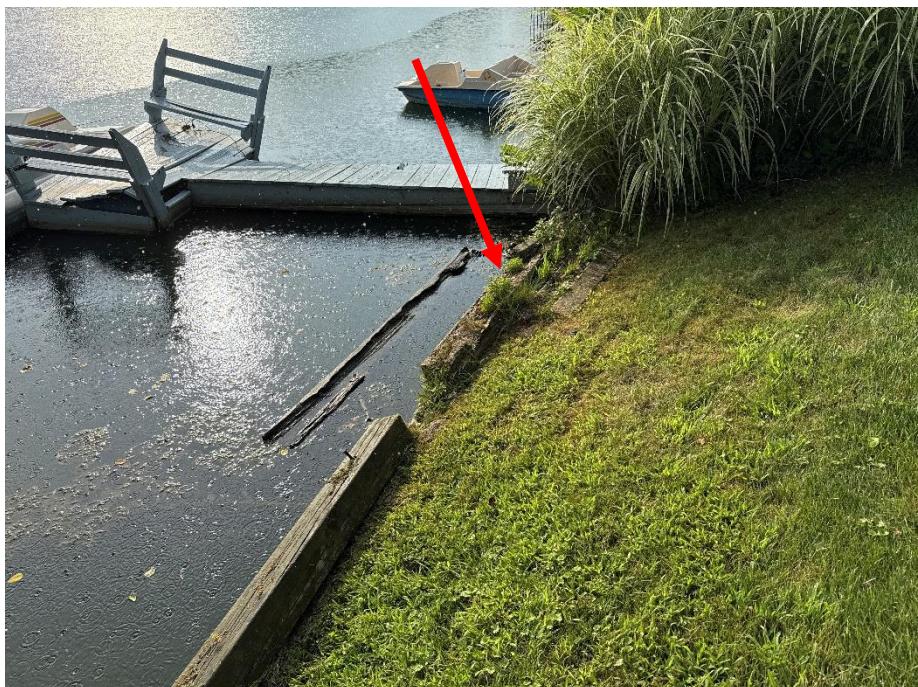
Bottom: Upstream slope right side. Note deteriorated wooden seawall with weedy vegetation growing through.

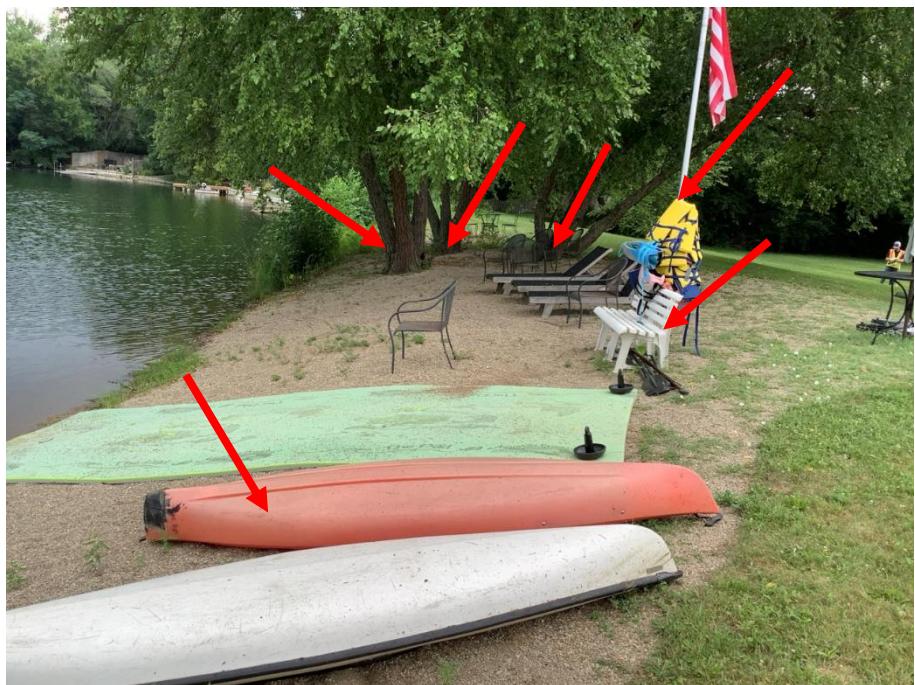
Top: Upstream slope left side. Note inadequate slope cover in gravel area with trees, weedy vegetation, and patio furniture encroaching.

| Component | Rating | Recommendations | Schedule | Importance |
|---|---|--|---|---|
| | | Replace gravel covered slope with grass, riprap or other erosion resistant material | Within 1 year | Medium |

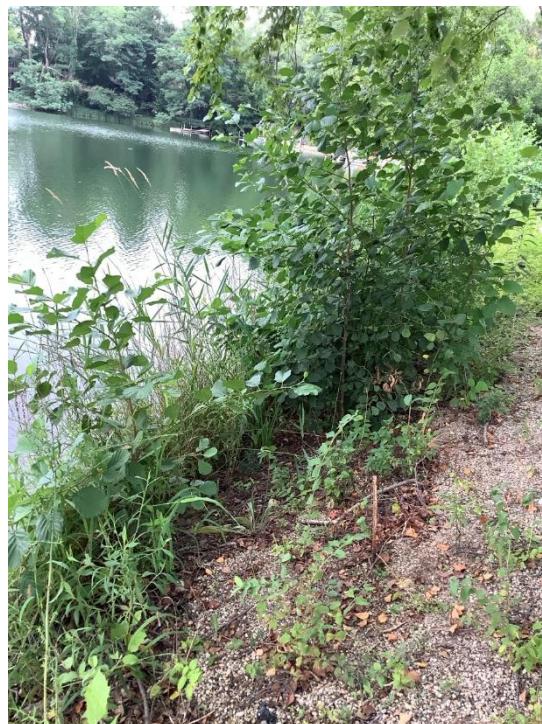
Bottom: Upstream slope left side. Note tall grass and weedy vegetation growth along shoreline.

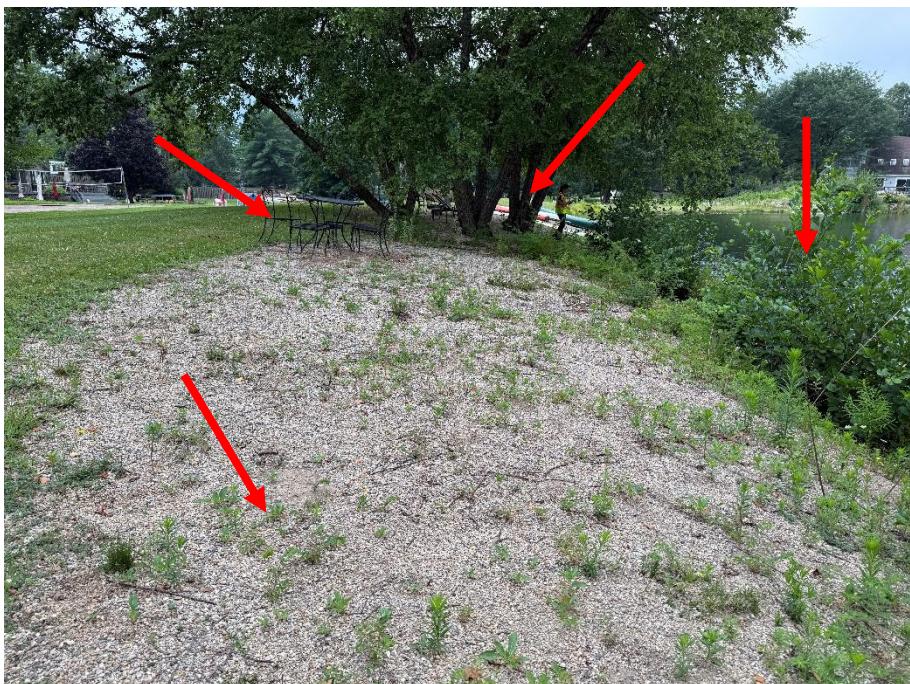
Top: Upstream slope left side. Note inadequate slope cover in gravel area with trees, weedy vegetation, and patio furniture encroaching.

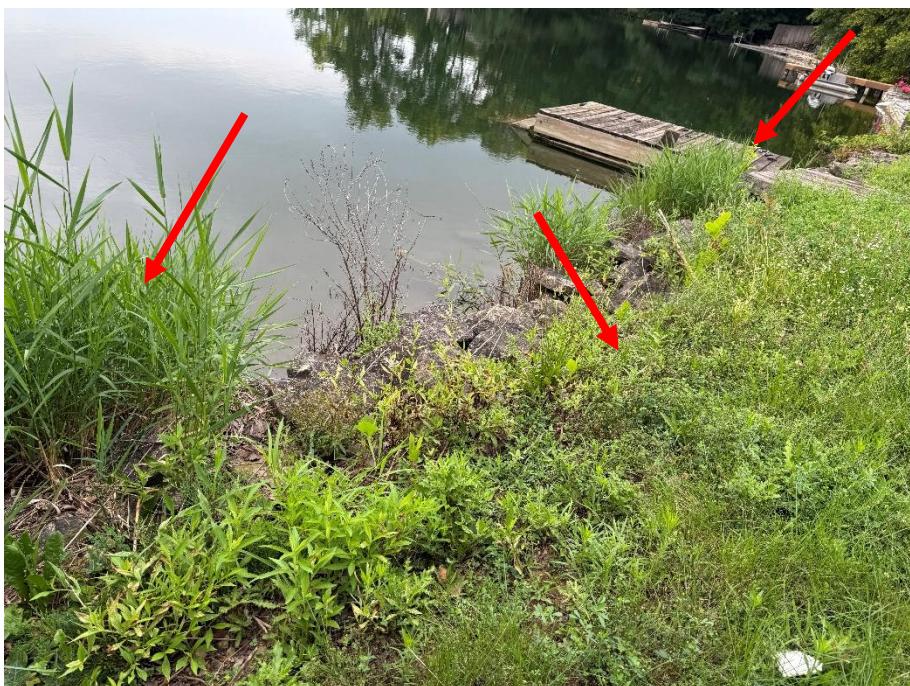
Bottom: Upstream slope left side. Note tall grass and weedy vegetation growth within riprap near wooden dock.

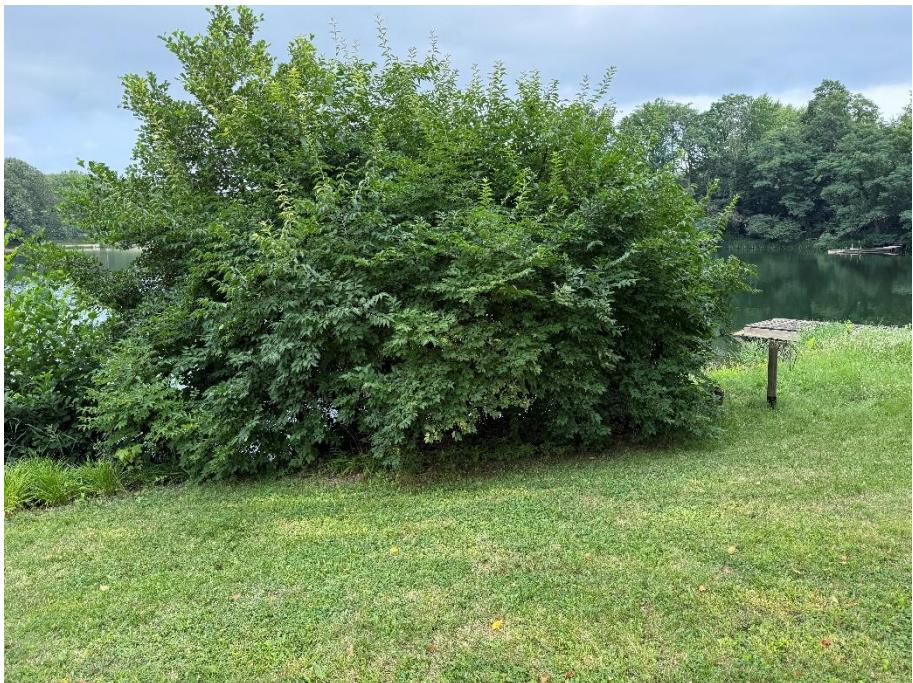
Top: Upstream slope left side. Note large bush on slope by irrigation spigot.

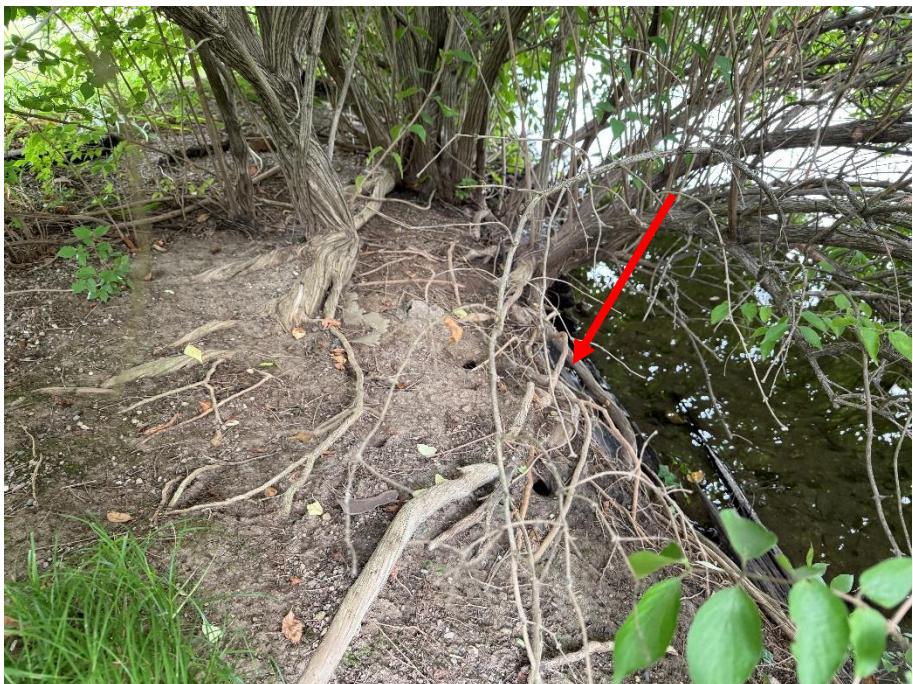
Bottom: Upstream slope left side. Note large bush hides bare and eroded area at shoreline. Burrow holes found around bush.

| Component | Rating | Recommendations | Schedule | Importance |
|---|---|--|---|---|
| | | Seed bare areas and repair divots along slope | Within 2 years | Low |

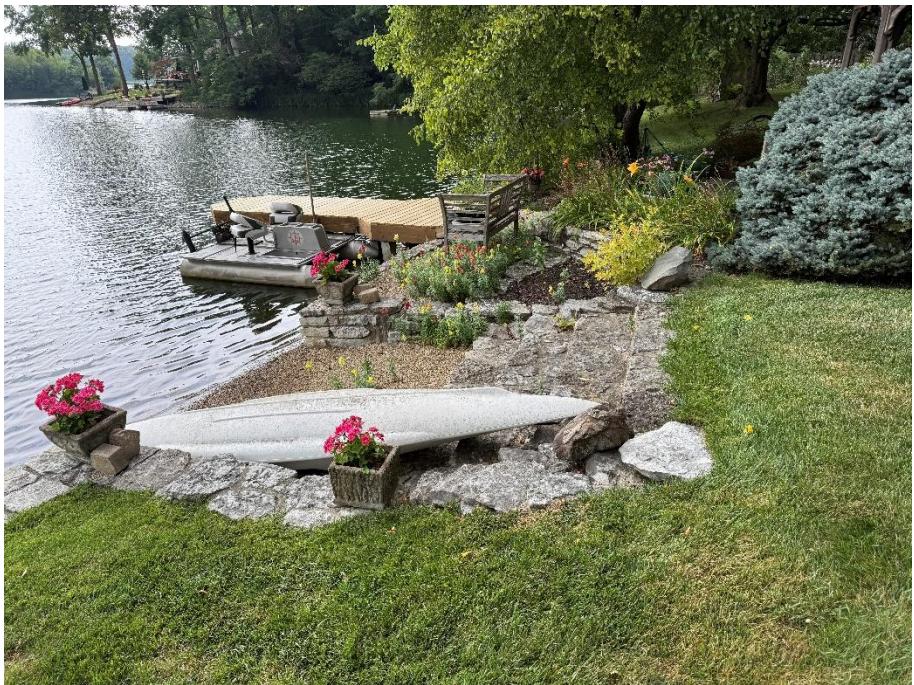
Top: Embankment crest on left abutment looking left. Note trees, brush, landscaping, and watercraft.

| Component | Rating | Recommendations | Schedule | Importance |
|---|---|--|---|---|
| Crest | Deficient | Remove trees and brush from the crest in accordance with the Indiana Dam Safety Inspection Manual | Within 1 year | Medium |

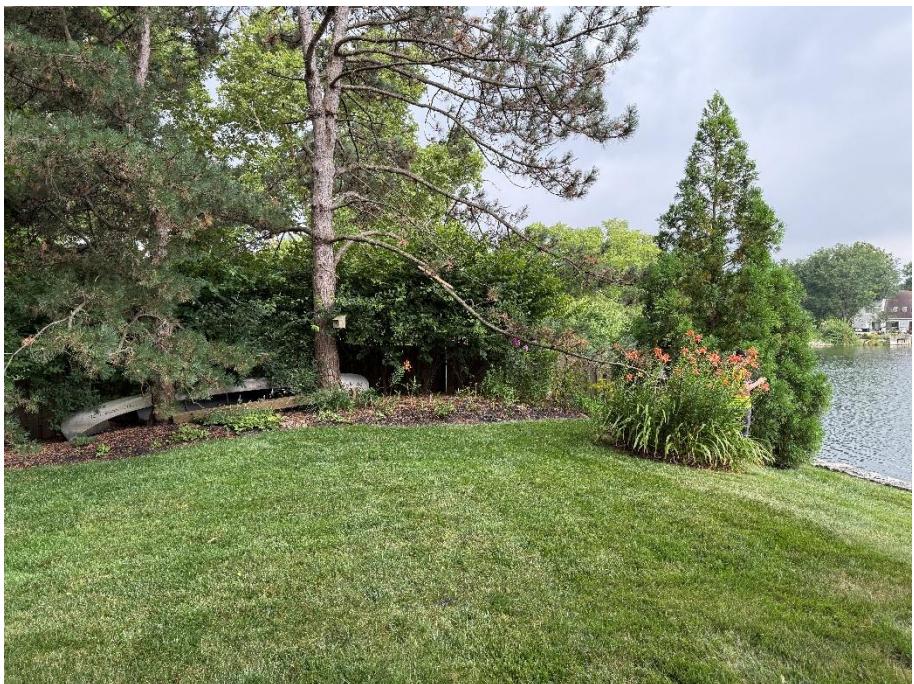
Bottom: Embankment crest on left abutment looking right. Note trees, brush, landscaping, and watercraft.

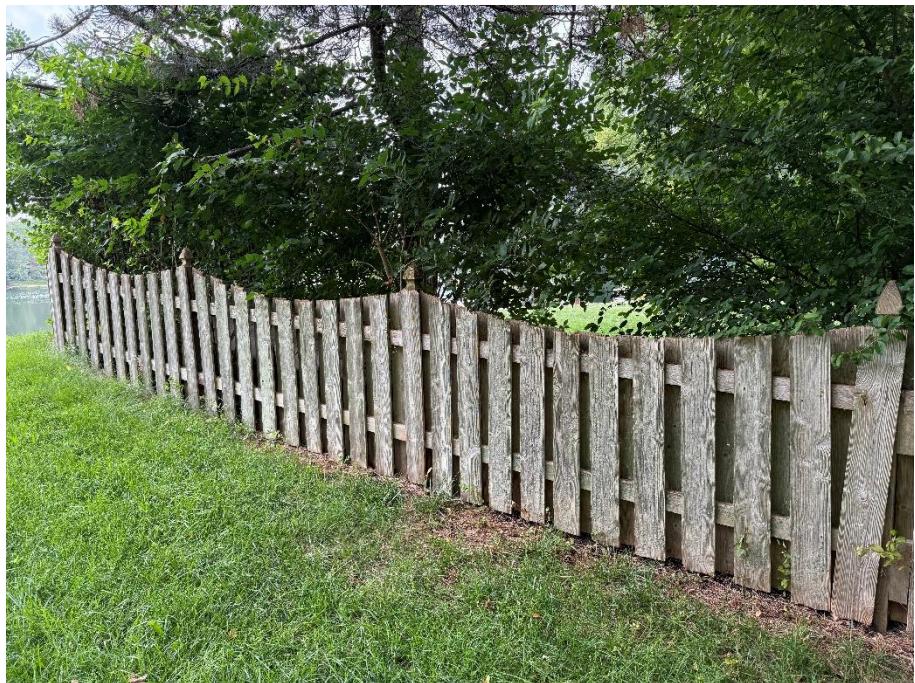
Top: Embankment crest left side. Note fence lines typical at property boundaries.

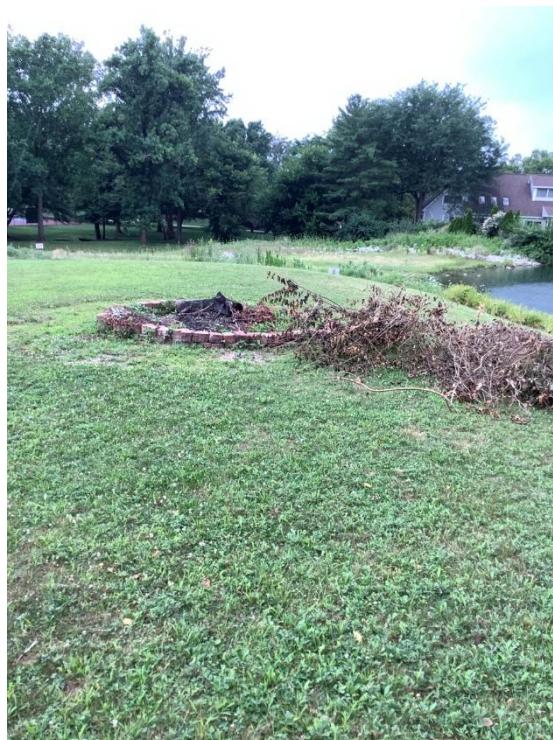
Bottom: Embankment crest left side. Note firepit and woody debris pile.

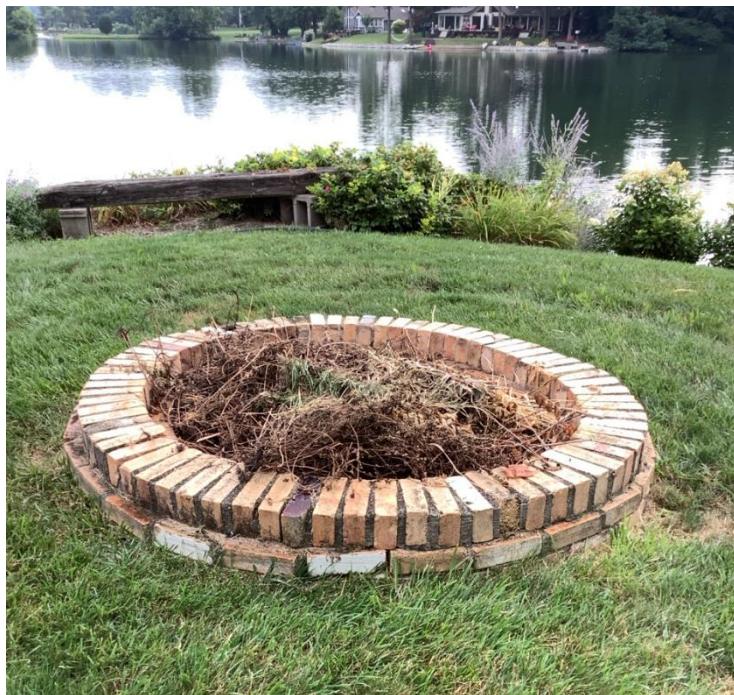
Top: Embankment crest right side. Note firepit encroachment.

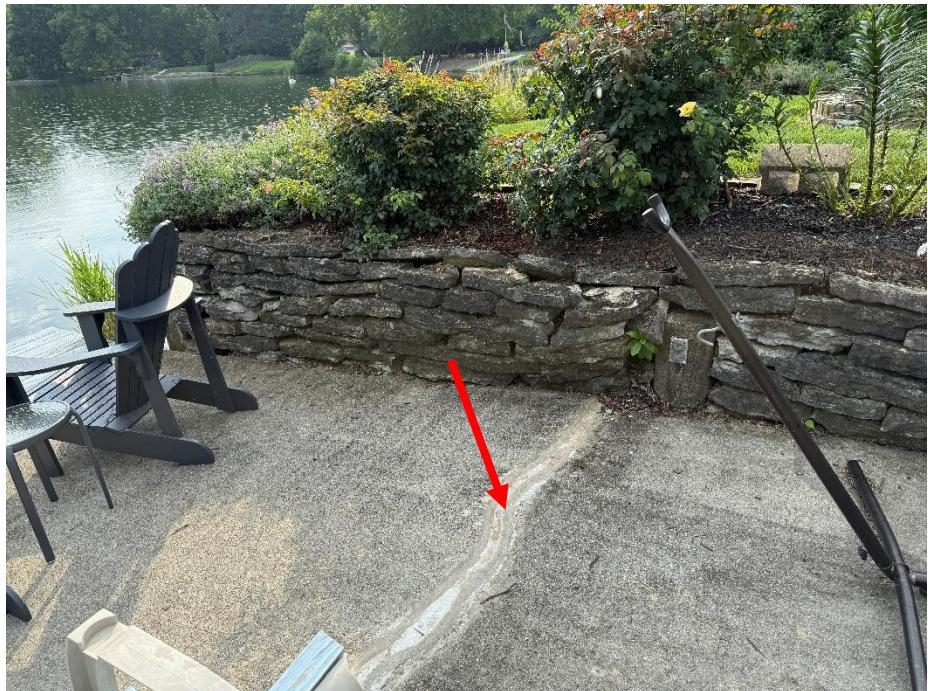
Bottom: Embankment crest right side. Note landscaping and brush encroaching near patio cut into the embankment. Crack in concrete patio has been patched.

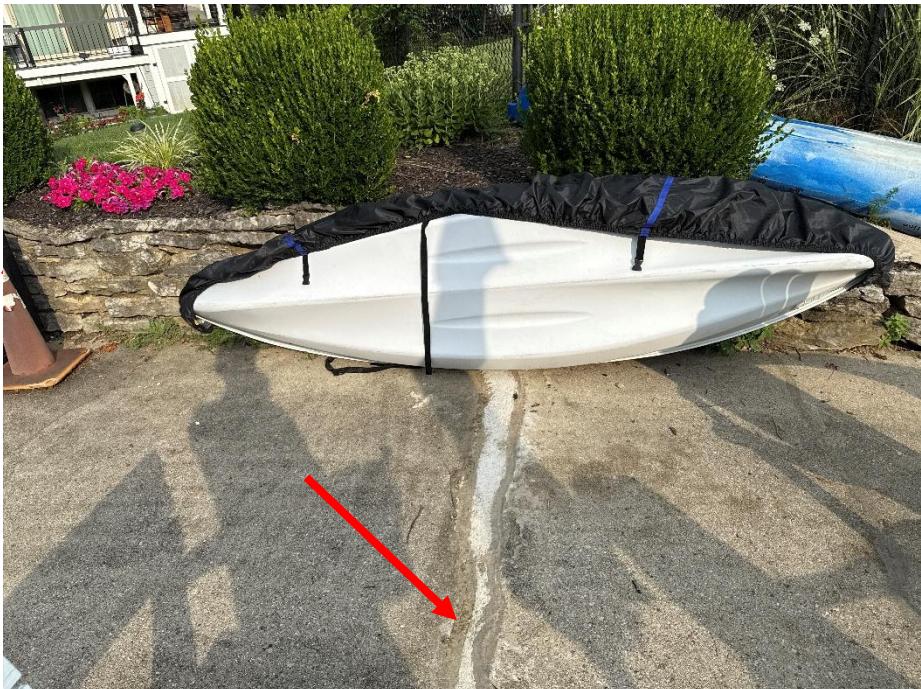
Top: Embankment crest right side. Note watercraft, landscaping, and brush encroaching around patio cut into the embankment. Crack in concrete patio has been patched.

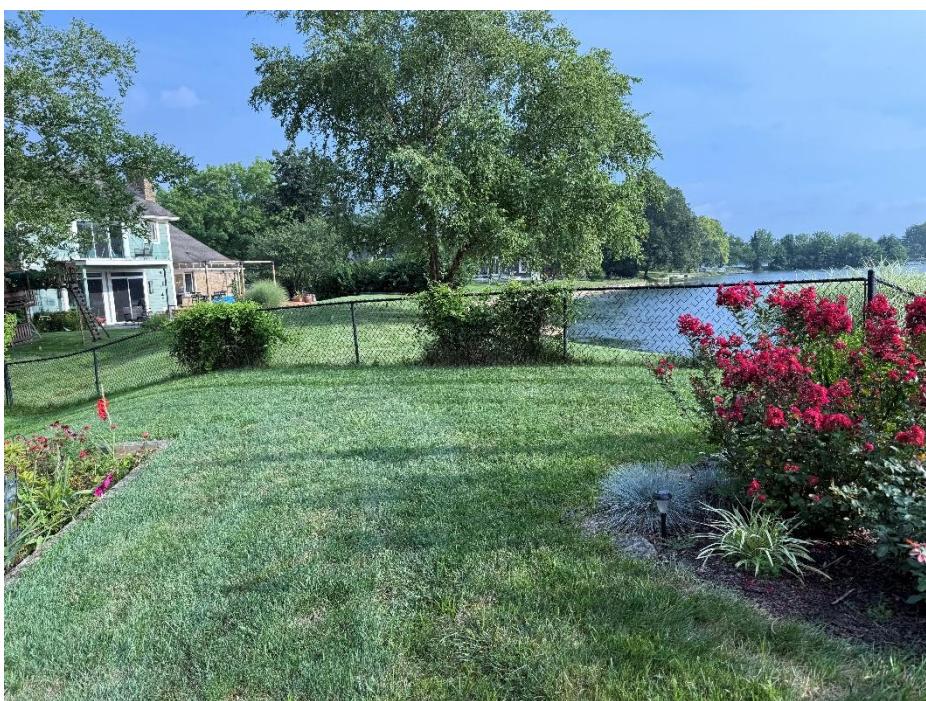
Bottom: Embankment crest right side. Note fencing and brush across embankment typical at each property boundary.

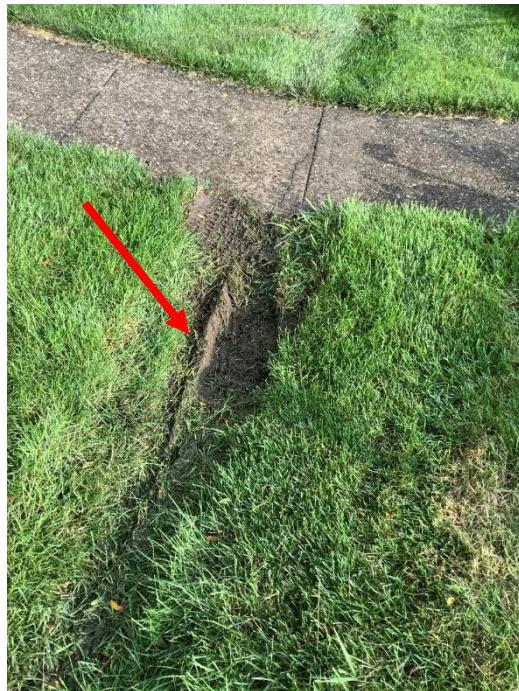
Top: Downstream slope from right side. Note typical damp bare area found at toe of slope likely from irrigation and poor surface drainage.

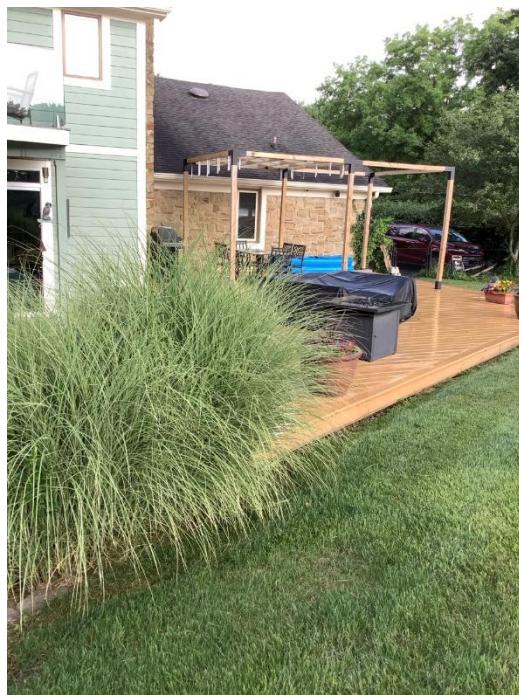
Bottom: Downstream slope from right side. Note extended decking on embankment with landscaping.

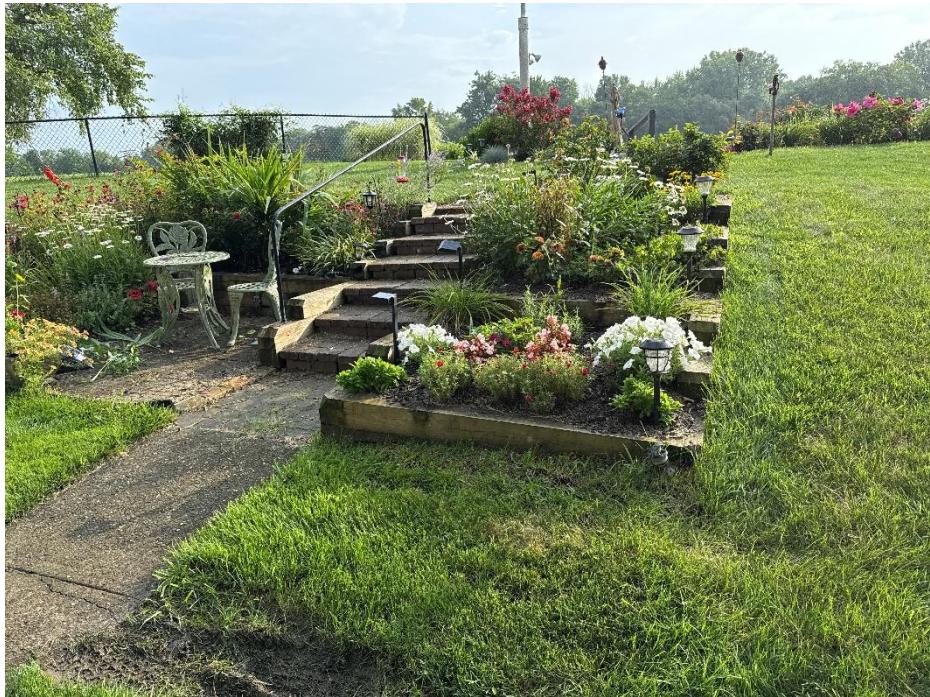
Top: Downstream slope right side. Note landscaping and stairs cut into embankment slope.

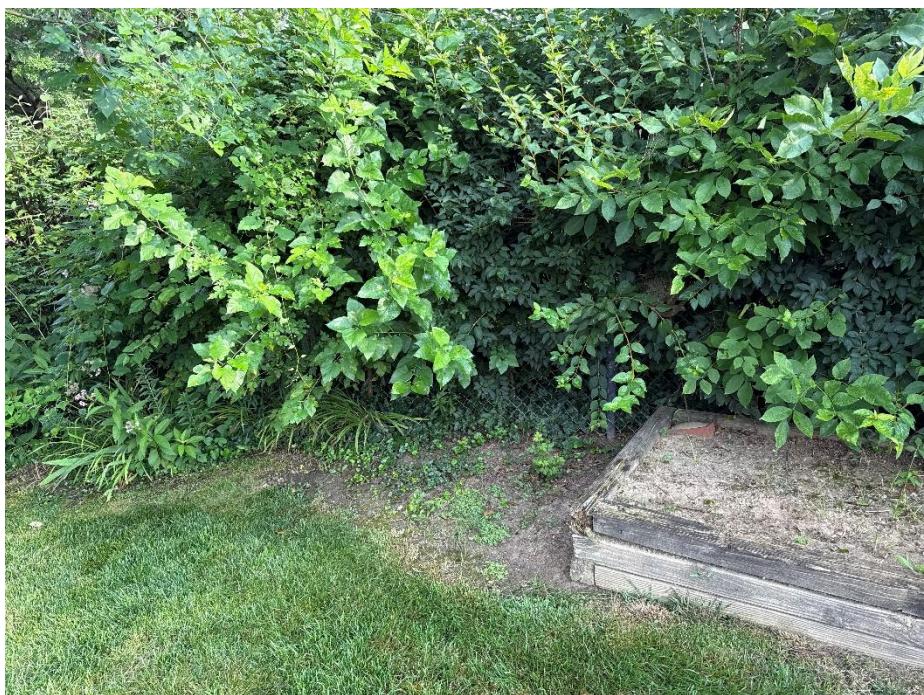
Bottom: Downstream slope right side. Note bare area next to raised garden bed at right abutment and fenceline. Note dense brush along the fenceline prevented a thorough inspection of the area.

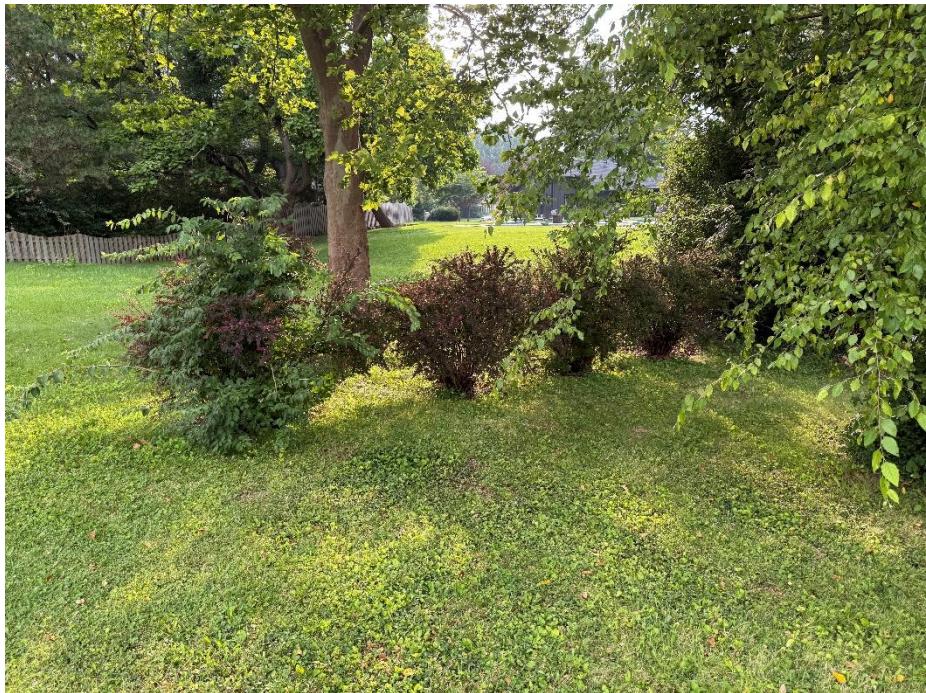
Top: Downstream slope left side. Note trees and bushes growing on and within 25 feet of embankment.

| Component | Rating | Recommendations | Schedule | Importance |
|---|---|--|---|---|
| Downstream Slope | Deficient | Remove trees and brush from the slope and within 25 feet of the slope and abutments in accordance with the Indiana Dam Safety Inspection Manual | Within 1 year | Medium |

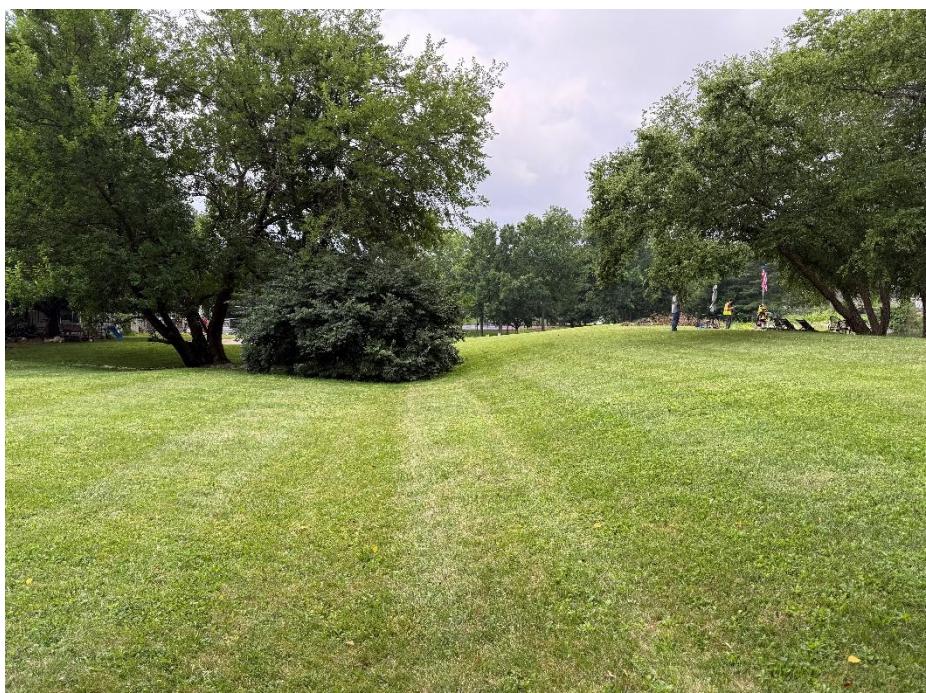
Bottom: Downstream slope from left side. Note trees and bushes growing on and within 25 feet of embankment.

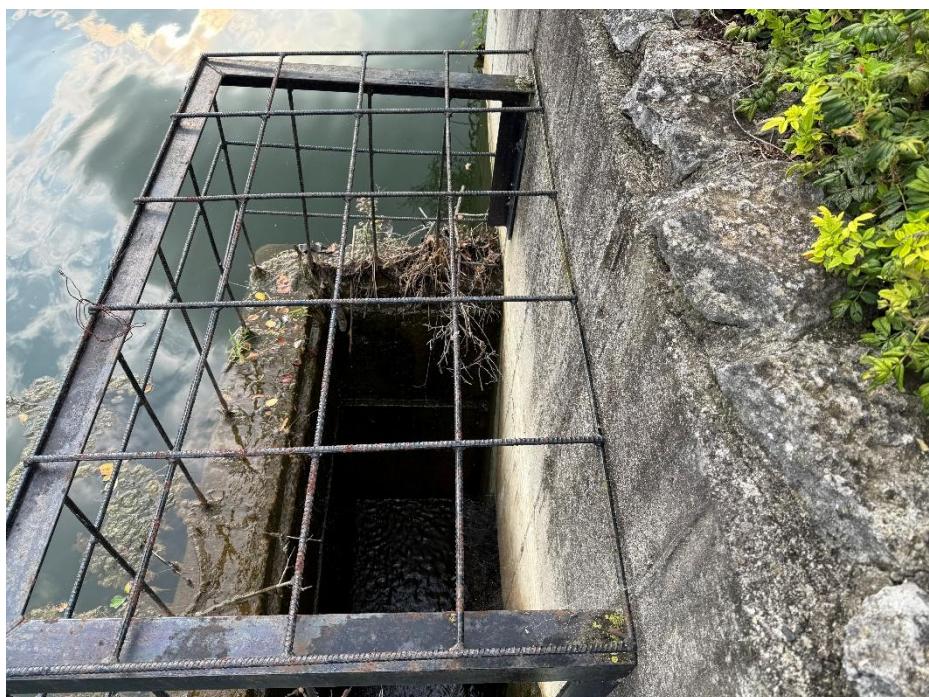
Bottom: Principal spillway drop inlet riser with trashrack near dock. Note minor debris accumulation around inlet and slight surface rust on trashrack.

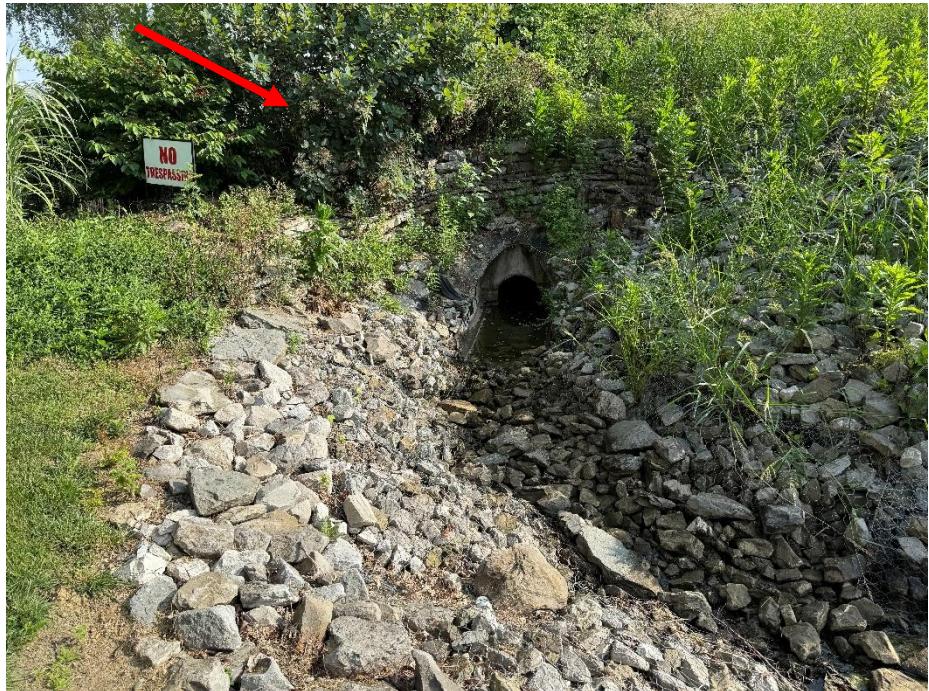
Top: Principal spillway outlet channel. Note tree stumps and surrounding vegetation growth.

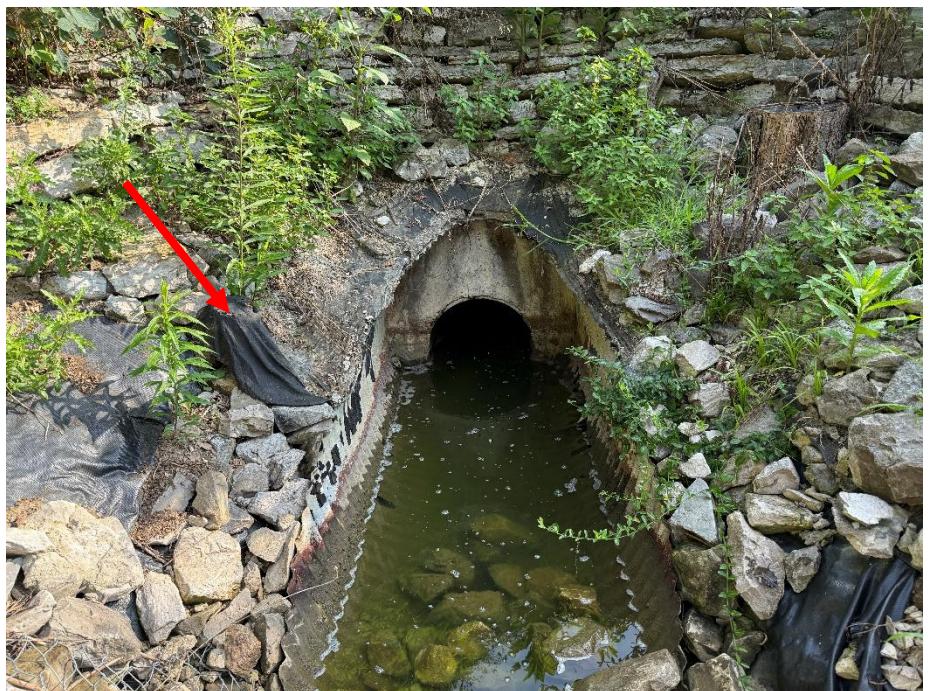
Bottom: Principal spillway outlet and interior of 24-inch CCFRPM discharge pipe outlet. Note exposed geotextile and surrounding vegetation growth.

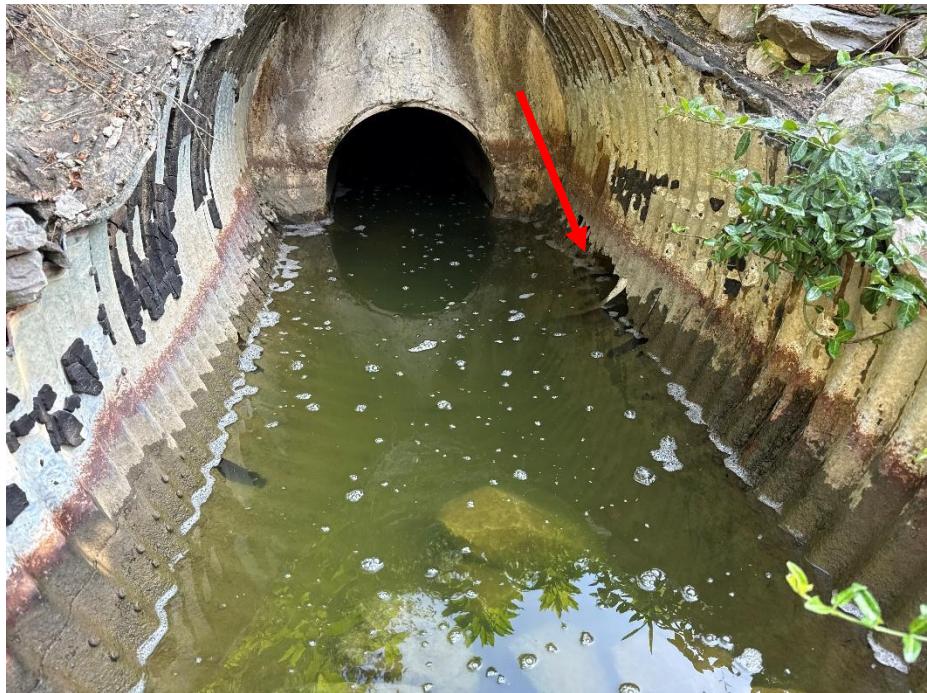
Top: Principal spillway outlet. Note metal end section rust and hole on side.

| Component | Rating | Recommendations | Schedule | Importance |
|---|---|--|---|---|
| | | Remove and replace metal end section at outlet | Within 2 years | Low |

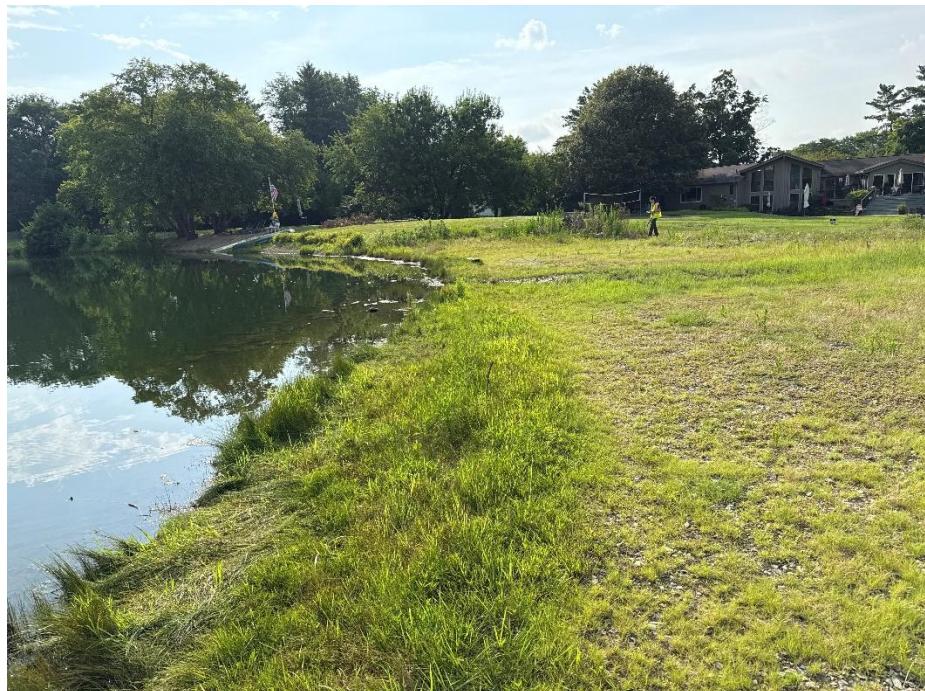
Top: Auxiliary spillway open channel. Note smaller riprap at inlet section with weedy vegetation growth throughout.

| Component | Rating | Recommendations | Schedule | Importance |
|---|---|--|---|---|
| Auxiliary Spillway | Deficient | Retain a qualified professional engineer to appropriately size riprap or other armoring to the spillway inlet section for installation of erosion protection and to establish a uniform crest elevation | Within 1 year | High |

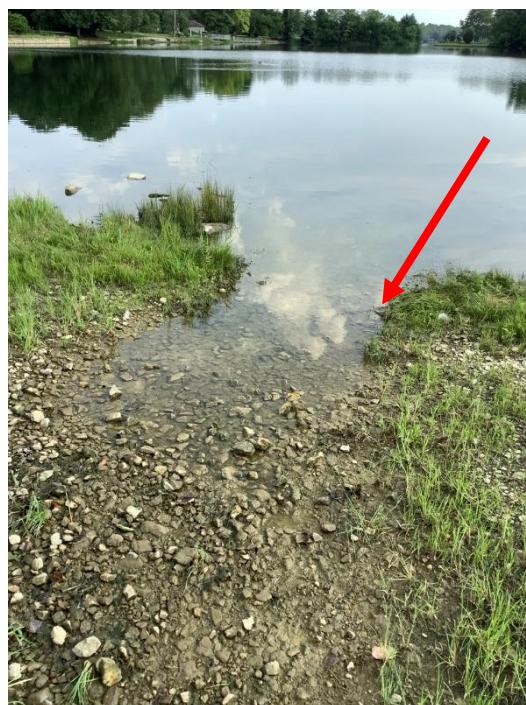
Bottom: Auxiliary spillway open channel. Note start of headcut at shoreline within sparse riprap.

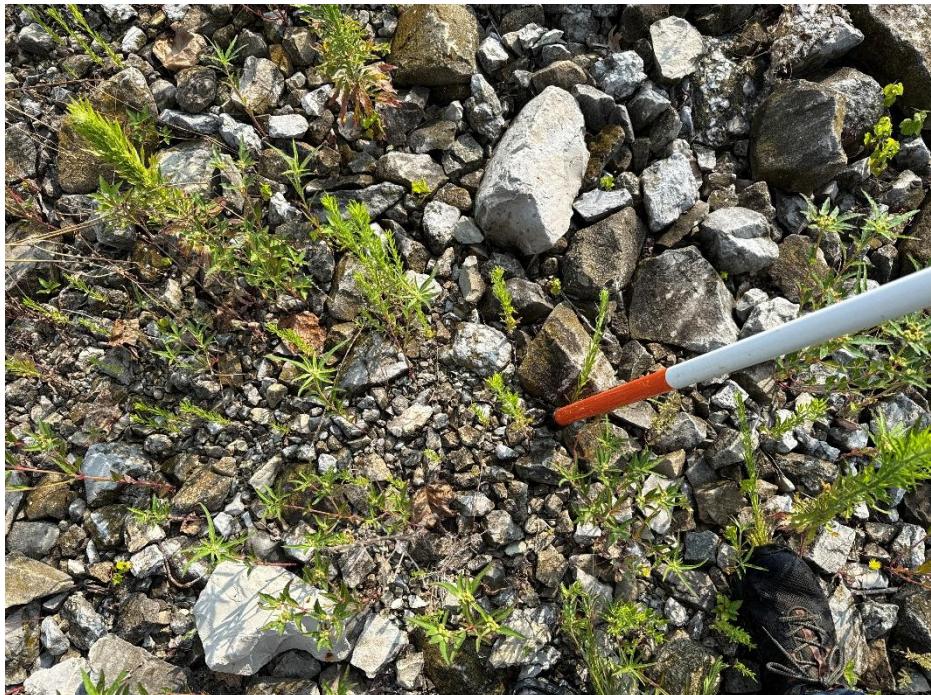
Top: Auxiliary spillway open channel. Note variable riprap sizes and weedy vegetation growth.

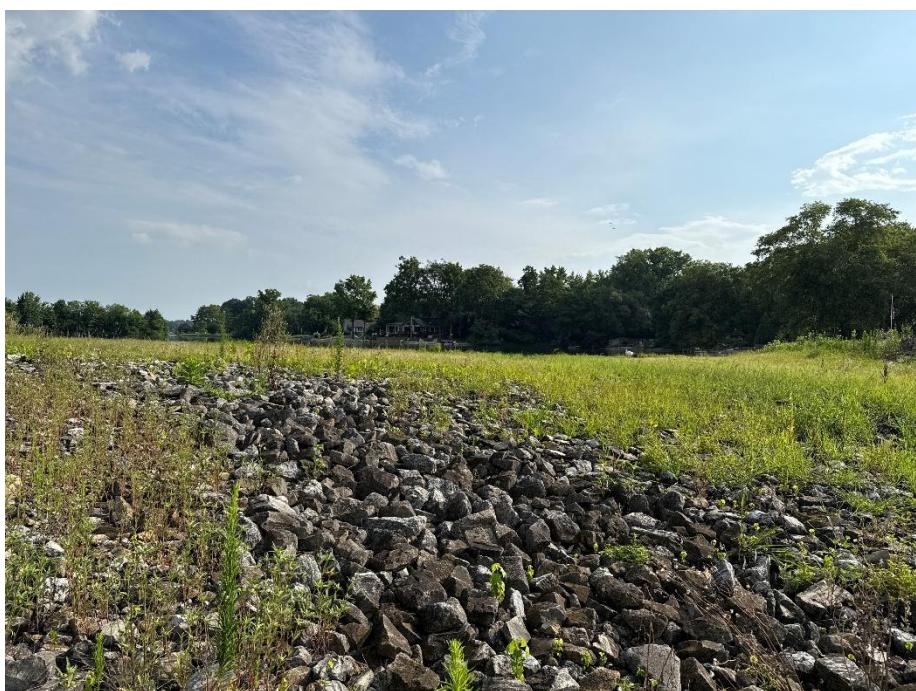
Bottom: Auxiliary spillway open channel with weedy vegetation growth throughout.

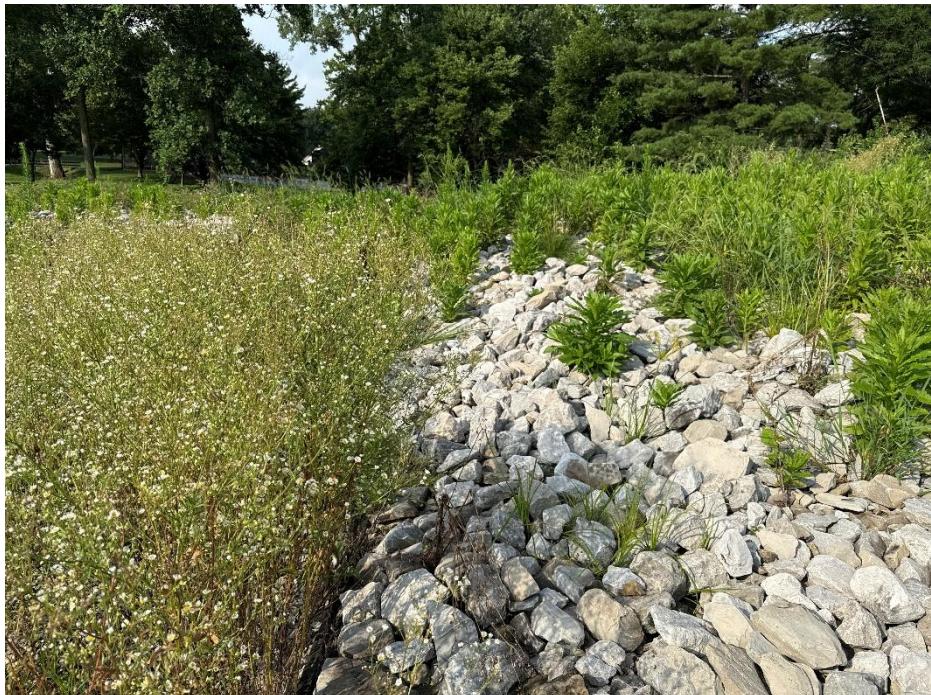
Top: Auxiliary spillway open channel. Looking downstream, note weedy vegetation growth within riprap.

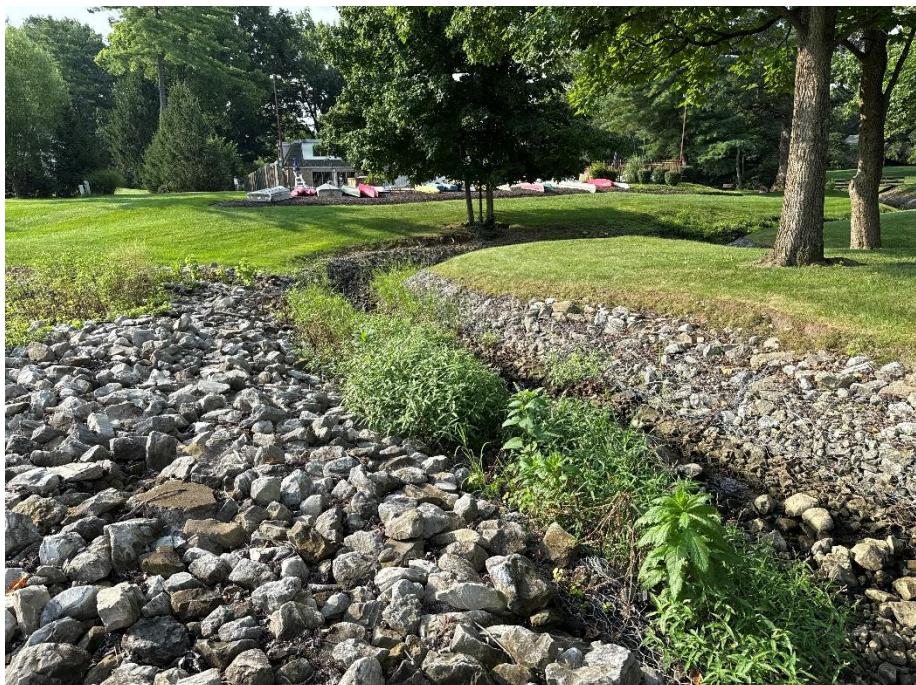
Bottom: Auxiliary spillway open channel. Looking downstream, note weedy vegetation growth within riprap.

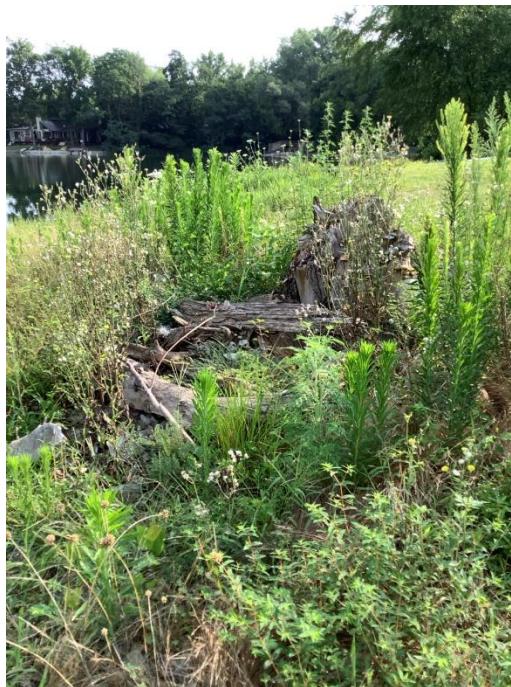
Top: Auxiliary spillway left side. Note tree stump and woody debris surrounded by tall grass.

| Component | Rating | Recommendations | Schedule | Importance |
|---|---|--|---|---|
| | | Evaluate options for removal of the large tree stump on left side and other tree stumps on right side in riprap; monitor areas adjacent to the stumps for seepage or other surficial deficiency monthly and/or after large rain events and notify a registered professional engineer of observed changes | Within 1 year | Low |

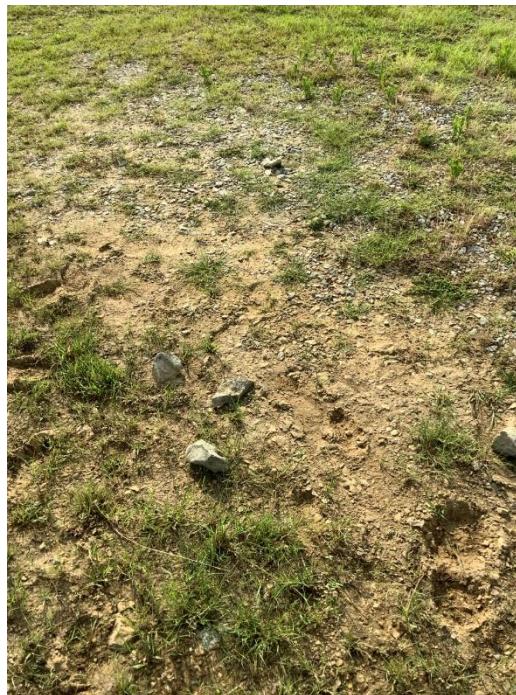
Bottom: Auxiliary spillway left side. Note sporadic bare areas next to channel.
