KEYSTONE WOODS LAKE DAM (29-5)

2025 Dam Safety Inspection Report

Hamilton County, IN | November 2025

Inspection Date: July 25, 2025

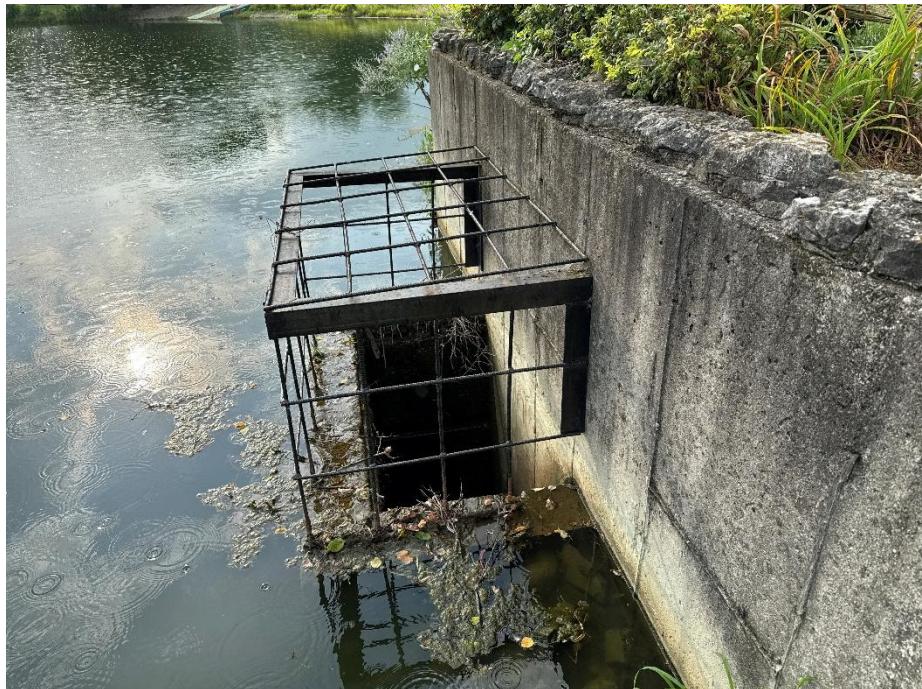
Bottom: Principal spillway drop inlet riser with trashrack near dock. Note minor debris accumulation around inlet and slight surface rust on trashrack.

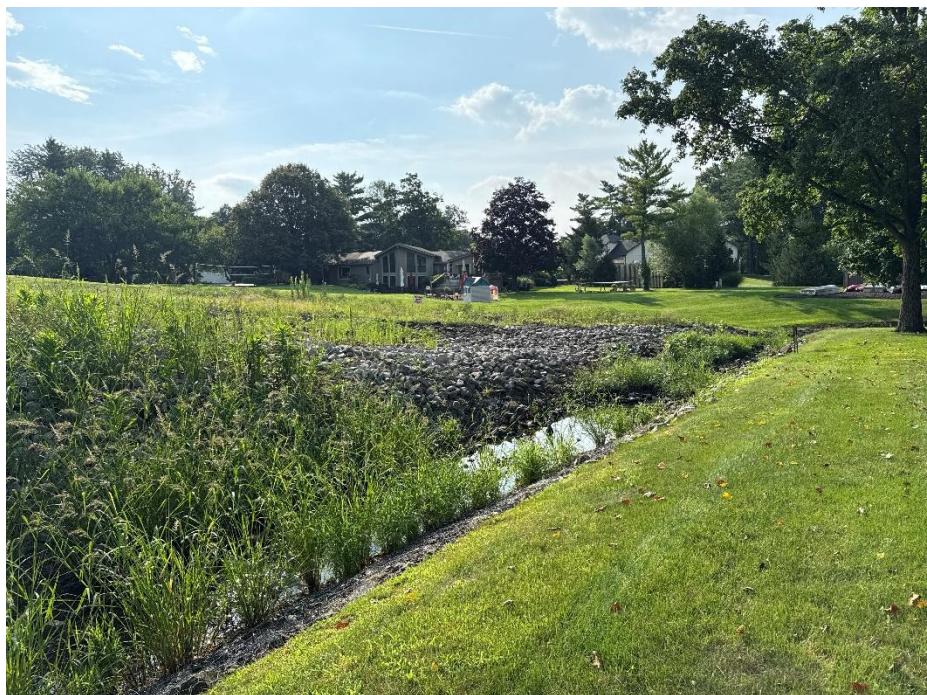
Top: Principal spillway outlet. Note metal end section rust and hole on side.

| Component | Rating | Recommendations | Schedule | Importance |
|---|---|--|---|---|
| | | Remove and replace metal end section at outlet | Within 2 years | Low |
